Visual Site Inspection Report

Project Name	H-600 Pipeline Spread H	AFE	124300138	Spread	H-600 Pipeline Spread H
Contractor	Precision			Report #	5554
Inspector	Dennis Evans			Date/Time	7/31/2018 5:25 PM
Permit #	TBD	Inspection Type	VA SWPP	Station Begin	12994+02
State	VA	Inspection Area	Partial	Station End	13024+06
County	Roanoke	Ground	Wet	Temperature (°F)	74.00
Municipality	N/A	Weather	Cloudy	Rain Gauge (in)	1.00
GPS Location	37.1335955784356, -80.1301673328338			Rain Accumulation Time (days)	1.00

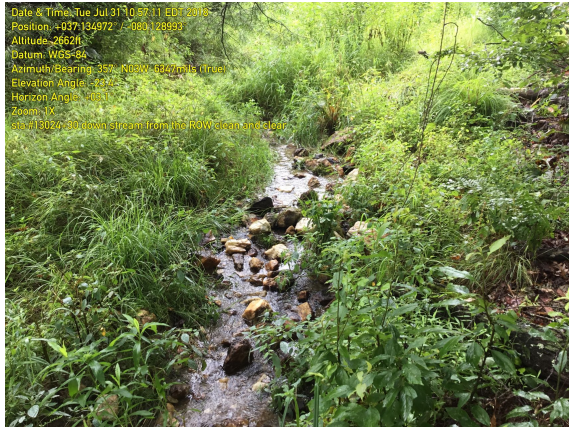
A/E	124300138	Date/Time	7/31/2018 5:25 PM	Report #	5554
Pictures					
<p>Date & Time: Tue Jul 31 10:57:11 EDT 2018 Position: +037.134972° / -080.128531° Altitude: 2662ft Datum: WGS-84 Azimuth/Bearing: 358° S08E 1003mils (True) Elevation Angle: +03.1° Horizon Angle: +03.1° Zoom: 1X Sta #13024+03 S-G24 clean and clear.</p>

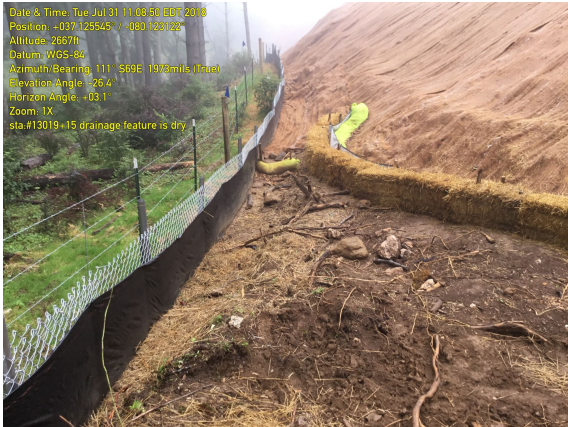
<p>Date & Time: Tue Jul 31 11:00:50 EDT 2018 Position: +037.125545° / -080.128123° Altitude: 2657ft Datum: WGS-84 Azimuth/Bearing: 111° S09E 1003mils (True) Elevation Angle: +06.4° Horizon Angle: +03.1° Zoom: 1X Sta #13019+15 drainage feature is dry.</p>

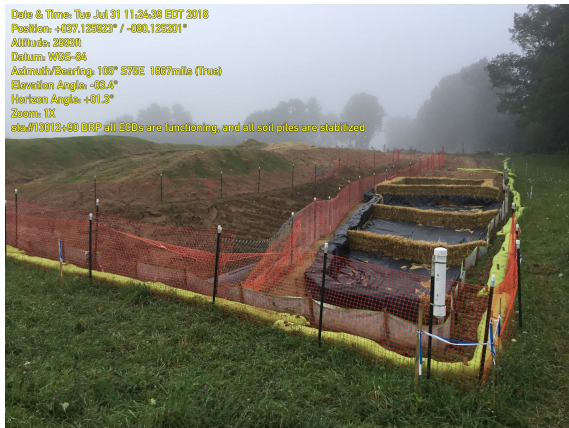
GPS Location	37.132656415959, -80.1311901212485	GPS Location	37.1326147579002, -80.1312111598254		
Description	Sta:#13024+03 S-G24 clean and clear. See photo for accurate coordinates.	Description	Sta:#13019+15 slope side curlexed and stabilized. See photo for accurate coordinates.		
<p>Date & Time: Tue Jul 31 11:26:30 EDT 2018 Position: +037.128822° / -080.128201° Altitude: 2603ft Datum: WGS-84 Azimuth/Bearing: 100° S75E 1007mils (True) Elevation Angle: -03.4° Horizon Angle: +01.5° Zoom: 1X Sta #13012+40 BRP all ECDs are functioning, and all soil piles are stabilized.</p>

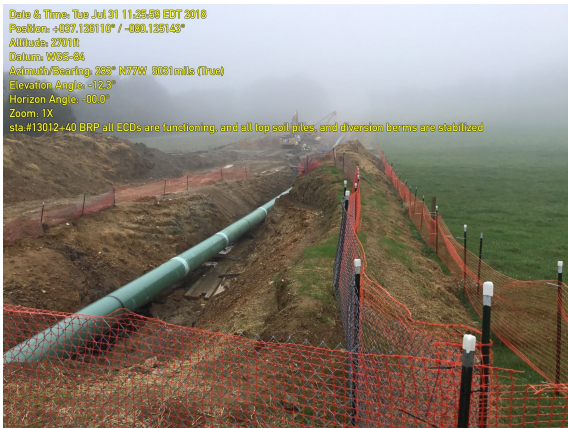
<p>Date & Time: Tue Jul 31 11:26:30 EDT 2018 Position: +037.128110° / -080.128143° Altitude: 2701ft Datum: WGS-84 Azimuth/Bearing: 283° N77W 5031mils (True) Elevation Angle: -13.3° Horizon Angle: -00.0° Zoom: 1X Sta #13012+40 BRP all ECDs are functioning, and all top soil piles, and diversion berms are stabilized.</p>

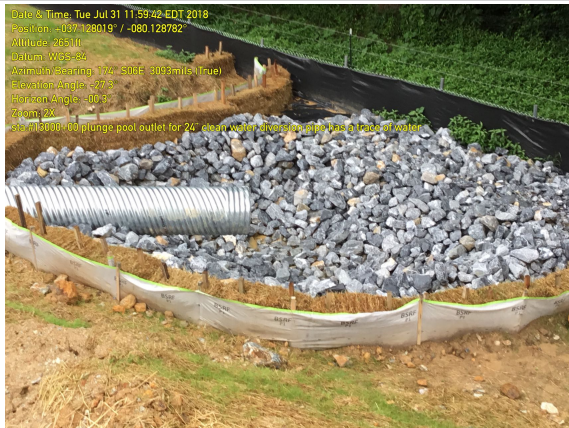
GPS Location	37.1324512269694, -80.1312509738655	GPS Location	37.1326469863179, -80.1312306058408		
Description	Sta:#13012+90 all ECDs functioning. See photo for accurate coordinates.	Description	Sta:#13012+90 all ECDs functioning. See photo for accurate coordinates.		
<p>Date & Time: Tue Jul 31 11:59:42 EDT 2018 Position: +037.128919° / -080.128782° Altitude: 2651ft Datum: WGS-84 Azimuth/Bearing: 110° S04E 9103mils (True) Elevation Angle: +12.4° Horizon Angle: +00.0° Zoom: 1X Sta #13000+00 plunge pool outlet for 26" clean water diversion pipe has a trace of water.</p>

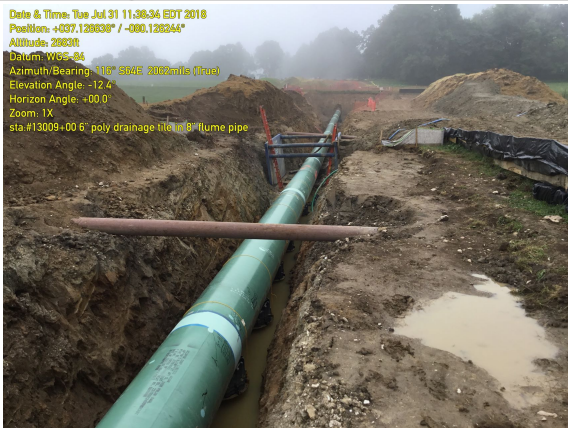
<p>Date & Time: Tue Jul 31 11:58:34 EDT 2018 Position: +037.128838° / -080.128244° Altitude: 2603ft Datum: WGS-84 Azimuth/Bearing: 110° S04E 9103mils (True) Elevation Angle: -12.4° Horizon Angle: +00.0° Zoom: 1X Sta #13009+00 6" poly drainage tile in 8" flume pipe.</p>

Description	Sta:#13000+00 plunge pool outlet with a trace of water. See photo for accurate coordinates.	Description	Sta:#13009+16 drain tile repaired. See photo for accurate coordinates.
