# Visual Site Inspection Report

<b>Project Name</b>	H-600 Pipeline Spread H	<b>AFE</b>	124300138	<b>Spread</b>	H-600 Pipeline Spread H
<b>Contractor</b>	Precision			<b>Report #</b>	6437
<b>Inspector</b>	Dennis Evans			<b>Date/Time</b>	8/16/2018 4:25 PM
<b>Permit #</b>	TBD	<b>Inspection Type</b>	VA SWPP	<b>Station Begin</b>	12944+02
<b>State</b>	VA	<b>Inspection Area</b>	Partial	<b>Station End</b>	13024+06
<b>County</b>	Roanoke	<b>Ground</b>	Dry	<b>Temperature (°F)</b>	84.00
<b>Municipality</b>	N/A	<b>Weather</b>	Sunny	<b>Rain Gauge (in)</b>	0.00
<b>GPS Location</b>	37.1280575590554, -80.1289561764152			<b>Rain Accumulation Time (days)</b>	1.00

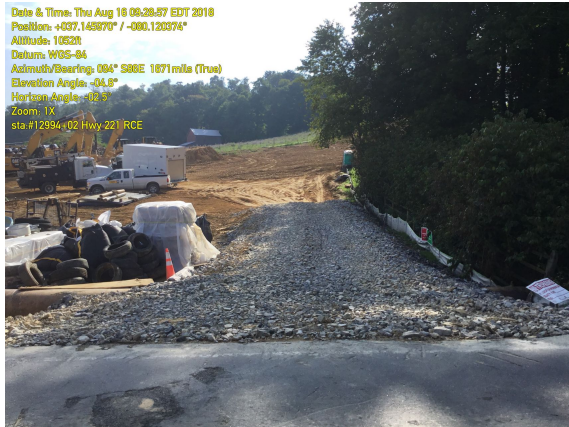
A/E	124300138	Date/Time	8/16/2018 4:25 PM	Report #	6437
Pictures					
<p>Date &amp; Time: Thu Aug 16 06:28:37 EDT 2018 Position: +037.145870° / -080.123374° Altitude: 1052ft Datum: WGS-84 Azimuth/Bearing: 094° S88E 1871mils (True) Elevation Angle: -04.0° Horizon Angle: -02.0° Zoom: 1X sta.#12994+02 Hwy 221 RCE</p>

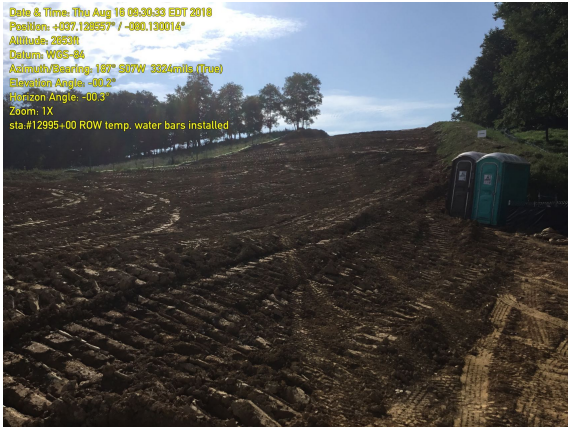
<p>Date &amp; Time: Thu Aug 16 06:30:33 EDT 2018 Position: +037.128857° / -080.130014° Altitude: 2653ft Datum: WGS-84 Azimuth/Bearing: 187° S07W 3334mils (True) Elevation Angle: -02.2° Horizon Angle: -00.3° Zoom: 1X sta.#12995+00 ROW temp. water bars installed</p>

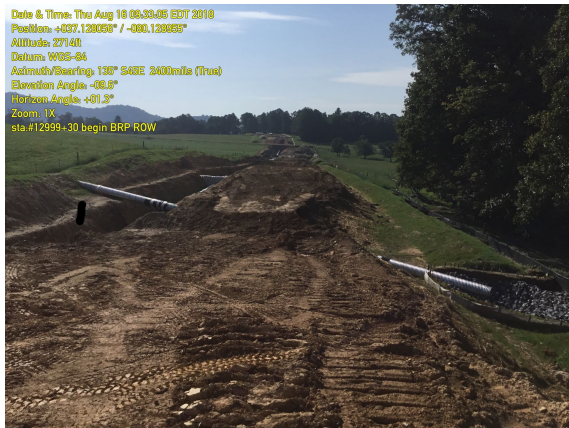
GPS Location	37.1280294377702, -80.1289810706676	GPS Location	37.1281140111732, -80.1288907137514		
Description	Sta:#12994+02 HWY 221 RCE See photo for accurate coordinates.	Description	Sta:#12995+00 Hwy 221 ROW See photo for accurate coordinates.		
<p>Date &amp; Time: Thu Aug 16 06:33:05 EDT 2018 Position: +037.129058° / -080.128658° Altitude: 2714ft Datum: WGS-84 Azimuth/Bearing: 130° S48E 2400mils (True) Elevation Angle: -08.8° Horizon Angle: +01.3° Zoom: 1X sta.#12999+30 begin BRP ROW</p>

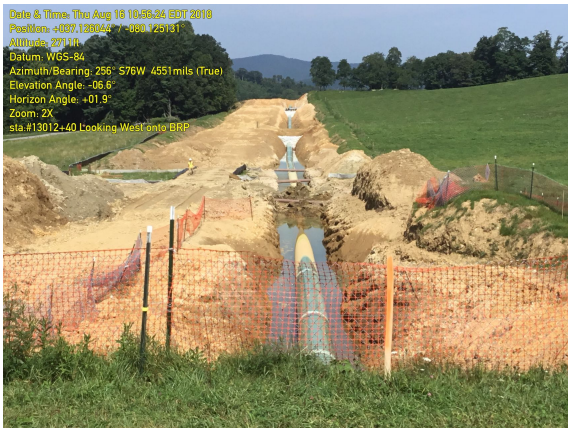
<p>Date &amp; Time: Thu Aug 16 10:40:54 EDT 2018 Position: +037.128044° / -080.12911° Altitude: 2711ft Datum: WGS-84 Azimuth/Bearing: 256° S76W 4551mils (True) Elevation Angle: -06.6° Horizon Angle: +01.9° Zoom: 2X sta.#13012+40 looking West onto BRP</p>

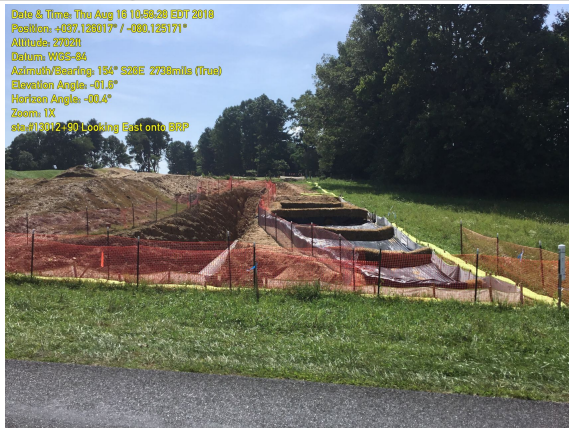
GPS Location	37.1279509831566, -80.1288938150556	GPS Location	37.2788264508739, -80.029417038185		
Description	Sta:#12999+30 Begin of BRP See photo for accurate coordinates.	Description	Sta:#13012+40 looking West onto the BRP See photo for accurate coordinates.		
<p>Date &amp; Time: Thu Aug 16 10:58:36 EDT 2018 Position: +037.128017° / -080.125171° Altitude: 2702ft Datum: WGS-84 Azimuth/Bearing: 154° S28E 2798mils (True) Elevation Angle: -01.8° Horizon Angle: -00.4° Zoom: 1X sta.#13012+90 looking East onto BRP</p>

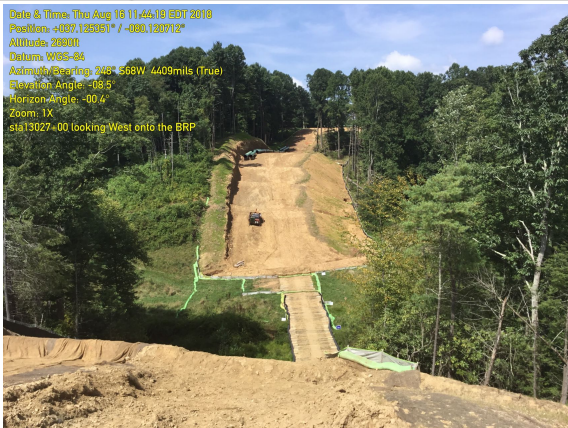
<p>Date &amp; Time: Thu Aug 16 11:44:16 EDT 2018 Position: +037.125861° / -080.130713° Altitude: 2600ft Datum: WGS-84 Azimuth/Bearing: 249° S68W 4409mils (True) Elevation Angle: -06.5° Horizon Angle: -00.4° Zoom: 1X sta.#13027+00 looking West onto the BRP</p>
