# Visual Site Inspection Report

<b>Project Name</b>	H-600 Pipeline Spread H	<b>AFE</b>	124300138	<b>Spread</b>	H-600 Pipeline Spread H
<b>Contractor</b>	Precision			<b>Report #</b>	6439
<b>Inspector</b>	Dennis Evans			<b>Date/Time</b>	8/16/2018 4:35 PM
<b>Permit #</b>	TBD	<b>Inspection Type</b>	VA SWPP	<b>Station Begin</b>	12994+02
<b>State</b>	VA	<b>Inspection Area</b>	Partial	<b>Station End</b>	13024+06
<b>County</b>	Roanoke	<b>Ground</b>	Dry	<b>Temperature (°F)</b>	84.00
<b>Municipality</b>	N/A	<b>Weather</b>	Sunny	<b>Rain Gauge (in)</b>	0.00
<b>GPS Location</b>	37.2788319836654, -80.0294919522294			<b>Rain Accumulation Time (days)</b>	1.00

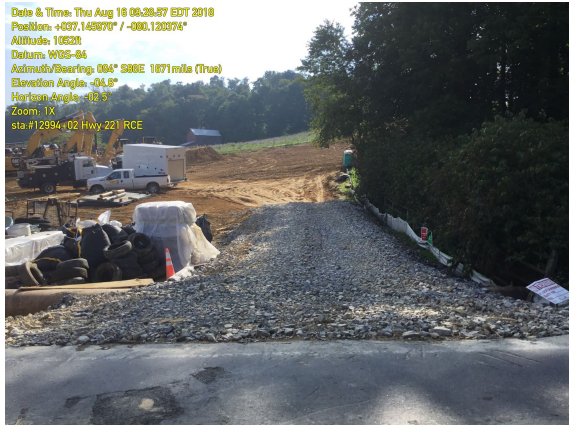
A/E	124300138	Date/Time	8/16/2018 4:35 PM	Report #	6439
Pictures					
<p>Date &amp; Time: Thu Aug 16 06:28:37 EDT 2018 Position: +037.145870° / -080.123374° Altitude: 1052ft Datum: WGS-84 Azimuth/Bearing: 094° S88E 1871mils (True) Elevation Angle: -04.0° Horizon Angle: -02.0° Zoom: 1X Sta:#12994+02 Hwy 221 RCE</p>

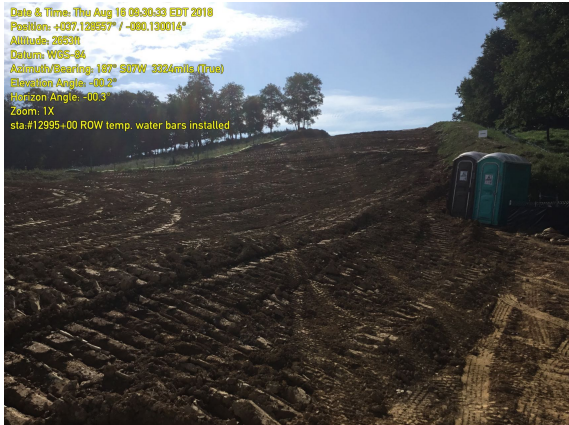
<p>Date &amp; Time: Thu Aug 16 06:30:33 EDT 2018 Position: +037.128857° / -080.130014° Altitude: 2653ft Datum: WGS-84 Azimuth/Bearing: 187° S07W 3334mils (True) Elevation Angle: -02.2° Horizon Angle: -00.3° Zoom: 1X Sta:#12995+00 ROW temp. water bars installed</p>

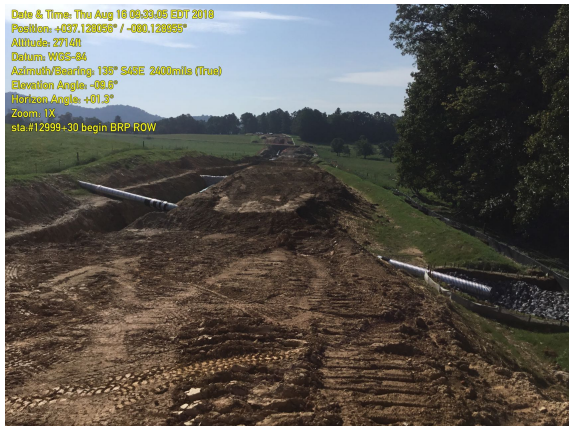
GPS Location	37.2788314470297, -80.0294846861816	GPS Location	37.2788322216485, -80.0294951745212		
Description	Sta:#12994+02 HWY 221 RCE See photo for accurate coordinates.	Description	Sta:#12995+00 ROW See photo for accurate coordinates.		
<p>Date &amp; Time: Thu Aug 16 06:33:05 EDT 2018 Position: +037.129358° / -080.128658° Altitude: 2714ft Datum: WGS-84 Azimuth/Bearing: 130° S48E 2400mils (True) Elevation Angle: -08.8° Horizon Angle: +01.3° Zoom: 1X Sta:#12999+30 begin BRP ROW</p>

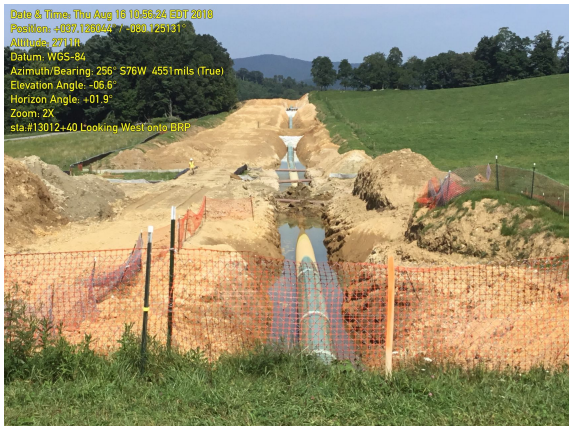
<p>Date &amp; Time: Thu Aug 16 10:40:54 EDT 2018 Position: +037.130042° / -080.129131° Altitude: 2711ft Datum: WGS-84 Azimuth/Bearing: 256° S76W 4551mils (True) Elevation Angle: -06.6° Horizon Angle: +01.9° Zoom: 2X Sta:#13012+40 Looking West onto BRP</p>

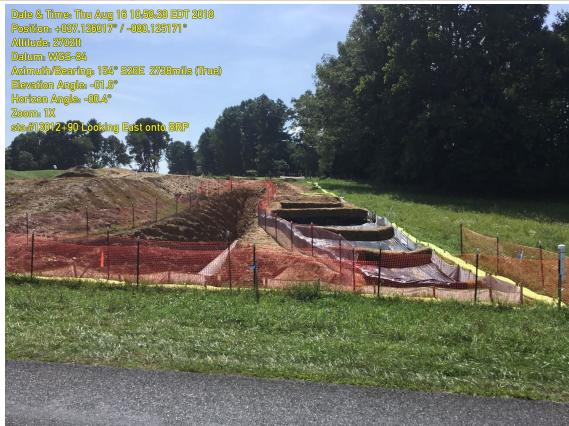
GPS Location	37.2788321800095, -80.0294946107295	GPS Location	37.2788322757627, -80.0294959072267		
Description	Sta:#12999+30 Begin of the BRP See photo for accurate coordinates.	Description	Sta:#13012+40 looking West onto the BRP See photo for accurate coordinates.		
<p>Date &amp; Time: Thu Aug 16 10:58:36 EDT 2018 Position: +037.125017° / -080.125171° Altitude: 2702ft Datum: WGS-84 Azimuth/Bearing: 154° S28E 2798mils (True) Elevation Angle: -01.8° Horizon Angle: -00.4° Zoom: 1X Sta:#13012+90 Looking East onto BRP</p>

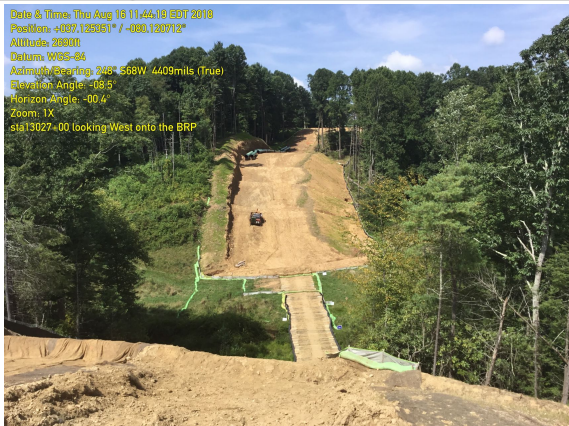
<p>Date &amp; Time: Thu Aug 16 11:44:16 EDT 2018 Position: +037.125017° / -080.120712° Altitude: 2600ft Datum: WGS-84 Azimuth/Bearing: 240° S68W 4409mils (True) Elevation Angle: -06.5° Horizon Angle: -00.4° Zoom: 1X Sta:#13027+00 looking West onto the BRP</p>
