Visual Site Inspection Report

Project Name	H-600 Pipeline Spread H	AFE	124300138	Spread	H-600 Pipeline Spread H
Contractor	Precision			Report #	6777
Inspector	Dennis Evans			Date/Time	8/22/2018 8:17 PM
Permit #	TBD	Inspection Type	VA SWPP	Station Begin	12661+50
State	VA	Inspection Area	Partial	Station End	13024+06
County	Roanoke	Ground	Dry	Temperature (°F)	73.00
Municipality	N/A	Weather	Sunny	Rain Gauge (in)	0.00
GPS Location	37.1930681867871, -80.1608773135395			Rain Accumulation Time (days)	1.00

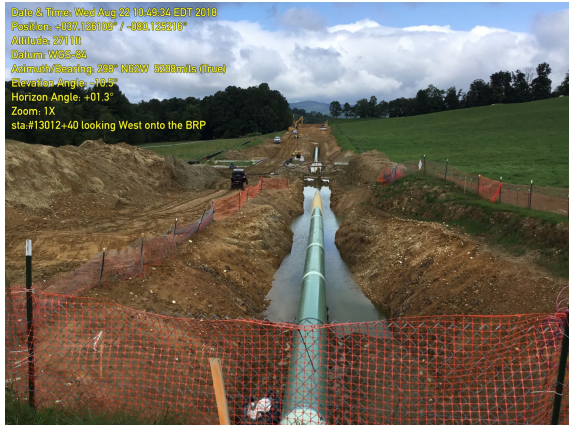
A/E	124300138	Date/Time	8/22/2018 8:17 PM	Report #	6777
Pictures					
<p>Date & Time: Wed Aug 22 10:46:07 EDT 2018 Position: +037.130100° / -080.128219° Altitude: 2711ft Datum: WGS-84 Azimuth/Bearing: 200° N029° 520mils (True) Elevation Angle: +02° Horizon Angle: +01.3° Zoom: 1X Sta:#13012+40 looking West onto the BRP</p>

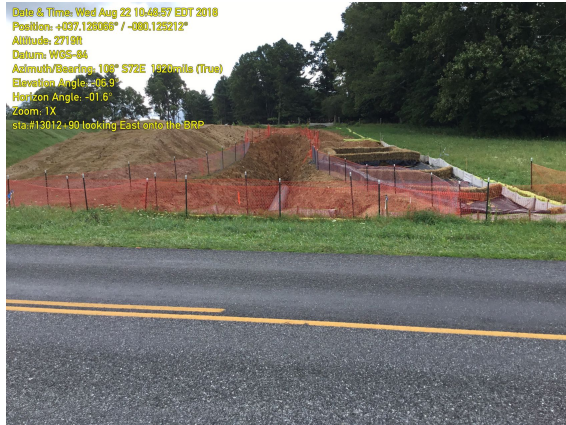
<p>Date & Time: Wed Aug 22 10:48:07 EDT 2018 Position: +037.129080° / -080.128212° Altitude: 2719ft Datum: WGS-84 Azimuth/Bearing: 100° S72E 1920mils (True) Elevation Angle: +08.9° Horizon Angle: -01.6° Zoom: 1X Sta:#13012+90 looking East onto the BRP</p>

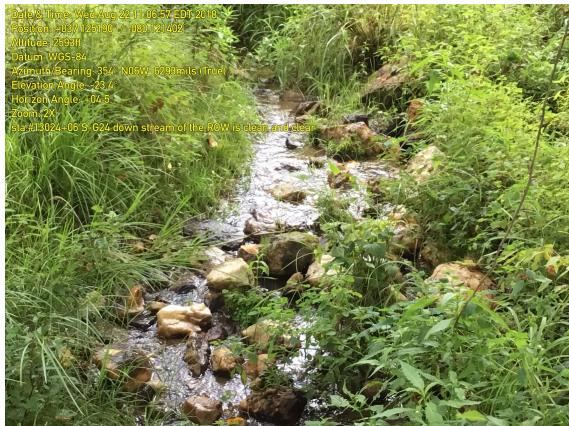
GPS Location	37.2790143001412, -80.0294608874509	GPS Location	37.2798401437461, -80.029259733324		
Description	Sta:#13012+40 looking onto the BRP See photo for accurate coordinates.	Description	Sta:#13012+90 looking onto the BRP See photo for accurate coordinates.		
<p>Date & Time: Wed Aug 22 11:08:29 EDT 2018 Position: +037.125418° / -080.121510° Altitude: 2438ft Datum: WGS-84 Azimuth/Bearing: 350° N060° 4782mils (True) Elevation Angle: +02.5° Horizon Angle: +02.5° Zoom: 2X Sta:#13024+06 S-G24 down stream of the ROW looking and east</p>

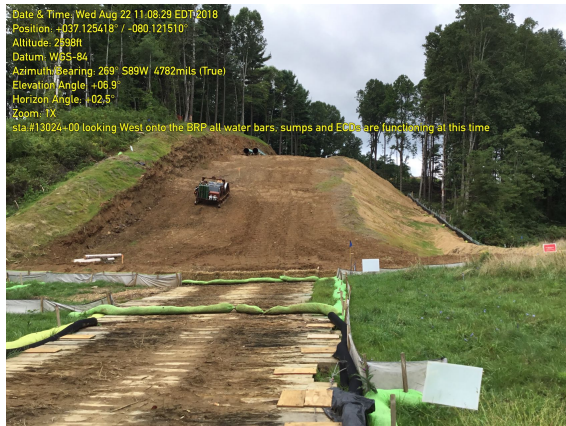
<p>Date & Time: Wed Aug 22 11:08:29 EDT 2018 Position: +037.125418° / -080.121510° Altitude: 2438ft Datum: WGS-84 Azimuth/Bearing: 269° S89W 4782mils (True) Elevation Angle: +06.9° Horizon Angle: +02.5° Zoom: 1X Sta:#13024+00 looking West onto the BRP all water bars, sumps and E ditches are functioning at this time</p>

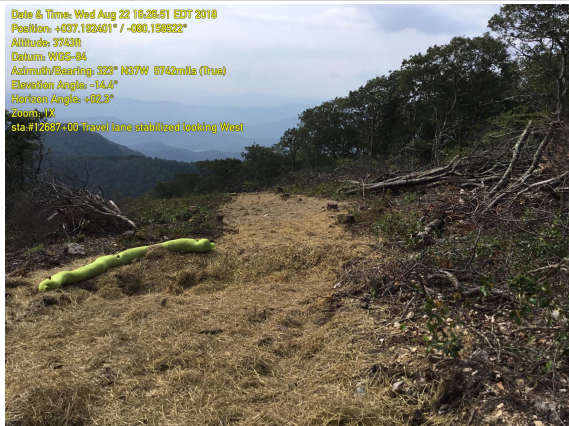
GPS Location	37.2798401437461, -80.029259733324	GPS Location	37.2798401437461, -80.029259733324		
Description	Sta:#13024+06 S-G24 clean and clear See photo for accurate coordinates.	Description	Sta:#13024+00 looking East onto the BRP See photo for accurate coordinates.		
<p>Date & Time: Wed Aug 22 16:35:51 EDT 2018 Position: +037.182601° / -080.138522° Altitude: 3743ft Datum: WGS-84 Azimuth/Bearing: 323° N037W 5742mils (True) Elevation Angle: +14.4° Horizon Angle: +05.2° Zoom: 1X Sta:#12687+00 Travel lane stabilized looking West</p>

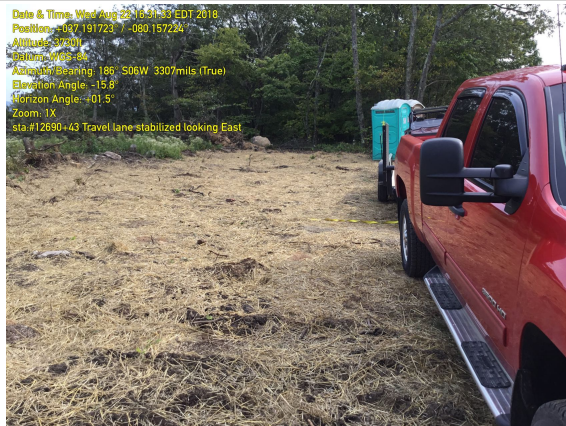
<p>Date & Time: Wed Aug 22 16:36:33 EDT 2018 Position: +037.191723° / -080.157224° Altitude: 3750ft Datum: WGS-84 Azimuth/Bearing: 166° S06W 3307mils (True) Elevation Angle: -15.8° Horizon Angle: -01.5° Zoom: 1X Sta:#12690+43 Travel lane stabilized looking East</p>

Description	Sta:#12687+00 Travel lane stabilized See photo for accurate coordinates.	Description	Sta:#12690+43 East side of ROW stabilized. See photo for accurate coordinates.
