# Visual Site Inspection Report

<b>Project Name</b>	H-600 Pipeline Spread H	<b>AFE</b>	124300138	<b>Spread</b>	H-600 Pipeline Spread H
<b>Contractor</b>	Precision			<b>Report #</b>	7054
<b>Inspector</b>	Dennis Evans			<b>Date/Time</b>	8/28/2018 5:20 PM
<b>Permit #</b>	TBD	<b>Inspection Type</b>	VA SWPP	<b>Station Begin</b>	12993+15
<b>State</b>	VA	<b>Inspection Area</b>	Partial	<b>Station End</b>	13024+06
<b>County</b>	Roanoke	<b>Ground</b>	Dry	<b>Temperature (°F)</b>	84.00
<b>Municipality</b>	N/A	<b>Weather</b>	Sunny	<b>Rain Gauge (in)</b>	0.00
<b>GPS Location</b>	37.1265840623873, -80.1262528450043			<b>Rain Accumulation Time (days)</b>	1.00

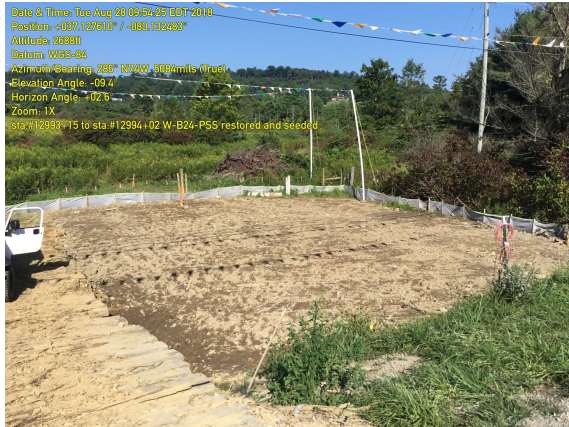
A/E	124300138	Date/Time	8/28/2018 5:20 PM	Report #	7054
Pictures					
<p>Date &amp; Time: Tue Aug 28 05:55:45 EDT 2018 Position: +037.127912° / -080.128663° Altitude: 2620ft Datum: WGS-84 Azimuth/Bearing: 207° S292W 1704mils (True) Elevation Angle: -09.2° Horizon Angle: +02.5° Zoom: 1X Sta: #12993+15 to Sta: #12994+02 W-B24-PSS restored and seeded</p>

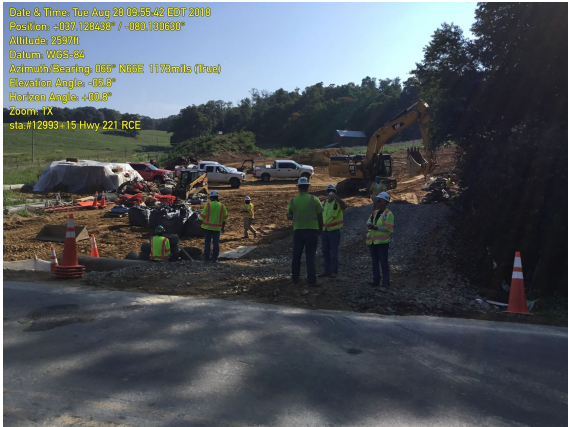
<p>Date &amp; Time: Tue Aug 28 05:55:48 EDT 2018 Position: +037.128692° / -080.128631° Altitude: 2620ft Datum: WGS-84 Azimuth/Bearing: 007° N00E 1172mils (True) Elevation Angle: -08.5° Horizon Angle: +05.5° Zoom: 1X Sta: #12993+15 Hwy 221 RCE</p>

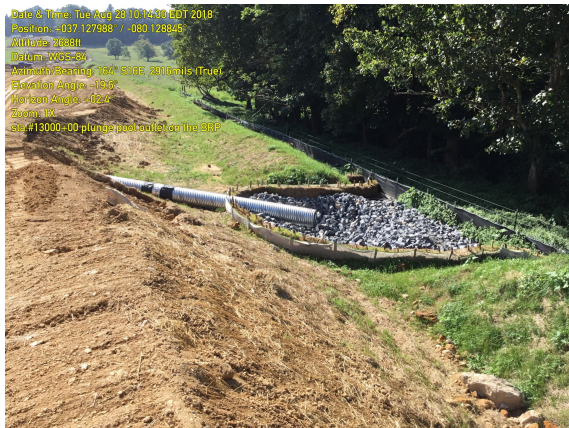
GPS Location	37.2801378598453, -80.0286723925048		GPS Location	37.2806928629786, -80.0286743847942	
Description	Sta: @12993+15 W-B24-PSS restored. See photo for accurate coordinates.		Description	Sta: #12994+02 RCE in compliance at this time See photo for accurate coordinates	
<p>Date &amp; Time: Tue Aug 28 10:25:17 EDT 2018 Position: +037.127908° / -080.128645° Altitude: 2600ft Datum: WGS-84 Azimuth/Bearing: 150° S15E 3410mils (True) Elevation Angle: -15.3° Horizon Angle: +02.2° Zoom: 1X Sta: #13000+00 plunge pool outlet on the BRP</p>

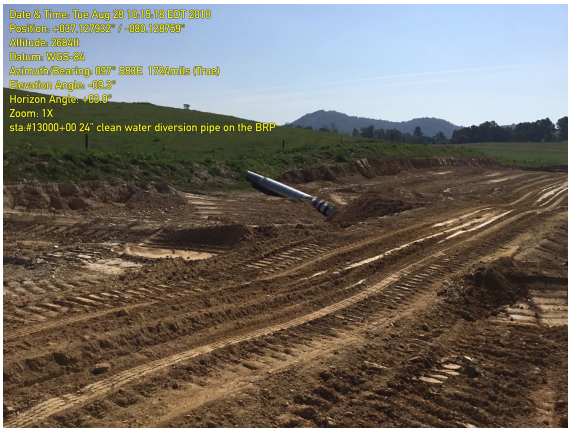
<p>Date &amp; Time: Tue Aug 28 10:16:18 EDT 2018 Position: +037.127692° / -080.128703° Altitude: 2600ft Datum: WGS-84 Azimuth/Bearing: 007° S00E 1724mils (True) Elevation Angle: -08.3° Horizon Angle: +05.0° Zoom: 1X Sta: #13000+00 24" clean water diversion pipe on the BRP</p>

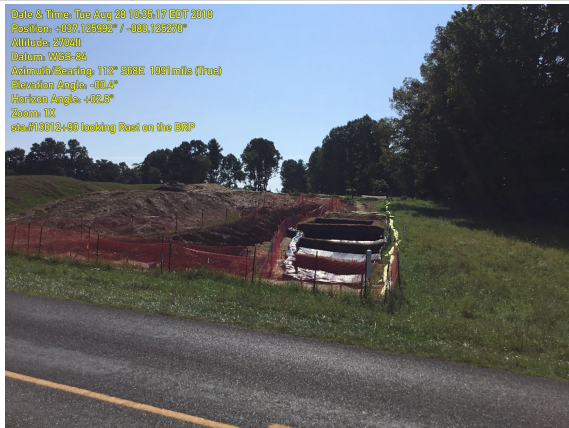
GPS Location	37.2804221207685, -80.0289193345395		GPS Location	37.2805085525365, -80.0287594714643	
Description	Sta: #13000+00 Plunge pool outlet functioning See photo for accurate coordinates.		Description	Sta: #13000+00 24" diversion pipe See photo for accurate coordinates.	
<p>Date &amp; Time: Tue Aug 28 10:35:17 EDT 2018 Position: +037.125082° / -080.125270° Altitude: 2700ft Datum: WGS-84 Azimuth/Bearing: 113° S09E 1001mils (True) Elevation Angle: -00.4° Horizon Angle: +02.5° Zoom: 1X Sta: #13012+00 looking East on the BRP</p>

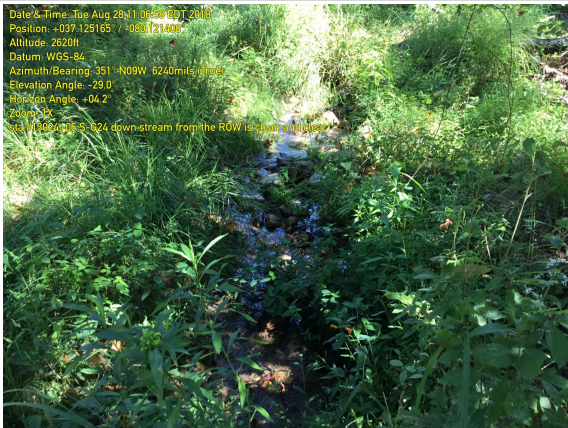
<p>Date &amp; Time: Tue Aug 28 11 05:40 EDT 2018 Position: +037.125165° / -080.121406° Altitude: 2620ft Datum: WGS-84 Azimuth/Bearing: 351° N09W 6240mils (True) Elevation Angle: -29.0° Horizon Angle: +04.2° Zoom: 1X Sta: #13024+06 S-G24 down stream from the ROW to East side BRP</p>

Description	Sta: #13012+90 East side BRP See photo for accurate coordinates.		Description	Sta: #13024+06 S-G24 down from ROW. See photo for accurate coordinates.
