# Visual Site Inspection Report

<b>Project Name</b>	H-600 Pipeline Spread H	<b>A/E</b>	124300138	<b>Spread</b>	H-600 Pipeline Spread H
<b>Contractor</b>	Precision			<b>Report #</b>	7310
<b>Inspector</b>	Dennis Evans			<b>Date/Time</b>	9/4/2018 4:20 PM
<b>Permit #</b>	TBD	<b>Inspection Type</b>	VA SWPP	<b>Station Begin</b>	12993+15
<b>State</b>	VA	<b>Inspection Area</b>	Partial	<b>Station End</b>	13024+06
<b>County</b>	Roanoke	<b>Ground</b>	Damp	<b>Temperature (°F)</b>	84.00
<b>Municipality</b>	N/A	<b>Weather</b>	Sunny	<b>Rain Gauge (in)</b>	0.40
<b>GPS Location</b>	37.132310243358, -80.1315284986795			<b>Rain Accumulation Time (days)</b>	1.00

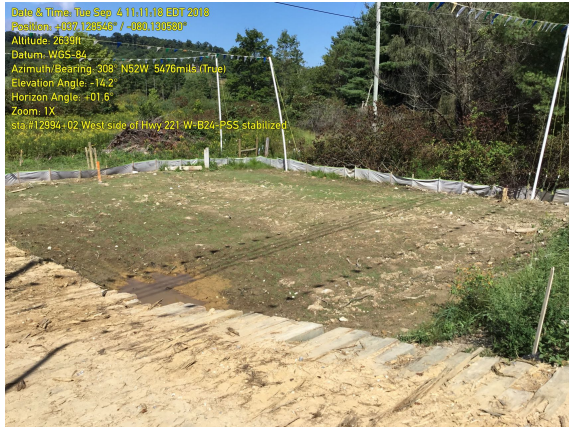
A/E	124300138	Date/Time	9/4/2018 4:20 PM	Report #	7310
Pictures					
<p><small>Date &amp; Time: Tue Sep 4 11:11:10 EDT 2018 Position: +037.132548° / -080.131330° Altitude: 2639ft Datum: WGS-84 Azimuth/Bearing: 305° N52W 547ft/mile (True) Elevation Angle: +01.6° Horizon Angle: -01.6° Zoom: 1X Sta.#12994+02 West side of Hwy 221 W-B24-PSS stabilized</small></p>

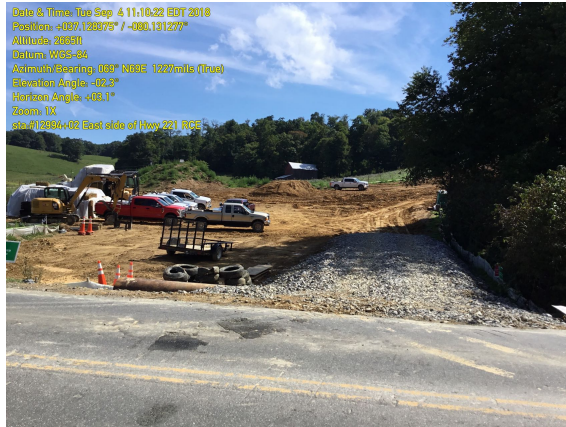
<p><small>Date &amp; Time: Tue Sep 4 11:10:22 EDT 2018 Position: +037.132672° / -080.131277° Altitude: 2633ft Datum: WGS-84 Azimuth/Bearing: 100° N80E 122ft/mile (True) Elevation Angle: +03.1° Horizon Angle: -03.1° Zoom: 1X Sta.#12994+02 East side of Hwy 221 RCE</small></p>

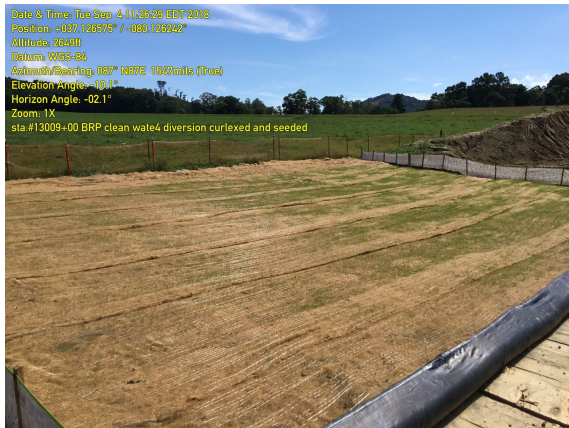
<p><small>Date &amp; Time: Tue Sep 4 11:35:39 EDT 2018 Position: +037.132672° / -080.132625° Altitude: 2640ft Datum: WGS-84 Azimuth/Bearing: 061° N57E 124ft/mile (True) Elevation Angle: +0.1° Horizon Angle: -02.1° Zoom: 1X Sta.#13009+00 BRP clean water4 diversion culxerted and seeded</small></p>

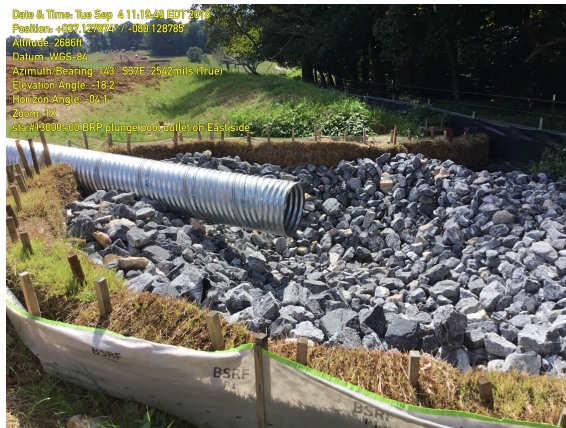
<p><small>Date &amp; Time: Tue Sep 4 11:18:40 EDT 2018 Position: +037.129774° / -080.128705° Altitude: 2686ft Datum: WGS-84 Azimuth/Bearing: +02° S32E 262ft/mile (True) Elevation Angle: -18.2° Horizon Angle: -04.1° Zoom: 1X Sta.#13000+00 BRP plunge pool outlet on East side</small></p>

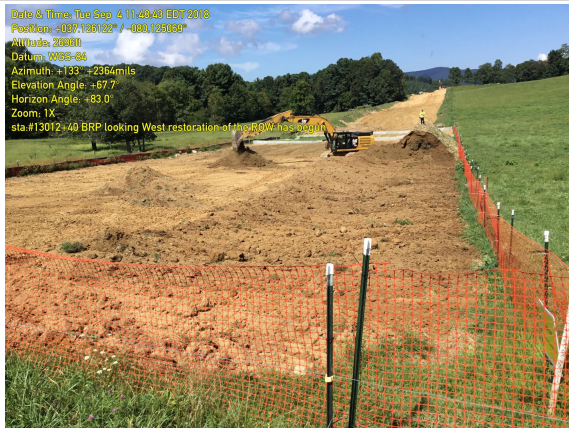
GPS Location	37.1321910946044, -80.1313535683603		GPS Location	37.1321960399273, -80.1312712580712	
Description	Sta:#13009+00 clean water diversion stabilized. See photo for accurate coordinates.		Description	Sta:#13000+00 Plunge pool outlet functioning. See photo for accurate coordinates.	
<p><small>Date &amp; Time: Tue Sep 4 11:45:40 EDT 2018 Position: +037.135122° / -080.133039° Altitude: 2630ft Datum: WGS-84 Azimuth: +133° +236ft/mils Elevation Angle: +67.7° Horizon Angle: -83.0° Zoom: 1X Sta.#13012+40 BRP looking West restoration of the BRP West side</small></p>

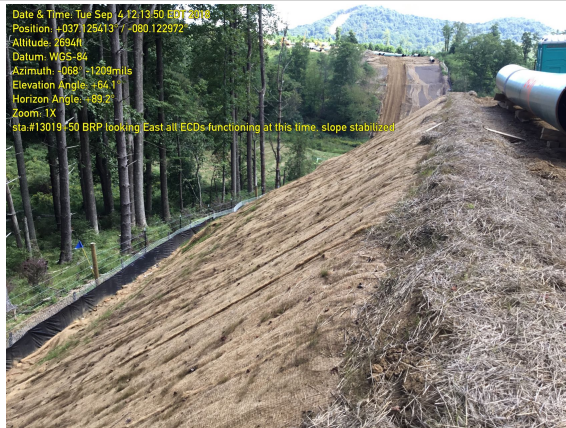
<p><small>Date &amp; Time: Tue Sep 4 12:13:50 EDT 2018 Position: +037.125413° / -080.122972° Altitude: 2634ft Datum: WGS-84 Azimuth: 088° +1209ft/mils Elevation Angle: +84.1° Horizon Angle: -83.2° Zoom: 1X Sta.#13019+50 BRP looking East all ECDs functioning at this time, slope stabilized</small></p>

GPS Location	37.1321368217814, -80.1313283388318		GPS Location	37.1322081098679, -80.1313599386067	
Description	Sta:#13012+40 top soil restoration on the BRP. See photo for accurate coordinates.		Description	Sta:#13019+50 looking East stabilized. See photo for accurate coordinates.
