Visual Site Inspection Report

Project Name	H-600 Pipeline Spread H	AFE	124300138	Spread	H-600 Pipeline Spread H
Contractor	Precision			Report #	7549
Inspector	Dennis Evans			Date/Time	9/8/2018 4:05 PM
Permit #	TBD	Inspection Type	VA SWPP	Station Begin	12993+15
State	VA	Inspection Area	Partial	Station End	13024+06
County	Roanoke	Ground	Dry	Temperature (°F)	81.00
Municipality	N/A	Weather	Light Rain	Rain Gauge (in)	0.00
GPS Location	37.1374338826304, -80.126581227521			Rain Accumulation Time (days)	1.00

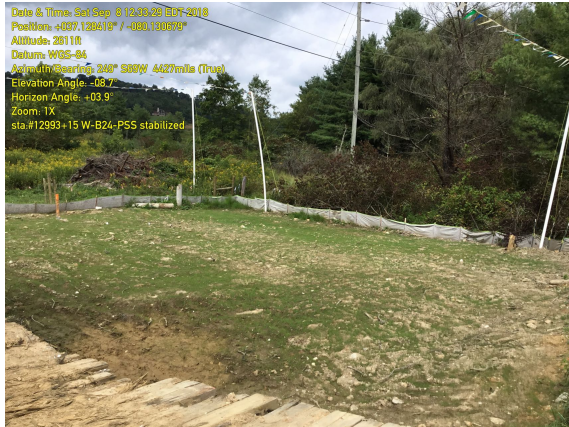
A/E	124300138	Date/Time	9/8/2018 4:05 PM	Report #	7549
Pictures					
<p>Date & Time: Sat Sep 8 13:35:30 EDT 2018 Position: +037.130611° / -080.130679° Altitude: 2611ft Datum: WGS-84 Azimuth/Bearing: 5.248° S89°W 4427mils (True) Elevation Angle: +08.1° Horizon Angle: +03.9° Zoom: 1X Sta:#12993+15 W-B24-PSS stabilized</p>

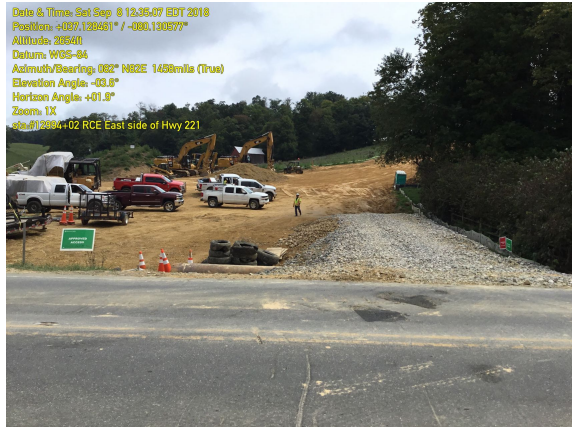
<p>Date & Time: Sat Sep 8 13:36:07 EDT 2018 Position: +037.130681° / -080.130679° Altitude: 2654ft Datum: WGS-84 Azimuth/Bearing: 082° N82°E 1458mils (True) Elevation Angle: +03.8° Horizon Angle: +01.9° Zoom: 1X Sta:#12994+02 RCE East side of Hwy 221</p>

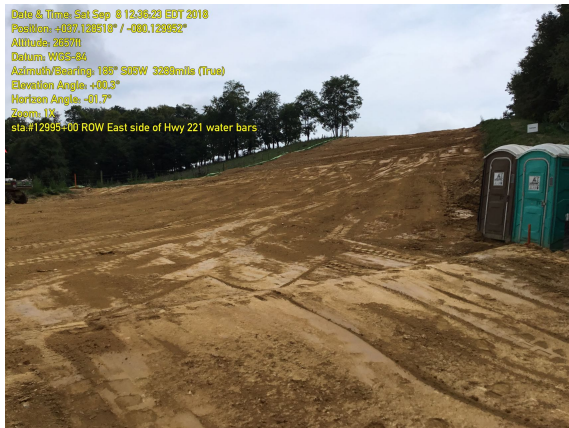
GPS Location	37.1374854146516, -80.1251631842639	GPS Location	37.1379342908386, -80.1255408861489		
Description	Sta:#12993+15 W-B24-PSS is stabilized. See photo for accurate coordinates.	Description	Sta:#12994+02 RCE Hwy 221 East side See photo for accurate coordinates.		
<p>Date & Time: Sat Sep 8 13:36:23 EDT 2018 Position: +037.130618° / -080.129852° Altitude: 2657ft Datum: WGS-84 Azimuth/Bearing: 180° S00°W 3288mils (True) Elevation Angle: +00.3° Horizon Angle: +01.3° Zoom: 1X Sta:#12995+00 ROW East side of Hwy 221 water bars</p>
