Visual Site Inspection Report

Project Name	H-600 Pipeline Spread H	AFE	124300138	Spread	H-600 Pipeline Spread H
Contractor	Precision			Report #	7775
Inspector	Dennis Evans			Date/Time	9/12/2018 6:50 PM
Permit #	TBD	Inspection Type	VA SWPP	Station Begin	12993+15
State	VA	Inspection Area	Partial	Station End	13024+06
County	Roanoke	Ground	Muddy	Temperature (°F)	75.00
Municipality	N/A	Weather	Light Rain	Rain Gauge (in)	1.00
GPS Location	37.2792922643409, -80.0292737884355			Rain Accumulation Time (days)	1.00

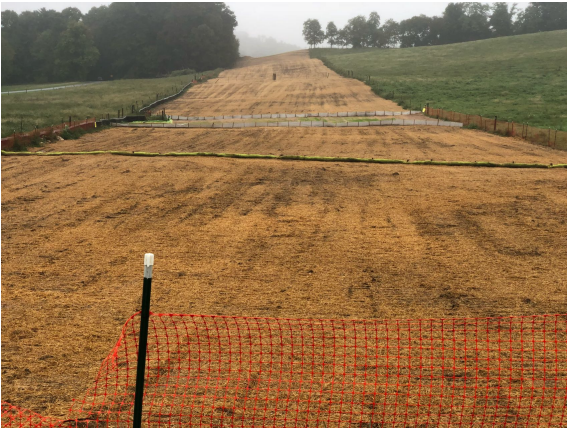
GPS Location	37.2794747090242, -80.0288685199525	GPS Location	37.2797054625669, -80.0288992723143		
Description	Sta:#12993+15 W-B24-PSS is stabilized. See station #.	Description	Sta:#1299+02 RCE Hwy 221 needs roughed up. See station #.
