Visual Site Inspection Report

Project Name	H-600 Pipeline Spread H	AFE	124300138	Spread	H-600 Pipeline Spread H
Contractor	Precision			Report #	8323
Inspector	Dennis Evans			Date/Time	9/24/2018 4:40 PM
Permit #	TBD	Inspection Type	VA SWPP	Station Begin	12993+15
State	VA	Inspection Area	Partial	Station End	13024+06
County	Roanoke	Ground	Wet	Temperature (°F)	60.00
Municipality	N/A	Weather	Light Rain	Rain Gauge (in)	0.25
GPS Location	37.1324645122859, -80.1310180407764			Rain Accumulation Time (days)	1.00

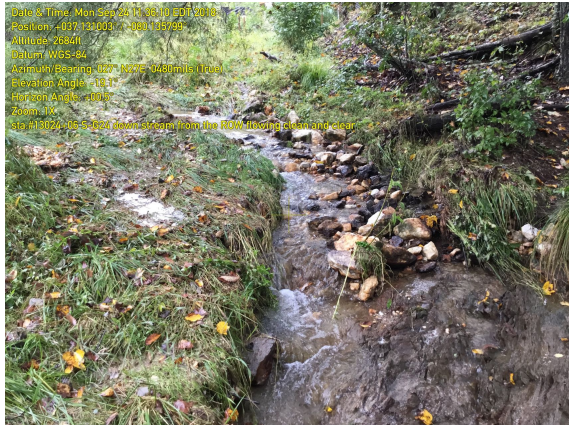
A/E	124300138	Date/Time	9/24/2018 4:40 PM	Report #	8323
Pictures					
<p>Date & Time: Mon Sep 24 12:01:24 EDT 2018 Position: +037.125003° / -080.118755° Altitude: 2680ft Datum: WGS-84 Azimuth/Bearing: 092° N85W 368m (True) Elevation Angle: -03.1° Horizon Angle: -04.1° Zoom: 1X Sta.#13024+06 S-G24 is flowing clean and clear. See photo for accurate coordinates.</p>

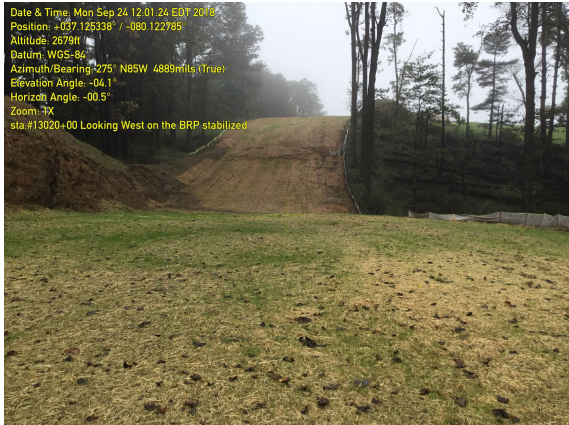
<p>Date & Time: Mon Sep 24 12:01:24 EDT 2018 Position: +037.125338° / -080.122785° Altitude: 2679ft Datum: WGS-84 Azimuth/Bearing: 275° N85W 489m (True) Elevation Angle: -04.1° Horizon Angle: -00.5° Zoom: 1X Sta.#13020+00 Looking West on the BRP stabilized</p>

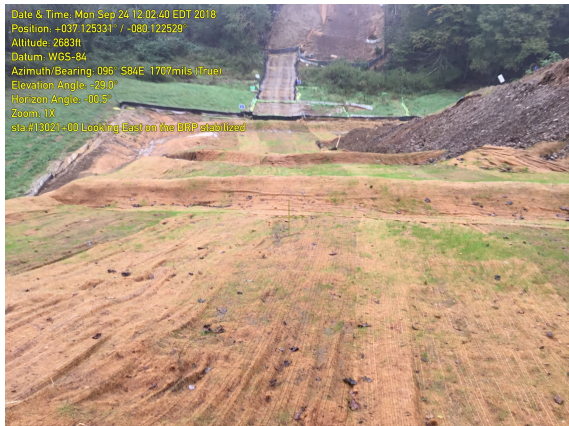
<p>Date & Time: Mon Sep 24 10:02:40 EDT 2018 Position: +037.125331° / -080.122579° Altitude: 2683ft Datum: WGS-84 Azimuth/Bearing: 090° S84E 170m (True) Elevation Angle: -25.0° Horizon Angle: -00.5° Zoom: 1X Sta.#13021+00 Looking East on the BRP stabilized</p>

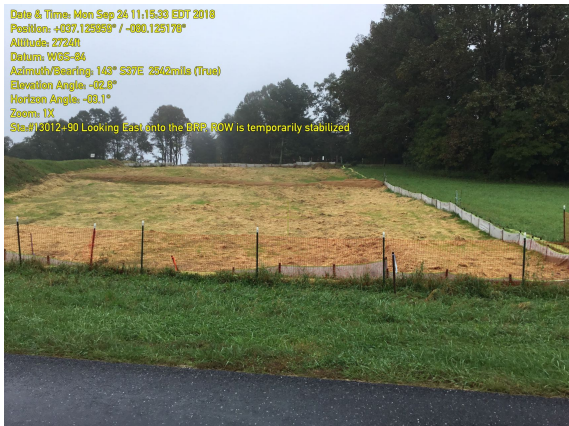
<p>Date & Time: Mon Sep 24 11:15:33 EDT 2018 Position: +037.128859° / -080.126178° Altitude: 2724ft Datum: WGS-84 Azimuth/Bearing: 143° S37E 2542m (True) Elevation Angle: -02.8° Horizon Angle: -03.1° Zoom: 1X Sta.#13012+90 Looking East onto the BRP. ROW is temporarily stabilized</p>

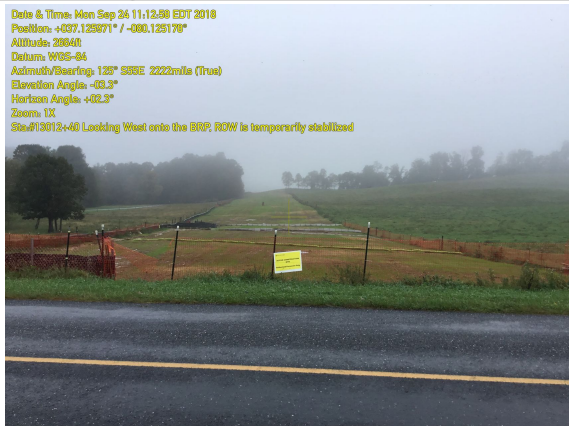
GPS Location	37.1324628778148, -80.1311855950208	GPS Location	37.1325054997924, -80.1311399136485		
Description	Sta:#13020+00 looking East on the BRP. See photo for accurate coordinates.	Description	Sta:#13012+90 looking East onto the BRP. See photo for accurate coordinates.		
<p>Date & Time: Mon Sep 24 11:12:58 EDT 2018 Position: +037.128871° / -080.125178° Altitude: 2604ft Datum: WGS-84 Azimuth/Bearing: 128° S88E 2222m (True) Elevation Angle: -03.3° Horizon Angle: +02.3° Zoom: 1X Sta.#13012+40 Looking West onto the BRP. ROW is temporarily stabilized</p>

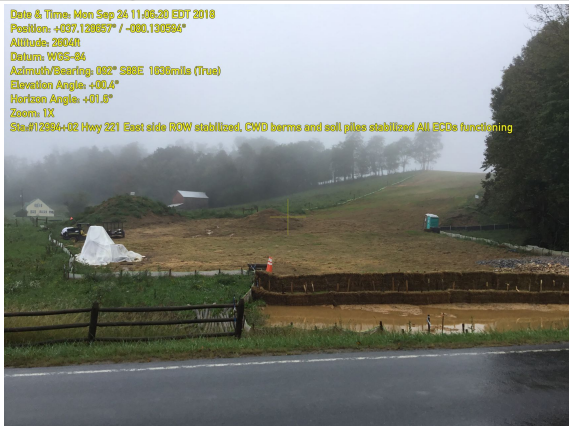
<p>Date & Time: Mon Sep 24 11:06:20 EDT 2018 Position: +037.128857° / -080.130594° Altitude: 2604ft Datum: WGS-84 Azimuth/Bearing: 092° S88E 1638m (True) Elevation Angle: +00.4° Horizon Angle: +01.8° Zoom: 1X Sta.#12994+02 Hwy 221 East side ROW stabilized, CWD berms and soil piles stabilized. All ECCs functioning</p>
