## Visual Site Inspection Report

<b>Project Name</b>	H-600 Pipeline Spread H		<b>AFE</b>	124300138	<b>Spread</b>	H-600 Pipeline Spread H
<b>Contractor</b>	Precision			<b>Report #</b>	1963	
<b>Inspector</b>	Doug Davenport			<b>Date/Time</b>	5/18/2018 4:11 PM	
<b>Permit #</b>	TBD	<b>Inspection Type</b>	VA SWPP		<b>Station Begin</b>	13336+40
<b>State</b>	VA	<b>Inspection Area</b>	Partial		<b>Station End</b>	13670+00
<b>County</b>	Franklin	<b>Ground</b>	Muddy		<b>Temperature (°F)</b>	76.00
<b>Municipality</b>	N/A	<b>Weather</b>	Heavy Rain		<b>Rain Gauge (in)</b>	6.25
<b>GPS Location</b>	37.0594010616307, -79.8825728563359			<b>Rain Accumulation Time (days)</b>		2.00

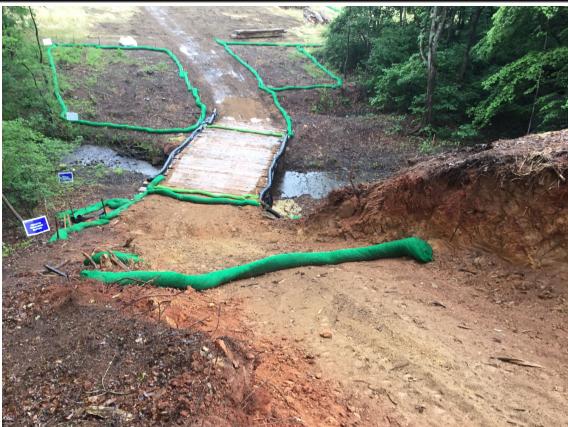
The GAS of House Rock Rd. has a very steep slope down to S-II9. The Wattles installed on the travel lane performed well, but were in need of maintenance due to the rain event. The contractor was notified of the issue and they responded immediately with an environmental crew which cleaned out the ECDS and re-staked them. A small amount of sediment had entered the creek and the contractor was able to remove the sediment with hand shovels.

<b>GPS Location</b>	37.0593974791638, -79.88257494338	<b>GPS Location</b>	37.0594010463797, -79.8825734689377
<b>Description</b>	S-II9 GAS House Rock Rd. The travel lane ECDS were installed and functional	<b>Description</b>	Bridge over W-IJ6 & S-IJ10 GAS of Cahas Rd. ECDS working as intended

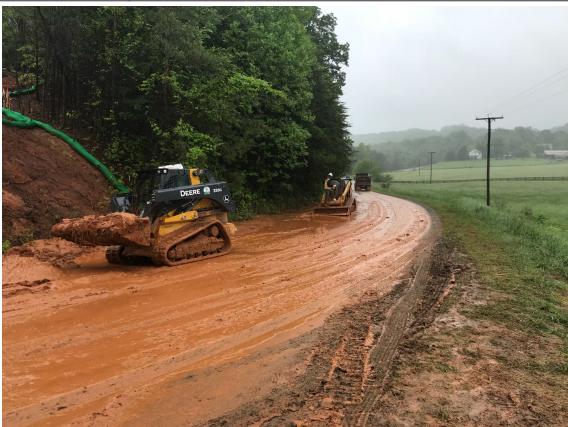
Cahas Mtn. Rd #2: Due to the excessive amount of rainfall, a water bar failed near the top of the slope which caused a cascading effect on the other water bars below on the lower portion of the slope. After multiple water bar failures, mud was deposited onto the road. The contractor closed the road after notifying VDOT and began the cleanup. The contractor worked from early morning until 9:30 pm. Cleaning the road. They installed a rock check dam at the bottom of the slope to prevent reoccurrence. VDOT was notified and the road was opened to the public again.

<b>GPS Location</b>	37.059409586713, -79.8825676923383	<b>GPS Location</b>	37.0594007925505, -79.8825760636685
<b>Description</b>	Cahas Mtn Rd. #2 mud from ROW on road. The contractor working to clean it up.	<b>Description</b>	Cahas Mtn. Rd #2 Contractor installing rock check dam to prevent reoccurrence. The road has been cleaned up.
