Visual Site Inspection Report

Project Name	H-600 Pipeline Spread H	AFE	124300138	Spread	H-600 Pipeline Spread H
Contractor	Precision			Report #	5192
Inspector	Glenn Mike Renfro			Date/Time	7/25/2018 9:34 PM
Permit #	TBD	Inspection Type	VA SWPP	Station Begin	13415+00
State	VA	Inspection Area	Full	Station End	13670+00
County	Franklin	Ground	Muddy	Temperature (°F)	86.00
Municipality	N/A	Weather	Heavy Rain	Rain Gauge (in)	1.00
GPS Location	37.4859297563972, -79.1778516717171			Rain Accumulation Time (days)	3.00

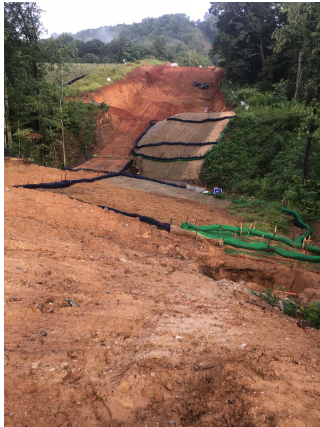
GPS Location	37.4860344341957, -79.1781186941577		GPS Location	37.485929127881, -79.1779846931956	
Description	stabilization in good condition at Stream crossing S-IJ4		Description	Triple stacked CFS protecting stream S-IJ4

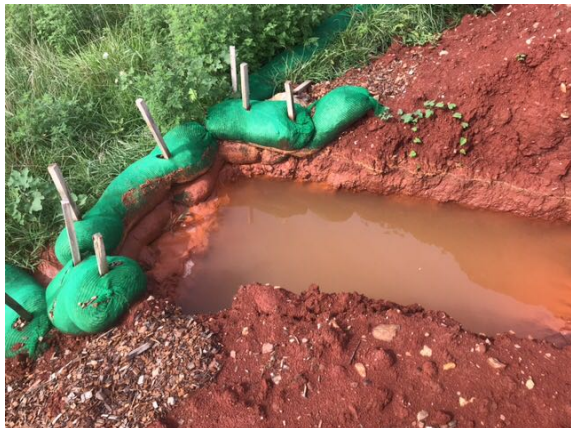
GPS Location	37.4859767009417, -79.1781843097272		GPS Location	37.4859052044821, -79.1781561297126	
Description	Sump functioning properly.		Description	Rain gauge readings.
