# Visual Site Inspection Report

<b>Project Name</b>	H-600 Pipeline Spread H	<b>AFE</b>	124300138	<b>Spread</b>	H-600 Pipeline Spread H
<b>Contractor</b>	Precision			<b>Report #</b>	5879
<b>Inspector</b>	Glenn Mike Renfro			<b>Date/Time</b>	8/6/2018 2:51 PM
<b>Permit #</b>	TBD	<b>Inspection Type</b>	VA SWPP	<b>Station Begin</b>	13415+00
<b>State</b>	VA	<b>Inspection Area</b>	Full	<b>Station End</b>	13670+00
<b>County</b>	Franklin	<b>Ground</b>	Wet	<b>Temperature (°F)</b>	90.00
<b>Municipality</b>	N/A	<b>Weather</b>	Cloudy	<b>Rain Gauge (in)</b>	0.00
<b>GPS Location</b>	36.9719277152291, -79.8701206125833			<b>Rain Accumulation Time (days)</b>	1.00

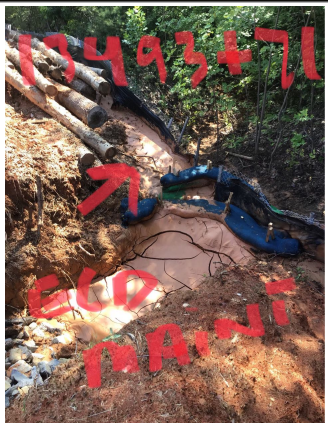
<b>GPS Location</b>	36.971898763475, -79.8700080905853	<b>GPS Location</b>	36.9720420102002, -79.8699277081339
<b>Description</b>	Spread H punch list	<b>Description</b>	ECD maintenance required at 13493+71
