Visual Site Inspection Report

Project Name	H-600 Pipeline Spread H	AFE	124300138	Spread	H-600 Pipeline Spread H
Contractor	Precision			Report #	6752
Inspector	Glenn Mike Renfro			Date/Time	8/22/2018 1:04 PM
Permit #	TBD	Inspection Type	VA SWPP	Station Begin	13415+00
State	VA	Inspection Area	Full	Station End	13670+00
County	Franklin	Ground	Damp	Temperature (°F)	82.00
Municipality	N/A	Weather	Cloudy	Rain Gauge (in)	1.40
GPS Location	36.9719178805635, -79.8702282587943			Rain Accumulation Time (days)	3.00

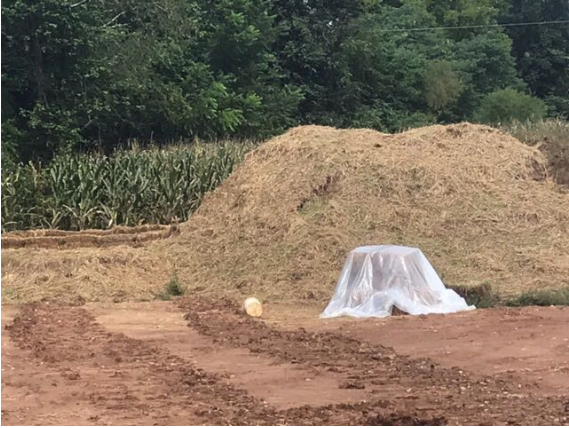
GPS Location	36.9719006046442, -79.8702745709256	GPS Location	36.9718262629188, -79.8700173388006		
Description	Topsoil pile seeded and mulched near 13644+00	Description	Clean up operations underway at 13454+12

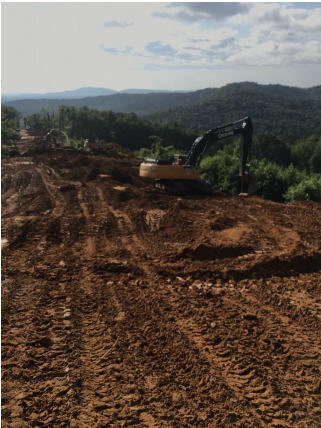
GPS Location	36.9719317449079, -79.8702557541099	GPS Location	36.9718821027418, -79.8700681956966		
Description	Clean up operations, putting back topsoil at 13451+00	Description	Additional rock needed at Cahas Mt access

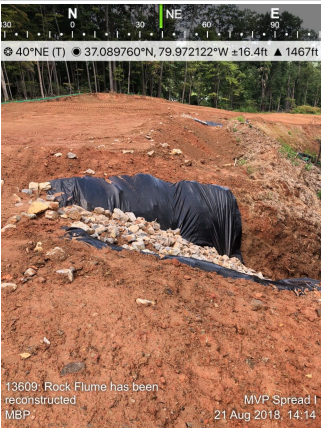
GPS Location	36.9719265613134, -79.8702611263753	GPS Location	36.9718633534451, -79.870041248738		
Description	Punch list item rock flume repair completed.	Description	Punch list for Spread H section.
