Visual Site Inspection Report

Project Name	H-600 Pipeline Spread H	AFE	124300138	Spread	H-600 Pipeline Spread H
Contractor	Precision			Report #	7806
Inspector	Glenn Mike Renfro			Date/Time	9/13/2018 10:10 AM
Permit #	TBD	Inspection Type	VA SWPP	Station Begin	13415+00
State	VA	Inspection Area	Full	Station End	13670+00
County	Franklin	Ground	Wet	Temperature (°F)	75.00
Municipality	N/A	Weather	Cloudy	Rain Gauge (in)	11.50
GPS Location	36.9719701353805, -79.8700609803944			Rain Accumulation Time (days)	6.00

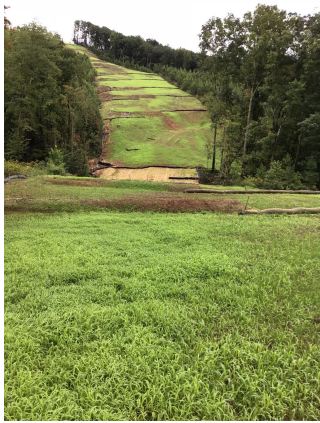
GPS Location	36.9719221408728, -79.8701314560676		GPS Location	36.9719935627999, -79.8700481560825	
Description	Permanent stabilization grow in from 13423+00 to 13437+00		Description	Area on northeast side of RoW at 13418+00 that will need to be restabilize with permanent seed.

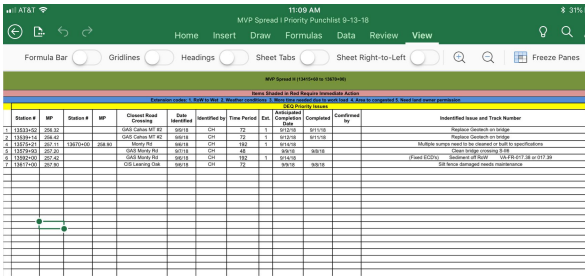
GPS Location	36.9719207770051, -79.8701310478945		GPS Location	36.9719197756727, -79.8701317704544	
Description	Punch list for Spread H section		Description	Sediment build up on ECD's at 13339+00

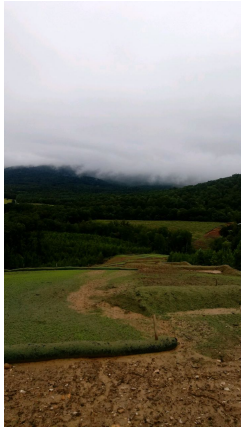
Insert image here		
GPS Location	36.9719701353805, -79.8700609803944		GPS Location		
Description	13437+00 looking back at kickoff		Description
