Visual Site Inspection Report

Project Name H-600 Pipeline Spread H		AFE 124300138	Spread H-600 Pipeline Spread H
Contractor Precision		Report # 4344	
Inspector Gwen Alley		Date/Time 7/9/2018 4:59 PM	
Permit # TBD	Inspection Type VA SWPP	Station Begin	133216+00
State VA	Inspection Area Partial	Station End	133227+00
County Franklin	Ground Dry	Temperature (°F)	84.00
Municipality N/A	Weather Sunny	Rain Gauge (in)	0.00
GPS Location 37.294464416719, -80.0283712906736		Rain Accumulation Time (days)	1.00

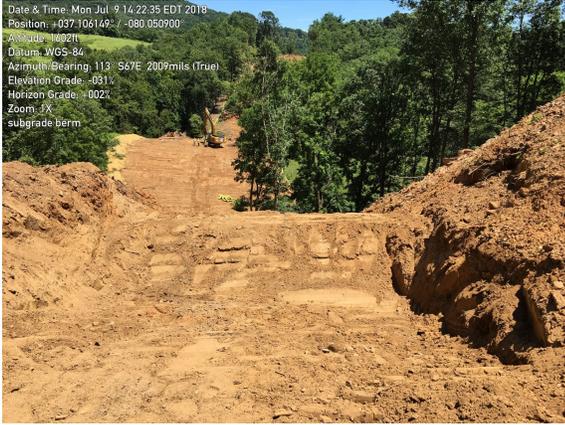
<p><small>Date & Time: Mon Jul 9 14:22:35 EDT 2018 Position: +037.1061492 / -080.050900 Altitude: 1602ft Datum: WGS-84 Azimuth/Bearing: 113 S67E 2009mils (True) Elevation Grade: +031 Horizon Grade: +002 Zoom: 1X subgrade berm</small></p>

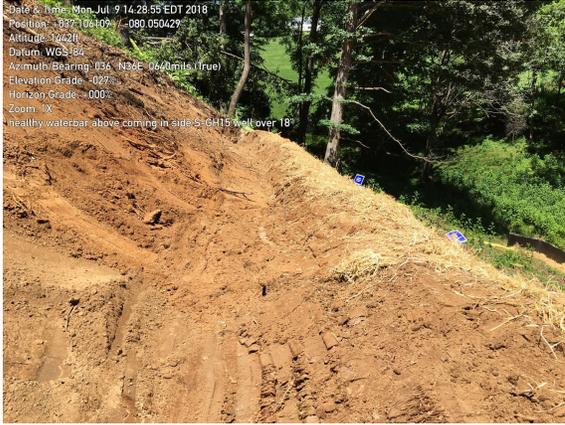
<p><small>Date & Time: Mon Jul 9 14:28:55 EDT 2018 Position: +037.1061072 / -080.050429 Altitude: 1522ft Datum: WGS-84 Azimuth/Bearing: 83 S128E 0640mils (True) Elevation Grade: +027 Horizon Grade: +000 Zoom: 1X healthy waterbar above coming in side S-GH15 well over 18'</small></p>

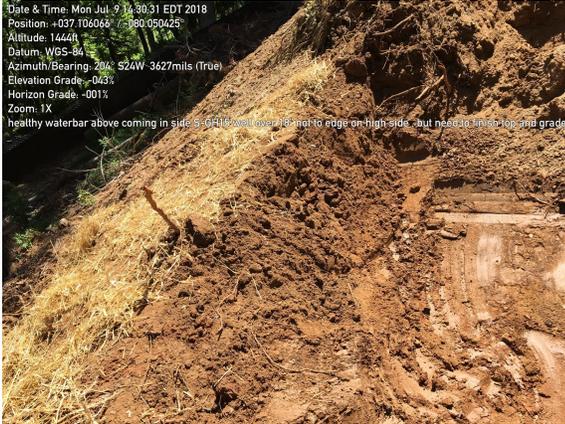
GPS Location 37.2943879437006, -80.0283467040093	GPS Location 37.2943898358024, -80.0283468720977
Description The number of berms above S-Gh15 was decreased to 3, and the height was increased to about 3feet.	Description A substantial waterbar was constructed between the series of berms and S-GH15. Height about 24". See photo for coordinates
<p><small>Date & Time: Mon Jul 9 14:30:31 EDT 2018 Position: +037.1060642 / -080.050425 Altitude: 1444ft Datum: WGS-84 Azimuth/Bearing: 204 S24W 3627mils (True) Elevation Grade: -043 Horizon Grade: -001 Zoom: 1X healthy waterbar above coming in side S-GH15 well over 18' not to edge on high side - but needs finish top and grade</small></p>

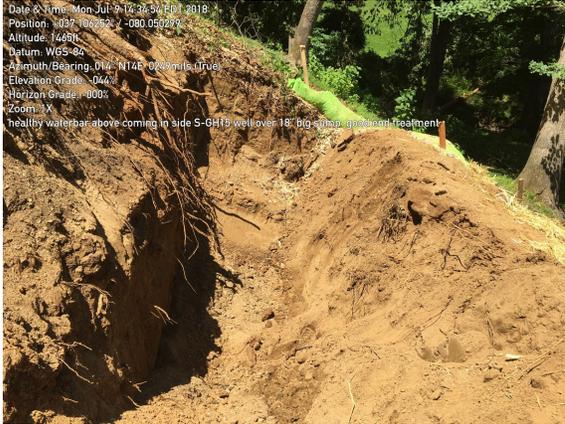
<p><small>Date & Time: Mon Jul 9 14:34:50 EDT 2018 Position: +037.1062522 / -080.050229 Altitude: 1448ft Datum: WGS-84 Azimuth/Bearing: 014 N14E 0299mils (True) Elevation Grade: -043 Horizon Grade: +000 Zoom: 1X healthy waterbar above coming in side S-GH15 well over 18' big sump in need of treatment</small></p>

GPS Location 37.2944711084781, -80.028361232548	GPS Location 37.294437432945, -80.0284168218741
Description The high end is not to ROW edge, but due to incomplete grade, further work on this end would be unsafe. See photo for coordinates	Description Sump at the end is nearly 4 ft deep. Berm extends to edge of ROW. see photo for coordinates
<p><small>Date & Time: Mon Jul 9 14:50:58 EDT 2018 Position: +037.1059402 / -080.049769 Altitude: 1424ft Datum: WGS-84 Azimuth/Bearing: 266 S86W 4729mils (True) Elevation Grade: +085 Horizon Grade: +007 Zoom: 1X going away side S-GH153rd BR</small></p>

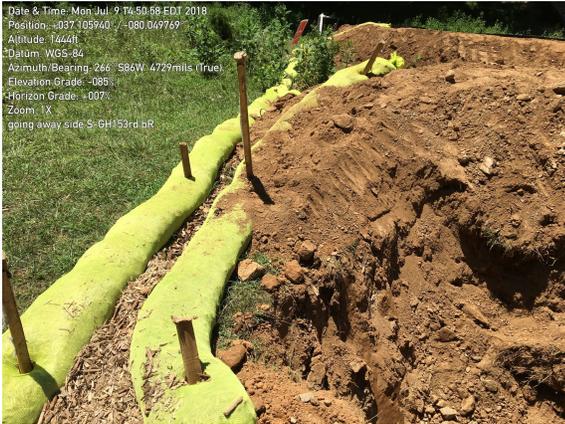
Description Berms are being extended to edge of ROW. I talked to the straw about pulling back some of the excess soil and they did. Photo, coords	Description Work is in progress and they are aiming to exceed requirements. See photo for coordinates

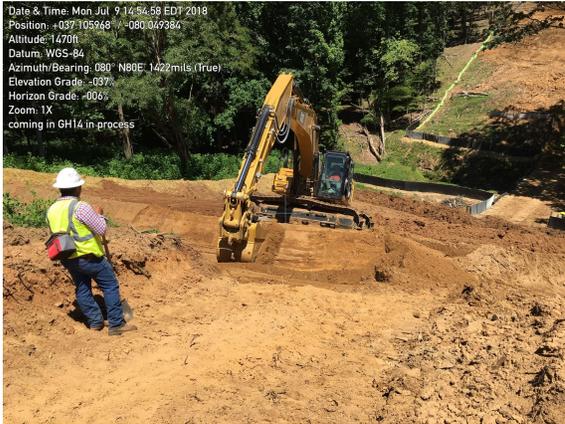
<p><small>Date & Time: Mon Jul 9 14:54:58 EDT 2018 Position: +037.1059468 / -080.049886 Altitude: 1470ft Datum: WGS-84 Azimuth/Bearing: 080 N80E 1422mils (True) Elevation Grade: +037 Horizon Grade: -005 Zoom: 1X coming in GH14 in process</small></p>
