A/E	124300138	Date/Time	7/31/2018 5:19 PM	Report #	5552
6. PCSM BMPs (List BMPs and note if installed and maintained as per the plan. If corrective action is needed, a picture is required.)					
PCSM BMPs		Compliance Level	Corrective Action	Corrective Time Frame

A/E	124300138	Date/Time	7/31/2018 5:19 PM	Report #	5552
Pictures					
<div><p>Date & Time: Tue, Jul 31, 2018, 11:37:18 EDT Position: +037.106443 / -80.053304 Altitude: 1389ft Datum: WGS-84 Azimuth/Bearing: 120.550E 622mils (True) Elevation Grade: -006 Horizon Grade: -000 Zoom: 1X sta13318+00 S-GH9</p>

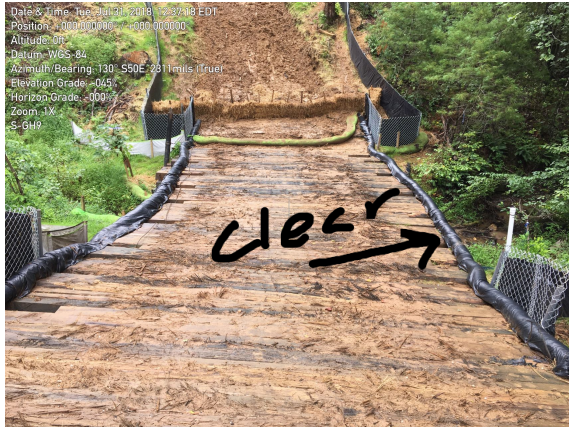
</div>			
GPS Location	37.2944125702244, -80.028558800735		GPS Location	37.2944459111194, -80.0286033013966	
Description	Streams GH11 and GH9 showed no signs of sediment impact. ECDs functioning. See photo for coordinates		Description	Norther Clearing's excavator is back at sta13318+00, and is leaking again. Equip ID# R17-211. See photo for coordinates

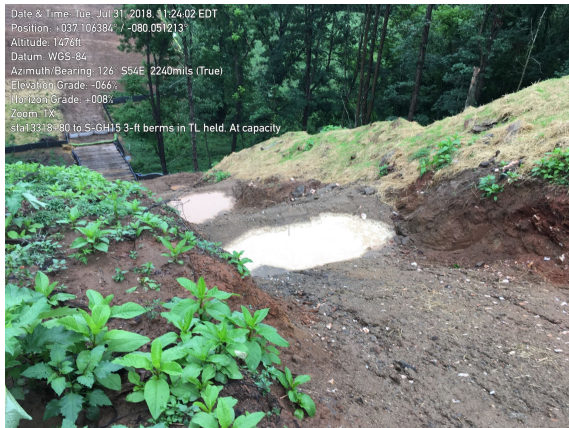
<div><p>Date & Time: Tue, Jul 31, 2018, 11:24:02 EDT Position: +037.106386 / -80.050422 Altitude: 1427ft Datum: WGS-84 Azimuth/Bearing: 126.554E 2240mils (True) Elevation Grade: -006 Horizon Grade: -008 Zoom: 1X sta13318+00 to S-GH15 3-ft berms in TL held. At capacity</p>

</div>			
GPS Location	37.2943994367437, -80.028539196022		GPS Location	37.2944441135983, -80.0285998196633	
Description	Large berms (over 3ft. tall) CIS S-GH15 are still holding, but are at capacity. See photo for coordinates		Description	End treatment on sump CIS S-GH15 in need of maintenance and adjustment. See photo for coordinates	
<div><p>Date & Time: Tue, Jul 31, 2018, 11:31:09 EDT Position: +037.106452 / -80.050432 Altitude: 1426ft Datum: WGS-84 Azimuth/Bearing: 120.550E 2276mils (True) Elevation Grade: -006 Horizon Grade: -008 Zoom: 1X S-RR11 ECDs functioning</p>

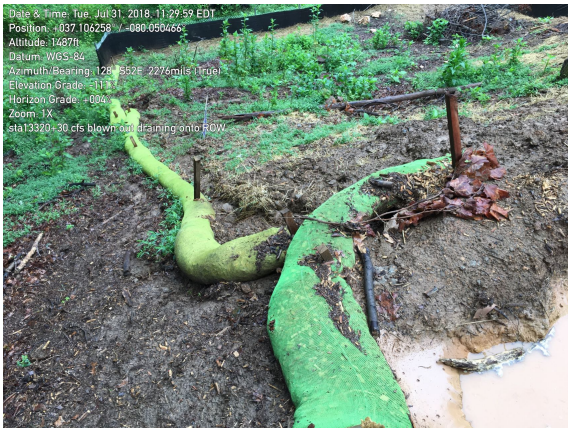
</div>		<div><p>Date & Time: Tue, Jul 31, 2018, 11:29:59 EDT Position: +037.106258 / -80.050466 Altitude: 1427ft Datum: WGS-84 Azimuth/Bearing: 128.582E 2276mils (True) Elevation Grade: -011 Horizon Grade: -009 Zoom: 1X sta13320+00 30 cfs blown out draining onto ROW</p>

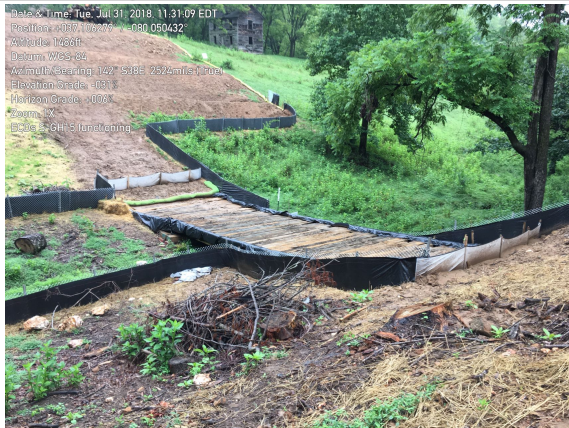
GPS Location	37.2944458284659, -80.028600897268		GPS Location	37.2944867715388, -80.0285606342625	
Description	S-GH15 ECDs on all streams in the survey area are functioning well. No sediment or off ROW issues. See photo for coordinates		Description	S-RR11 ECDs functioning, no issues. See photo for coordinates

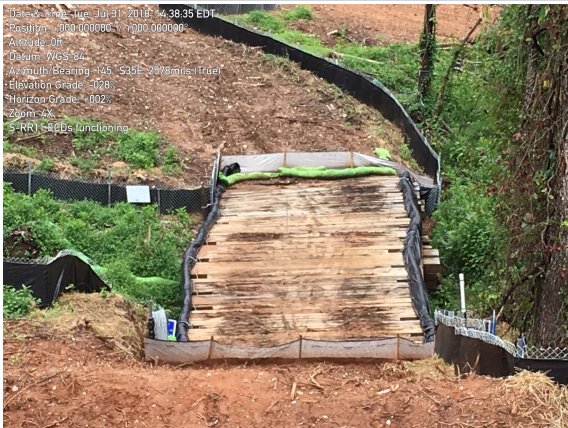
</div>		<div><p>Date & Time: Tue, Jul 31, 2018, 11:38:35 EDT Position: +037.106452 / -80.050432 Altitude: 1426ft Datum: WGS-84 Azimuth/Bearing: 120.550E 2276mils (True) Elevation Grade: -006 Horizon Grade: -008 Zoom: 1X S-RR11 ECDs functioning</p>
