# Visual Site Inspection Report

<b>Project Name</b>	H-600 Pipeline Spread H	<b>AFE</b>	124300138	<b>Spread</b>	H-600 Pipeline Spread H
<b>Contractor</b>	Precision	<b>Report #</b>	5904		
<b>Inspector</b>	Gwen Alley	<b>Date/Time</b>	8/6/2018 6:03 PM		
<b>Permit #</b>	TBD	<b>Inspection Type</b>	VA SWPP	<b>Station Begin</b>	13260+00
<b>State</b>	VA	<b>Inspection Area</b>	Full	<b>Station End</b>	1351+15
<b>County</b>	Franklin	<b>Ground</b>	Damp	<b>Temperature (°F)</b>	91.00
<b>Municipality</b>	N/A	<b>Weather</b>	Sunny	<b>Rain Gauge (in)</b>	0.00
<b>GPS Location</b>	37.2944321784231, -80.0285690316362			<b>Rain Accumulation Time (days)</b>	1.00

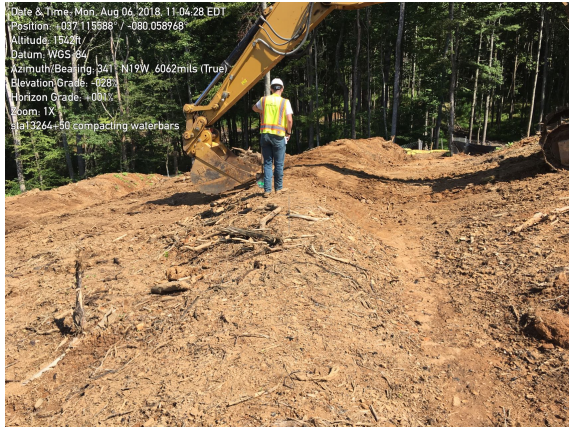
A/E	124300138	Date/Time	8/6/2018 6:03 PM	Report #	5904
Pictures					
<p>Date &amp; Time: Mon, Aug 06, 2018, 11:04:28 EDT Position: +037.115988° / -080.058746° Altitude: 1522ft Datum: WGS-84 Azimuth/Bearing: 341° N19W, 6062mils (True) Elevation Grade: -028° Horizon Grade: -001° Zoom: 1X S-GH14-50 compacting waterbars</p>

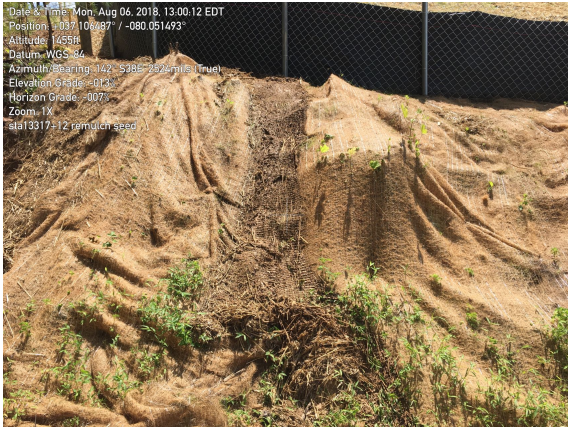
<p>Date &amp; Time: Mon, Aug 06, 2018, 13:00:12 EDT Position: +037.106387° / -080.051493° Altitude: 1455ft Datum: WGS-84 Azimuth/Bearing: 142° S38E-3622mils (True) Elevation Grade: -013° Horizon Grade: -007° Zoom: 1X S-GH13-12 rammed seed</p>

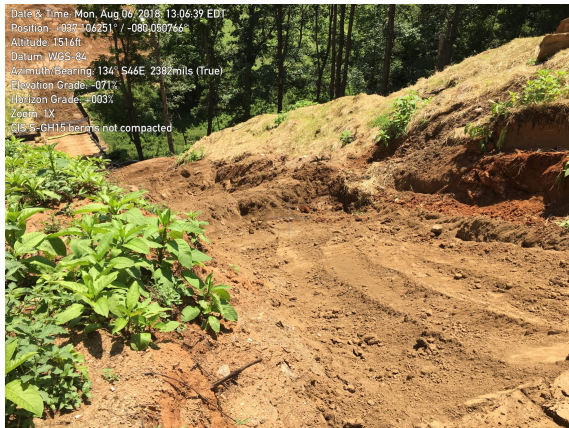
GPS Location	37.2944763225947, -80.0285310253156	GPS Location	37.2944303163155, -80.0285497436384		
Description	Excavator walking from Flanders to Wade's Gap, compacting berms in travel lane. See photo for coordinates	Description	Straw washed out of curlex, needs seed and mulch. See photo for coordinates		
<p>Date &amp; Time: Mon, Aug 06, 2018, 13:06:39 EDT Position: +037.106251° / -080.050744° Altitude: 1514ft Datum: WGS-84 Azimuth/Bearing: 134° S46E, 2382mils (True) Elevation Grade: -071° Horizon Grade: -003° Zoom: 1X CIS S-GH15 berms not compacted</p>

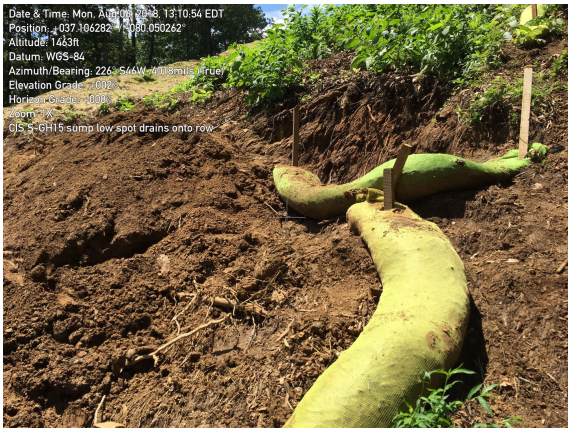
<p>Date &amp; Time: Mon, Aug 06, 2018, 13:10:54 EDT Position: +037.106282° / -080.050242° Altitude: 1443ft Datum: WGS-84 Azimuth/Bearing: 226° S46W, 7018mils (True) Elevation Grade: -002° Horizon Grade: -000° Zoom: 1X CIS S-GH15 sump low spot drains onto row</p>

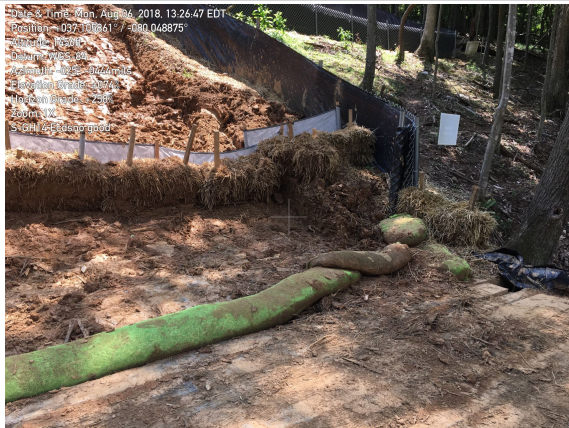
GPS Location	37.2944337065437, -80.0285512683966	GPS Location	37.294432912515, -80.0285519889988		
Description	Berms in travel lane CIS S-GH15 not compacted. See photo for coordinates	Description	Sump that failed and washed sediment into S-GH15. Low spot drains to same area failure occurred. See photo for coordinates		
<p>Date &amp; Time: Mon, Aug 06, 2018, 13:26:47 EDT Position: +037.10961° / -080.048875° Altitude: 1520ft Datum: WGS-84 Azimuth/Bearing: 341° N19W, 6062mils (True) Elevation Grade: -003° Horizon Grade: -001° Zoom: 1X S-GH14-50 compacting waterbars</p>

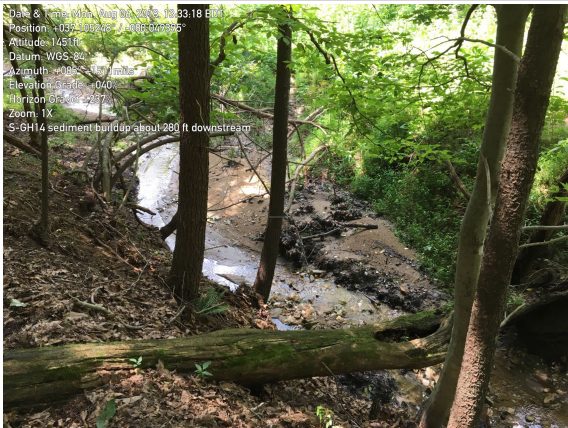
<p>Date &amp; Time: Mon, Aug 06, 2018, 13:33:18 EDT Position: +037.10961° / -080.048875° Altitude: 1451ft Datum: WGS-84 Azimuth/Bearing: 341° N19W, 6062mils (True) Elevation Grade: -040° Horizon Grade: -007° Zoom: 1X S-GH14 sediment buildup about 200 ft downstream</p>

Description	ECDs GAS S-GH14 bridge need to be replaced.	Description	Sediment washed about 200 ft. downstream during Friday's flood event.
