Visual Site Inspection Report

| Project Name | H-600 Pipeline Spread H | | AFE | 124300138 | Spread | H-600 Pipeline Spread H | |
| Contractor | Precision | | | | Report # | 3405 | |
| Inspector | Jason Nielsen | | | | Date/Time | 6/21/2018 10:12 PM | |

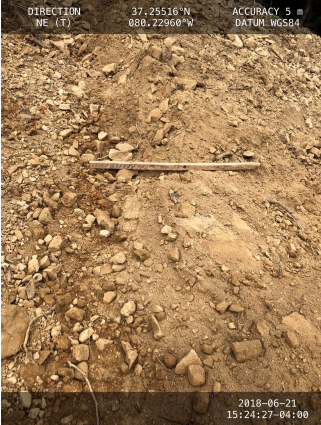
| Description | 12288+00_062118 stake showing height of water bar. Looking NE. See picture for GPS data. | Description | 12287+00_062118 Stake showing height of water bar. Looking E. See picture for GPS data. | | |

| Waterbar | | Communication | | Needs better constructed | | | |

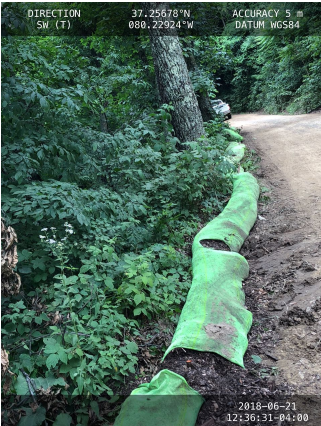
| Description | MVP-MN-276.01 damaged CFS. Looking SW. See picture for GPS data. | Description | MVP-MN-276.01_062118 water truck settling dust. Looking SE. See picture for GPS data. | | |

| Compost Filter Sock | | Communication | | Holes need repaired | | | |

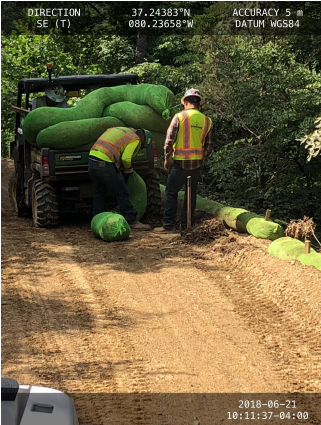
| Description | MVP-MN-276.03 Crew repairing CFS. Looking SE. See picture for GPS data. | Description | MVP-MN-276.03_062118 Crew unloading CFS for perimeter of LOD. Looking S. See picture for GPS data. | | |
