# Visual Site Inspection Report

<b>Project Name</b>	H-600 Pipeline Spread H	<b>A/E</b>	124300138	<b>Spread</b>	H-600 Pipeline Spread H
<b>Contractor</b>	Precision			<b>Report #</b>	3743
<b>Inspector</b>	Jason Nielsen			<b>Date/Time</b>	6/27/2018 10:08 PM
<b>Permit #</b>	TBD	<b>Inspection Type</b>	VA SWPP	<b>Station Begin</b>	12298+39
<b>State</b>	VA	<b>Inspection Area</b>	Partial	<b>Station End</b>	12197+48
<b>County</b>	Montgomery	<b>Ground</b>	Wet	<b>Temperature (°F)</b>	75.00
<b>Municipality</b>	N/A	<b>Weather</b>	Cloudy	<b>Rain Gauge (in)</b>	0.00
<b>GPS Location</b>	37.2668609535669, -80.0310438965261			<b>Rain Accumulation Time (days)</b>	0.00

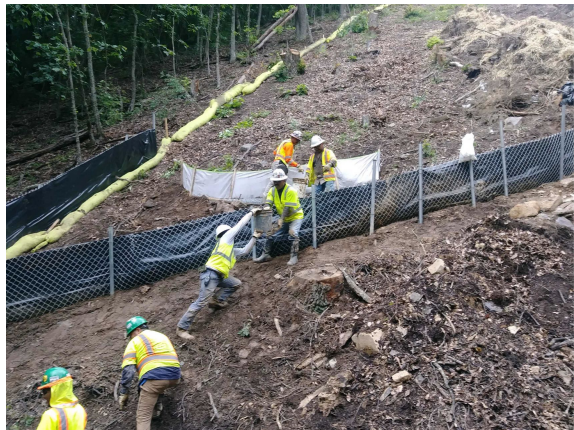
<b>GPS Location</b>	37.2670192749197, -80.0310222730989	<b>GPS Location</b>	37.2668620851238, -80.0308621768654		
<b>Description</b>	12291+64_062718 Crew passing buckets of sediment up hill from off LOD.	<b>Description</b>	12288+50_062718 Crew cleaning sediment build up from water bar. Looking SW. See picture for GPS data.

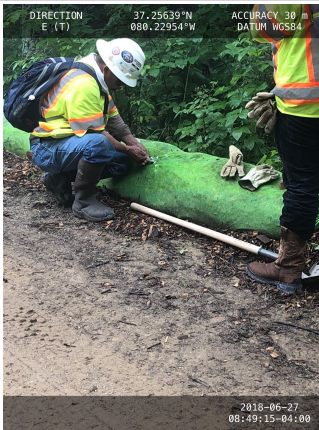
<b>GPS Location</b>	37.266986975481, -80.0309840497375	<b>GPS Location</b>	37.2668840457101, -80.0309076067806		
<b>Description</b>	12290+00_062718 Crew installing P2 silt fence across disturbed ground. Looking W. See picture for GPS data	<b>Description</b>	12291+61_062718 Crew dumping sediment back on ROW.
