Visual Site Inspection Report

Project Name	H-600 Pipeline Spread H	AFE	124300138	Spread	H-600 Pipeline Spread H
Contractor	Precision			Report #	4028
Inspector	Jason Nielsen			Date/Time	7/3/2018 5:15 AM
Permit #	TBD	Inspection Type	VA SWPP	Station Begin	12298+39
State	VA	Inspection Area	Partial	Station End	12190+85
County	Montgomery	Ground	Dry	Temperature (°F)	92.00
Municipality	N/A	Weather	Sunny	Rain Gauge (in)	0.00
GPS Location	37.2667543357585, -80.03103836447			Rain Accumulation Time (days)	0.00

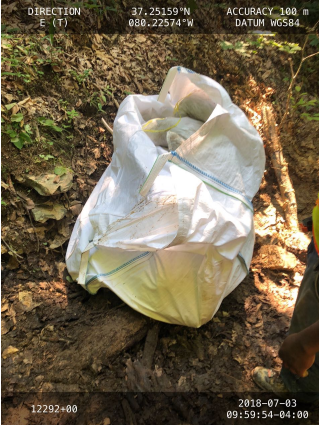
GPS Location	37.2670509836245, -80.0309595095477	GPS Location	37.2670510551308, -80.0309489295632		
Description	070318 Super sack full of sediment filled sand bags. Looking E. See picture for GPS data.	Description	070318 Area that crew as cleaned up sediment run off. Looking SE. See picture for GPS data.

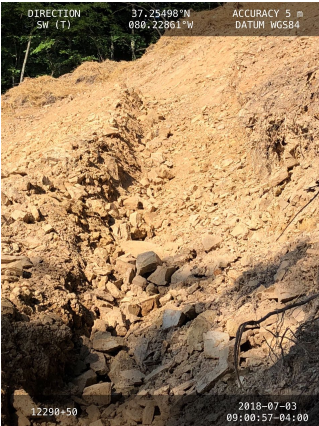
GPS Location	37.2668098239575, -80.0309150666744	GPS Location	37.2668201756079, -80.0308839698136		
Description	12290+50_070318 Rocks piled up in water bar drain. Looking SW. See picture for GPS data.	Description	12286+00_070318 Water bar doesn't continue past sump. Looking S. See picture for GPS data.

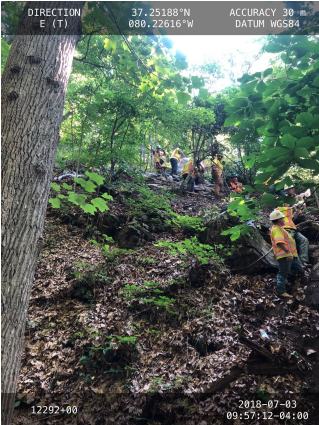
GPS Location	37.2668201756079, -80.0308839698136	GPS Location	37.2667690879081, -80.0308229495585		
Description	070318 Crew loading super sack with sediment filled sand bags for helicopter to pick up. Looking E. See picture for GPS data.	Description	12289+50_070318 Rocks filling up water bar. Looking SW. See picture for GPS data.
