Visual Site Inspection Report

Project Name	H-600 Pipeline Spread H	AFE	124300138	Spread	H-600 Pipeline Spread H
Contractor	Precision			Report #	4850
Inspector	Jason Nielsen			Date/Time	7/19/2018 3:54 PM
Permit #	TBD	Inspection Type	VA SWPP	Station Begin	12072+84
State	VA	Inspection Area	Partial	Station End	12298+39
County	Montgomery	Ground	Dry	Temperature (°F)	84.00
Municipality	N/A	Weather	Sunny	Rain Gauge (in)	0.00
GPS Location	37.2670223380547, -80.0310211359787			Rain Accumulation Time (days)	0.00

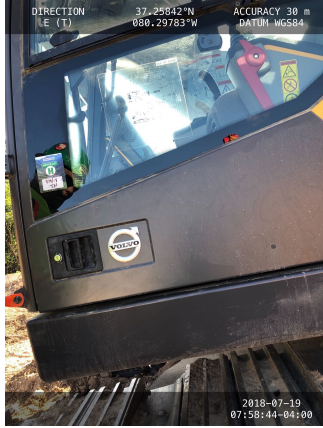
GPS Location	37.2668543067473, -80.0310026724303	GPS Location	37.2669370787922, -80.0309325128359		
Description	12072+84_071918 Piece of equipment that was inspected. Looking E. See picture for GPS data.	Description	12072+84_071918 Piece of equipment that was inspected. Looking E. See picture for GPS data.

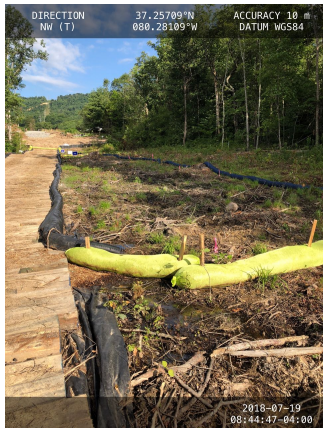
GPS Location	37.2669298109014, -80.0309048407525	GPS Location	37.2669468680744, -80.0309118815512		
Description	12121+29_071918 Beginning of wetland W-C12 that was outlined with CFS. Looking E. See picture for GPS data.	Description	12123+23_071918 End of wetland W-C11 that had CFS installed around outer edge. Looking NW. See picture for GPS data.
