# Visual Site Inspection Report

<b>Project Name</b>	H-600 Pipeline Spread H	<b>AFE</b>	124300138	<b>Spread</b>	H-600 Pipeline Spread H
<b>Contractor</b>	Precision			<b>Report #</b>	6779
<b>Inspector</b>	Jason Nielsen			<b>Date/Time</b>	8/22/2018 8:23 PM
<b>Permit #</b>	TBD	<b>Inspection Type</b>	VA SWPP	<b>Station Begin</b>	13343+22
<b>State</b>	VA	<b>Inspection Area</b>	Partial	<b>Station End</b>	13371+50
<b>County</b>	Franklin	<b>Ground</b>	Damp	<b>Temperature (°F)</b>	80.00
<b>Municipality</b>	N/A	<b>Weather</b>	Sunny	<b>Rain Gauge (in)</b>	0.00
<b>GPS Location</b>	37.3313688918058, -79.958285660279			<b>Rain Accumulation Time (days)</b>	0.00

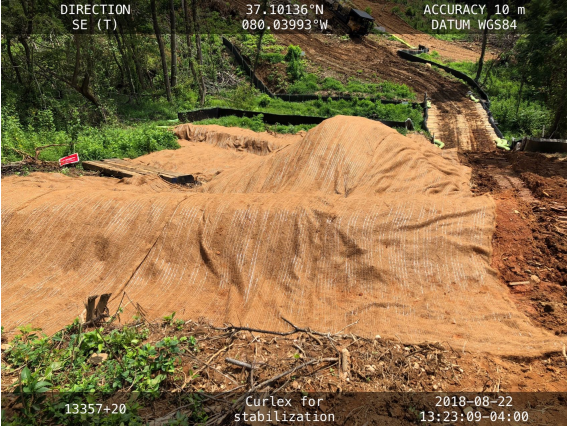
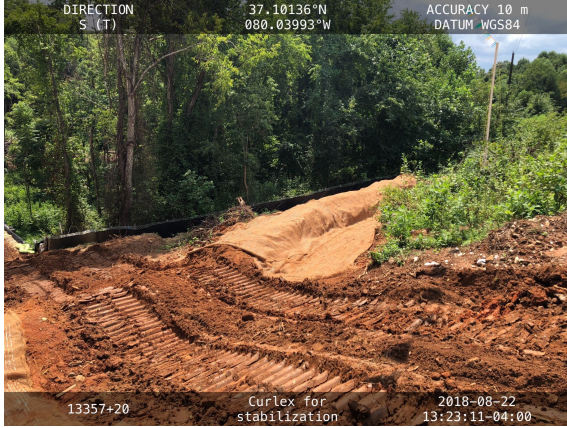
<b>GPS Location</b>	37.3315734999155, -79.9582702728712		<b>GPS Location</b>	37.3313621142065, -79.957903042663	
<b>Description</b>	13357+20_082218 Curlex for stabilization. Looking SE. See picture for GPS data.		<b>Description</b>	13357+20_082218 Curlex for stabilization. Looking S. See picture for GPS data.

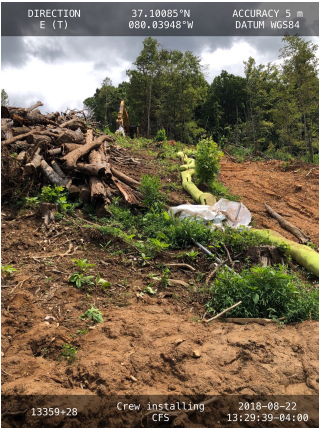
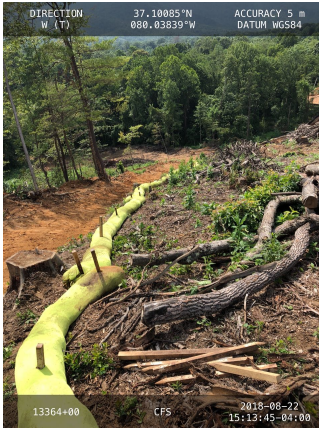
<b>GPS Location</b>	37.3313531583836, -79.9578969002887		<b>GPS Location</b>	37.3313519603726, -79.9578980677091	
<b>Description</b>	13359+28_082218 Crew installing CFS along perimeter of LOD. Looking E. See picture for GPS data.		<b>Description</b>	13364+00_082218 Ending of CFS for the day. Looking W. See picture for GPS data.

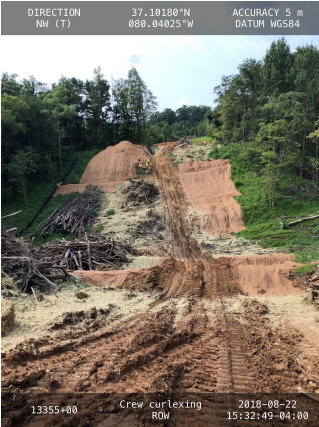
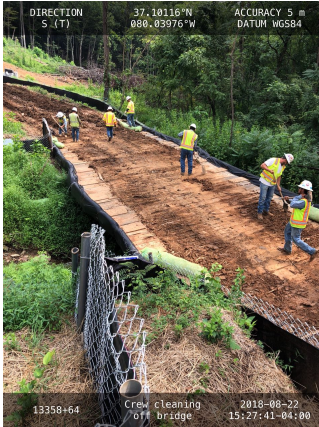
<b>GPS Location</b>	37.3313056769823, -79.9581155574524		<b>GPS Location</b>	37.3313056769823, -79.9581155574524	
<b>Description</b>	13355+00_082218 Crew curlexing ROW for stabilization. Looking NW. See picture for GPS data.		<b>Description</b>	13358+64_082218 Crew cleaning off bridge after equipment crossed. Looking S. See picture for GPS data.
