# Visual Site Inspection Report

<b>Project Name</b>	H-600 Pipeline Spread H	<b>AFE</b>	124300138	<b>Spread</b>	H-600 Pipeline Spread H
<b>Contractor</b>	Precision			<b>Report #</b>	6780
<b>Inspector</b>	Jason Nielsen			<b>Date/Time</b>	8/22/2018 8:46 PM
<b>Permit #</b>	TBD	<b>Inspection Type</b>	VA SWPP	<b>Station Begin</b>	12102+69
<b>State</b>	VA	<b>Inspection Area</b>	Partial	<b>Station End</b>	12291+64
<b>County</b>	Montgomery	<b>Ground</b>	Damp	<b>Temperature (°F)</b>	78.00
<b>Municipality</b>	N/A	<b>Weather</b>	Sunny	<b>Rain Gauge (in)</b>	0.10
<b>GPS Location</b>	37.3313358100479, -79.9580347538739			<b>Rain Accumulation Time (days)</b>	1.00

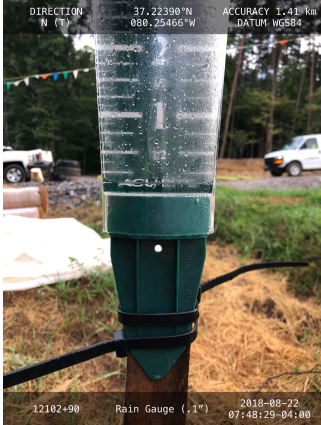
<b>GPS Location</b>	37.3312812140056, -79.9579804188413	<b>GPS Location</b>	37.3313307374152, -79.9580967219405		
<b>Description</b>	12102+90_082218 Rain gauge with .1" of rain. Looking N. See picture for GPS data.	<b>Description</b>	12137+00_082218 ATWS rock pad and well vegetated diversion berm. Looking E. See picture for GPS data.

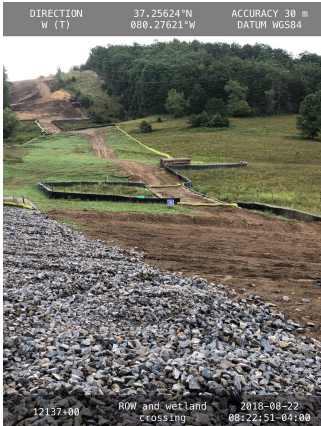
<b>GPS Location</b>	37.3313627578666, -79.9582198262959	<b>GPS Location</b>	37.3313376032943, -79.9581208037658		
<b>Description</b>	12137+00_082218 ROW and wetland crossing. Looking W. See picture for GPS data.	<b>Description</b>	12121+00_082218 Plywood covering hook mat slots. Looking NW. See picture for GPS data.

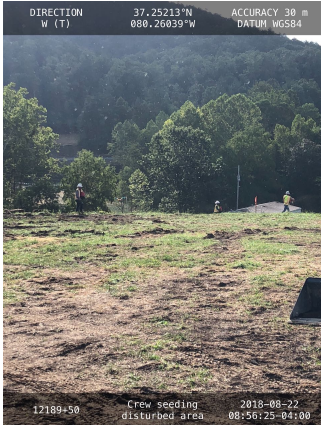
<b>GPS Location</b>	37.3313707625841, -79.9580598157644	<b>GPS Location</b>	37.3313734867026, -79.9581140466779		
<b>Description</b>	12189+50_082218 Crew seeding disturbed area. Looking W. See picture for GPS data.	<b>Description</b>	12286+50_082218 Crew installing curlex for steep slope stabilization. Looking SE. See picture for GPS data.
