Visual Site Inspection Report

Project Name	H-600 Pipeline Spread H	AFE	124300138	Spread	H-600 Pipeline Spread H
Contractor	Precision			Report #	7063
Inspector	Jason Nielsen			Date/Time	8/28/2018 9:11 PM
Permit #	TBD	Inspection Type	VA SWPP	Station Begin	12214+63
State	VA	Inspection Area	Partial	Station End	12300+11
County	Montgomery	Ground	Dry	Temperature (°F)	90.00
Municipality	N/A	Weather	Sunny	Rain Gauge (in)	0.00
GPS Location	37.3313891492143, -79.9582919218379			Rain Accumulation Time (days)	0.00

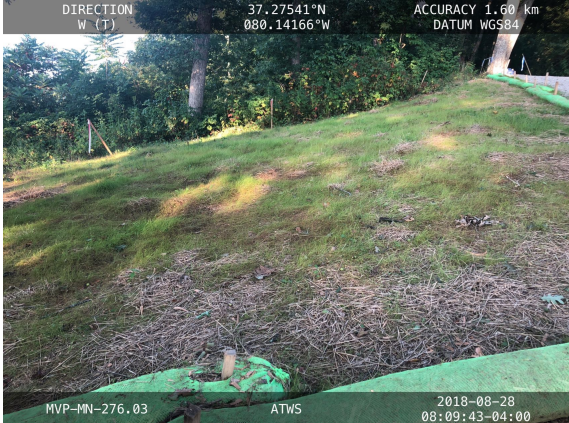
GPS Location	37.3314158797942, -79.9584196017664		GPS Location	37.3311706446459, -79.9580516853183	
Description	MVP-MN-276.03_082818 ATWS that has been stabilized and sprouted. Looking W. See picture for GPS data.		Description	MVP-MN-276.03_082818 stabilized access road where road meets ROW. Looking SE. See picture for GPS data.

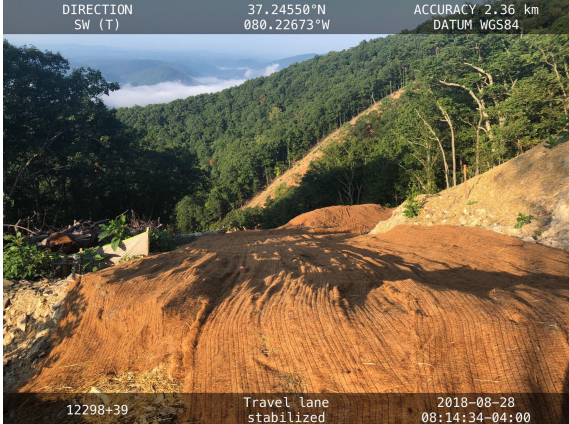
GPS Location	37.3313138494616, -79.9580505118519		GPS Location	37.3313138494616, -79.9580505118519	
Description	12298+39_082818 Travel lane stabilized down ROW. Looking SW. See picture for GPS data.		Description	12285+75_082818 Water bar after stabilization. Looking SW. See picture for GPS data.

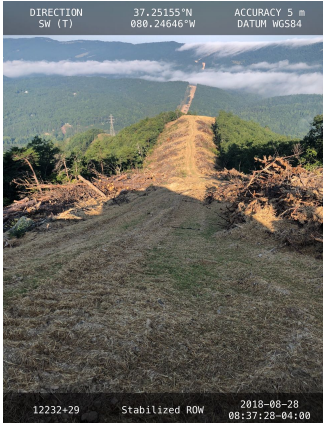
GPS Location	37.3313138494616, -79.9580505118519		GPS Location	37.3313138494616, -79.9580505118519	
Description	12232+29_082818 Stabilized ROW beginning to sprout. Looking SW. See picture for GPS data.		Description	12285+75_082818 Stabilized ROW (Curlex) Looking SE. See picture for GPS data
