Visual Site Inspection Report

Project Name	H-600 Pipeline Spread H	AFE	124300138	Spread	H-600 Pipeline Spread H
Contractor	Precision			Report #	7834
Inspector	Jason Nielsen			Date/Time	9/13/2018 11:38 PM
Permit #	TBD	Inspection Type	VA SWPP	Station Begin	12298+39
State	VA	Inspection Area	Partial	Station End	12217+62
County	Montgomery	Ground	Wet	Temperature (°F)	78.00
Municipality	N/A	Weather	Cloudy	Rain Gauge (in)	0.00
GPS Location	37.3313223460407, -79.9579313376368			Rain Accumulation Time (days)	0.00

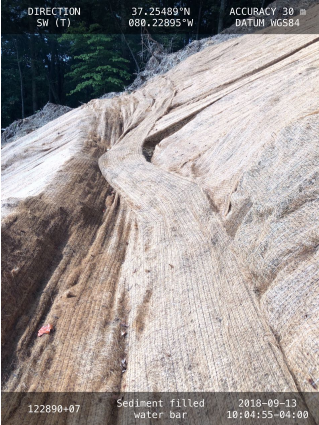
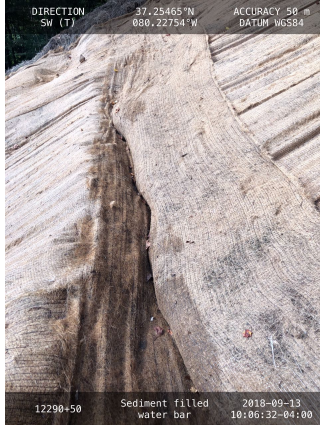
GPS Location	37.3312105381789, -79.9582049372366	GPS Location	37.3313483933574, -79.958379852395		
Description	12289+07_091318 Sediment filled water bar. Looking SW. See picture for GPS data.	Description	12290+50_091318 Sediment filled water bar. Looking SW. See picture for GPS data.

4. E&S BMPs (List BMPs and note if installed and maintained as per the plan. If corrective action is needed, a picture is required.)					
E&S BMPs	Compliance Level	Corrective Action	Corrective Time Frame	Date Repaired	
Compost Filter Sock	Communication	Needs repaired along access road			
Erosion Control Blanket	Communication	Needs repaired on steep slope			
Rock Construction Entrance	Acceptable				
Silt Fence (Filter Fabric Fence)	Acceptable				
Silt Fence (Reinforced Filter Fabric Fence)	Acceptable				
Vegetative Stabilization (Temporary)	Acceptable				
Waterbar	Communication	Needs sediment cleaned out			
Waterbar Outlet Protection	Acceptable

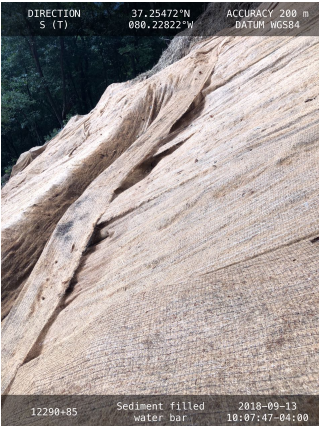
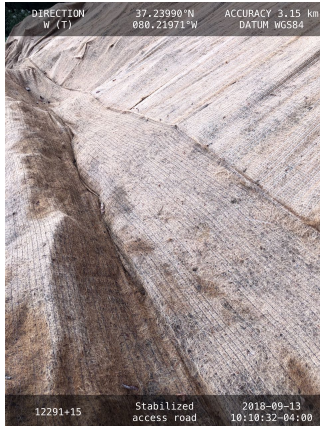
GPS Location	37.3314089421531, -79.9581016414612	GPS Location	37.3313806532299, -79.9581096880883		
Description	12290+86_091318 Sediment filled water bar. Looking S. See picture for GPS data.	Description	12291+15_091318 Sediment filled water bar. Looking W. See picture for GPS data.

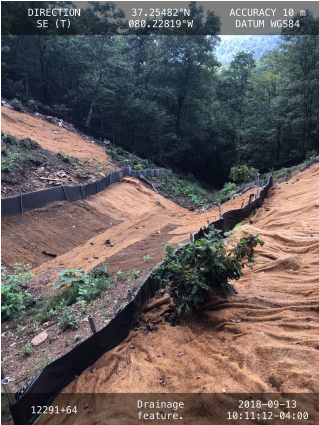
7. Identify all remedial measures that have been taken since the previous inspection was conducted. Since my last inspection of the area the stabilization (curlex) in the travel lane has been pulled down into water bars, crews were working on repairing the issue today.					
Comments (Reference above questions as appropriate.) Went to access road MVP-MN-276.03 to perform a VASWPP inspection. During my inspection I found damaged CFS along the Access road from rain events over the past few days, the damaged CFS had been undermined in one area and the outlets have been filled with sediment. The travel lane down the ROW between MP 232.5-232.6 had a few issues where the area between water bars had began to slip down into the water bar and could have been problematic if not taken care of. Environmental crew went to the area and began cleaning the water bars out by hand and repaired the curlex stabilization that had been damaged during the slip, the crew also had guys repairing the CFS and outlets along the access road. The water bar outlets were still in good condition and had no sediment build up. SSF, CFS, and RCEs along the ROW were in good condition and didn't show any damaged areas. The drainage feature at STA# 12291+64 was stabilized and had no sediment impact.

GPS Location	37.3313604947527, -79.9580057524889	GPS Location	37.3313604947527, -79.9580057524889		
Description	12291+64_091318 Drainage Feature. Looking SE. See picture for GPS data.	Description	MVP-MN-276.03_091318 CFS undermined on the access road. Looking SE. See picture for GPS data.
