Visual Site Inspection Report

Project Name	H-600 Pipeline Spread H	AFE	124300138	Spread	H-600 Pipeline Spread H
Contractor	Precision			Report #	8149
Inspector	Jason Nielsen			Date/Time	9/19/2018 7:15 AM
Permit #	TBD	Inspection Type	VA SWPP	Station Begin	12190+85
State	VA	Inspection Area	Partial	Station End	12298+39
County	Montgomery	Ground	Damp	Temperature (°F)	84.00
Municipality	N/A	Weather	Sunny	Rain Gauge (in)	0.00
GPS Location	37.2356847563858, -80.2294638031484			Rain Accumulation Time (days)	0.00

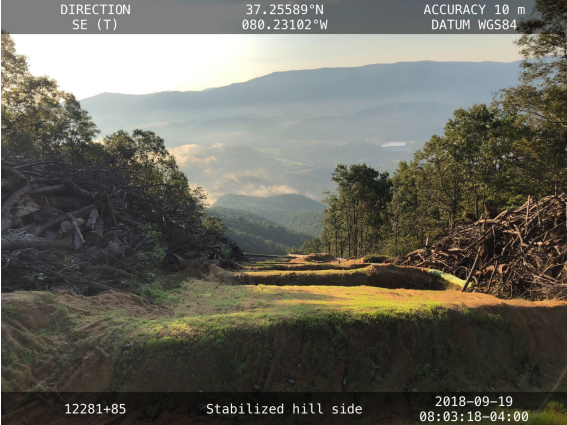
<p>DIRECTION SE (T) 37.25589°N 080.23102°W ACCURACY 10 m DATUM WGS84</p> <p>12281+85 Stabilized hill side 2018-09-19 08:03:18-04:00</p>

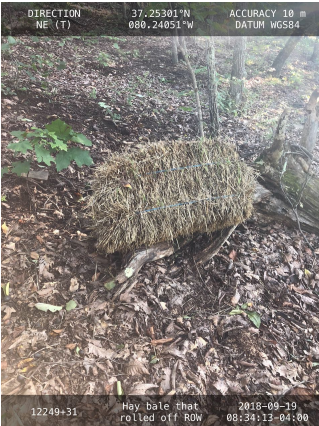
<p>DIRECTION NE (T) 37.25301°N 080.24051°W ACCURACY 10 m DATUM WGS84</p> <p>12249+31 Hay bale that rolled off ROW 2018-09-19 08:34:13-04:00</p>

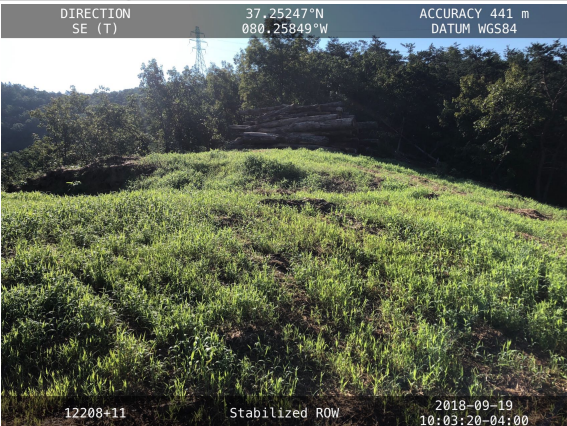
<p>DIRECTION SE (T) 37.25247°N 080.25849°W ACCURACY 441 m DATUM WGS84</p> <p>12208+11 Stabilized ROW 2018-09-19 10:03:20-04:00</p>

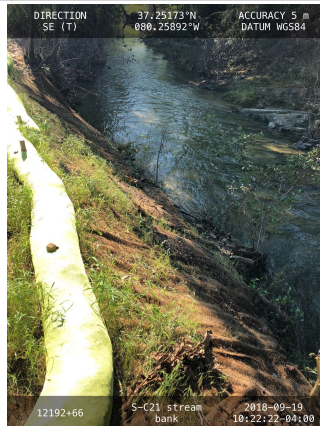
<p>DIRECTION SE (T) 37.25173°N 080.25892°W ACCURACY 5 m DATUM WGS84</p> <p>12192+66 S-C21 stream bank 2018-09-19 10:22:22-04:00</p>		GPS Location 37.2356284736071, -80.2296182234587	
Description		12208+11_091918 Stabilized ROW. Looking SE. See picture for GPS data.		Description	
		GPS Location 37.235641465557, -80.2296338137986		Description 12192+66_091918 S-C21 Stream bank. Looking SE. See picture for GPS data.
