# Visual Site Inspection Report

<b>Project Name</b>	H-600 Pipeline Spread H	<b>AFE</b>	124300138	<b>Spread</b>	H-600 Pipeline Spread H
<b>Contractor</b>	Precision			<b>Report #</b>	8741
<b>Inspector</b>	Jason Nielsen			<b>Date/Time</b>	10/1/2018 8:32 PM
<b>Permit #</b>	TBD	<b>Inspection Type</b>	VA SWPP	<b>Station Begin</b>	12190+85
<b>State</b>	VA	<b>Inspection Area</b>	Partial	<b>Station End</b>	12448+50
<b>County</b>	Franklin	<b>Ground</b>	Dry	<b>Temperature (°F)</b>	74.00
<b>Municipality</b>	N/A	<b>Weather</b>	Sunny	<b>Rain Gauge (in)</b>	0.00
<b>GPS Location</b>	37.2516576061372, -80.2462982945892			<b>Rain Accumulation Time (days)</b>	0.00

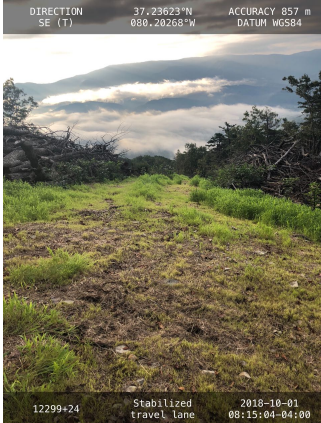
<b>GPS Location</b>	37.2516243299816, -80.246361242682		<b>GPS Location</b>	37.2516243299816, -80.246361242682	
<b>Description</b>	12299+24_100118 Stabilized Travel lane. Looking SE. See picture for GPS data.		<b>Description</b>	12295+92_100118 Stabilized Travel lane and undisturbed ROW. Looking SW. See picture for GPS data.

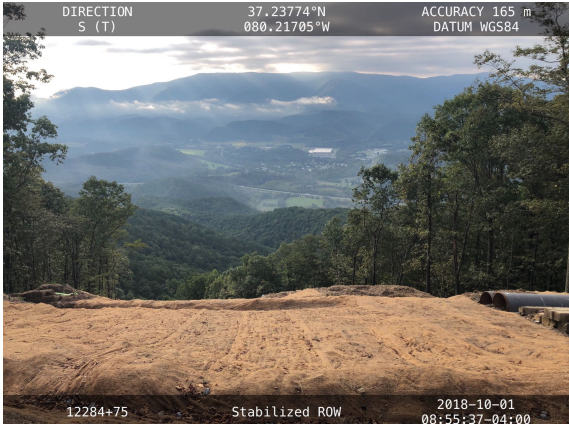
<b>GPS Location</b>	37.2516243299816, -80.246361242682		<b>GPS Location</b>	37.251728433219, -80.2463178244235	
<b>Description</b>	12284+75_100118 Stabilized ROW. Looking S. See picture for GPS data.		<b>Description</b>	12445+04_100118 SSF perimeter controls. Looking W. See picture for GPS data.

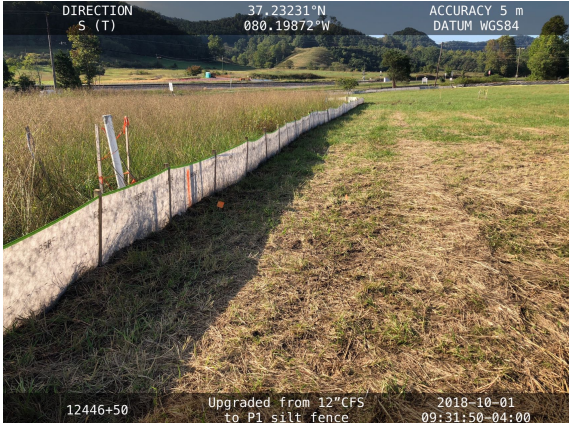
<b>GPS Location</b>	37.251712507603, -80.246300473884		<b>GPS Location</b>	37.2516538342808, -80.2462853026392	
<b>Description</b>	12446+50_100118 Upgraded from 12\"CFS to P1 silt fence. Looking S. See picture for GPS data.		<b>Description</b>	12442+04_100118 Port-O-Potties. Looking E. See picture for GPS data.
