# Visual Site Inspection Report

<b>Project Name</b>	H-600 Pipeline Spread H	<b>AFE</b>	124300138	<b>Spread</b>	H-600 Pipeline Spread H
<b>Contractor</b>	Precision			<b>Report #</b>	2916
<b>Inspector</b>	Joe Scott			<b>Date/Time</b>	6/11/2018 2:34 PM
<b>Permit #</b>	TBD	<b>Inspection Type</b>	VA SWPP	<b>Station Begin</b>	13024+00
<b>State</b>	VA	<b>Inspection Area</b>	Full	<b>Station End</b>	13080+00
<b>County</b>	Franklin	<b>Ground</b>	Muddy	<b>Temperature (°F)</b>	79.00
<b>Municipality</b>	N/A	<b>Weather</b>	Light Rain	<b>Rain Gauge (in)</b>	1.00
<b>GPS Location</b>	37.1335027786318, -80.4540204630051			<b>Rain Accumulation Time (days)</b>	2.00

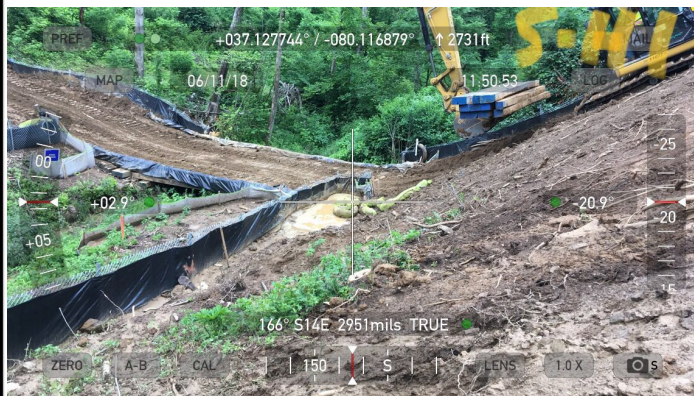
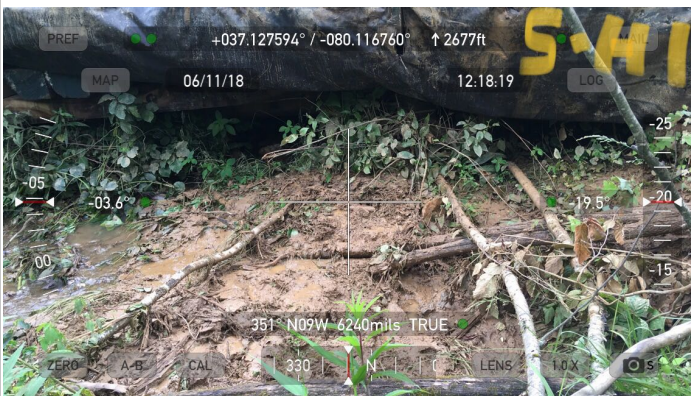
Attended the Monday morning contractors safety meeting before traveling to MVP-FR-289. Upon arriving the rain gauge measured 1 inch of rainfall over the weekend. At stream crossing, S-H1. The first water bar to fail was at 13041+00, it washed out at the travel lane. The water from there washed out the next water bar down the hill 13041+50 at the travel lane also. Then the water bar at 13042+25 washed out at both the travel lane and at the sump. The water then over filled the super silt fence and flowed out where it met the mats of the bridge and over the bumpers on the edges. The sediment in the stream appeared to be the result of water bar failures at the travel lane. The environmental crew cleared the sediment out of the stream and reinforced the bumpers on the mat bridge. The also added hay bales where the silt fence met the mats. 40-50 gallons of sediment in a 5x10 area of the creek was removed.

GPS Location		37.1334824466259, -80.4540956243165		GPS Location		37.1334709693092, -80.4540046212081	
Description		Overfilled super silt fence. Please see photo for proper GPS data.		Description		Impacted area of S-H1. Please see photo for proper GPS data.

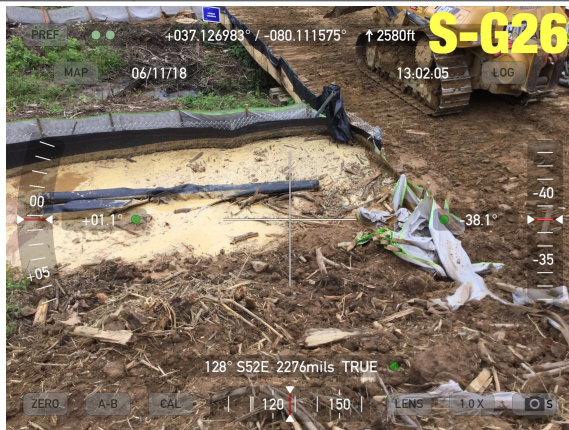
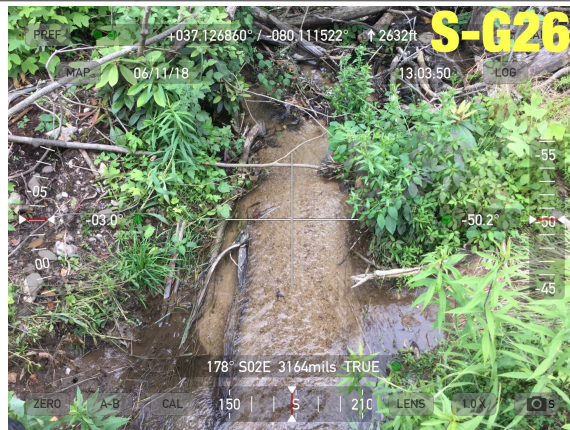
At stream crossing S-G26 a very small amount of sediment found its way into the stream. The water bar at 13060+20 above the stream blew out where the water bar connected to the sump bypassing the sump and overflowing the super silt fence where it met the mat bridge. Then a small amount flowed under the bridge into the stream. The environmental crew removed the sediment from the stream and cleaned out the corner where the super silt fence was holding water. The water bars were addressed when the trac-hoe was traveling out. 5-7 gallons of sediment in a 3x6 area of the creek was removed.

GPS Location		37.1334633836869, -80.4539153539394		GPS Location		37.1335339593116, -80.4541996680949	
Description		Overfilled super silt fence. Please see photo for proper GPS data.		Description		Impacted area of S-G26. Please see photo for proper GPS data.

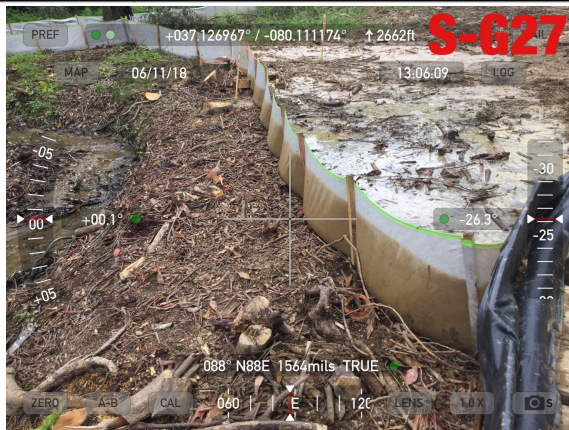
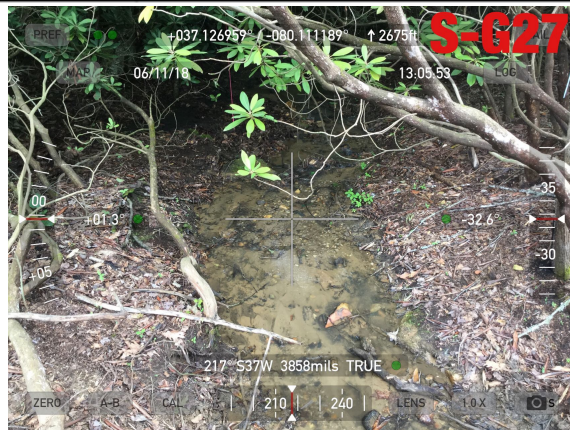
At stream crossing S-G27 about 20 gallons of sediment was in the stream and was cleaned out by the environmental crew. The P1 silt fence at the edge of the stream buffer overflowed past the buffer and then overflowed the P1 at the stream edge. Sediment flowed under the bridge and into the stream. Hay bales were placed behind the P1 silt fence at the buffer to upgrade the design. NOTE: ground conditions will have to improve for slope breakers to be repaired and reinstalled with the proper compaction.

GPS Location		37.1334880683917, -80.4541753605757		GPS Location		37.1334767729228, -80.4540962977246	
Description		Overfilled P1 silt fence after it flowed over P1 silt fence up hill. Please see photo for proper GPS data.		Description		Impacted area of S-G27. Please see photo for proper GPS data.
