Visual Site Inspection Report

Project Name	H-600 Pipeline Spread H	AFE	124300138	Spread	H-600 Pipeline Spread H
Contractor	Precision			Report #	3722
Inspector	Joe Scott			Date/Time	6/27/2018 2:39 PM
Permit #	TBD	Inspection Type	VA SWPP	Station Begin	13024+50
State	VA	Inspection Area	Partial	Station End	13117+50
County	Franklin	Ground	Muddy	Temperature (°F)	88.00
Municipality	N/A	Weather	Cloudy	Rain Gauge (in)	0.00
GPS Location	37.1254874999049, -80.1194743160904			Rain Accumulation Time (days)	1.00

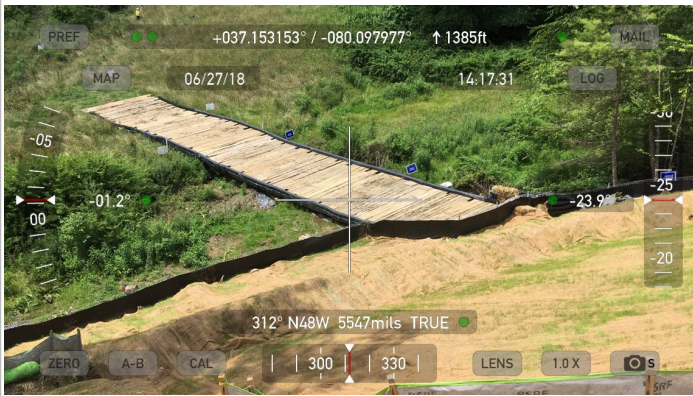
GPS Location 37.1254747175026, -80.1199016255141 Description ECD's near 13024+50 holding up to recent rain fall

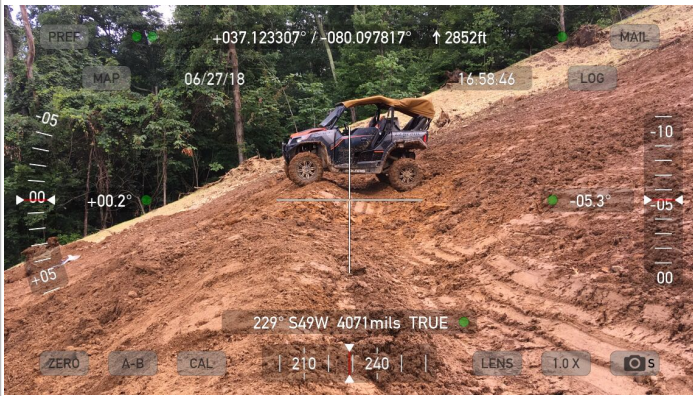
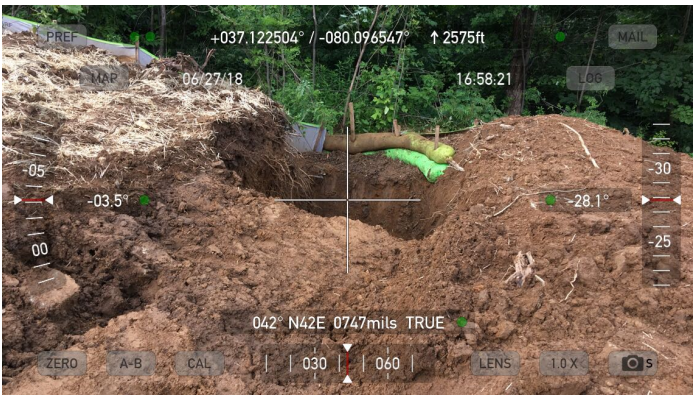
GPS Location 37.1229959791872, -80.0974177569897 Description Several sumps and j hooks have been improved as well.
