Visual Site Inspection Report

Project Name H-600 Pipeline Spread H		AFE 124300138	Spread H-600 Pipeline Spread H
Contractor Precision		Report # 4567	
Inspector Joe Scott		Date/Time 7/13/2018 2:46 PM	
Permit # TBD	Inspection Type VA SWPP	Station Begin	13024+50
State VA	Inspection Area Full	Station End	13117+50
County Franklin	Ground Dusty	Temperature (°F)	85.00
Municipality N/A	Weather Sunny	Rain Gauge (in)	0.00
GPS Location 37.1504083229575, -80.1182434336097		Rain Accumulation Time (days)	1.00

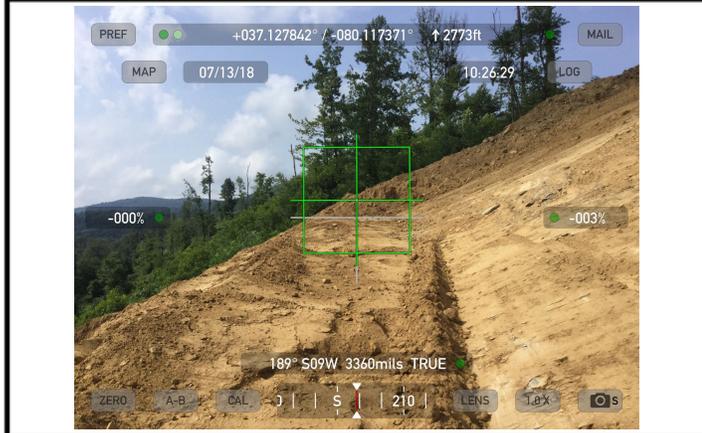
GPS Location 37.1503970912072, -80.1182306092979

E&S BMPs	Compliance Level	Corrective Action	Corrective Time Frame
Erosion Control Blanket	Acceptable		
Housekeeping	Acceptable		
Silt Fence (Filter Fabric Fence)	Acceptable		
Silt Fence (Reinforced Filter Fabric Fence)	Acceptable		
Straw Bale Barrier	Acceptable		
Sump Pit	Acceptable		
Vegetative Stabilization (Temporary)	Communication	Inadequate coverage on spoil piles	Addressed
Waterbar	Communication	Not compacted under 18"height	Addressed
Waterbar Outlet Protection	Acceptable

Description 13041+00 below 18" height requirement

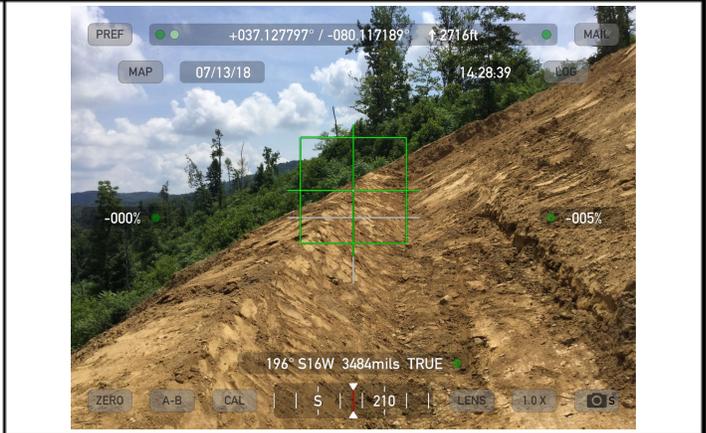
GPS Location 37.1503591211859, -80.1180593670161

Description 13041+00 rebuilt to specifications

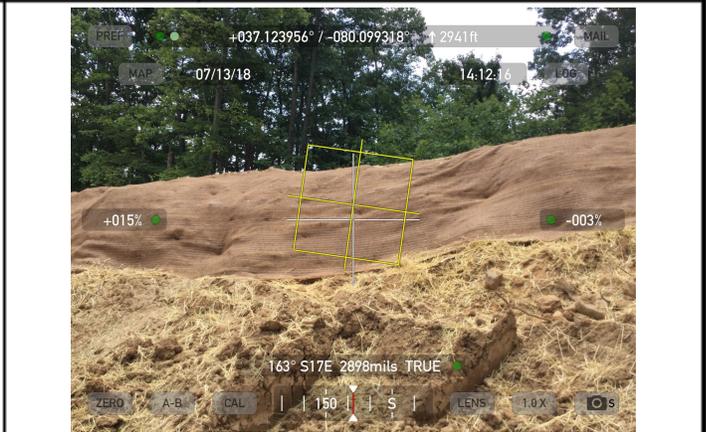
GPS Location 37.1503591211859, -80.1180593670161

Description Curlex was used to stabilize the spoil piles where seed and mulch would not adhere.

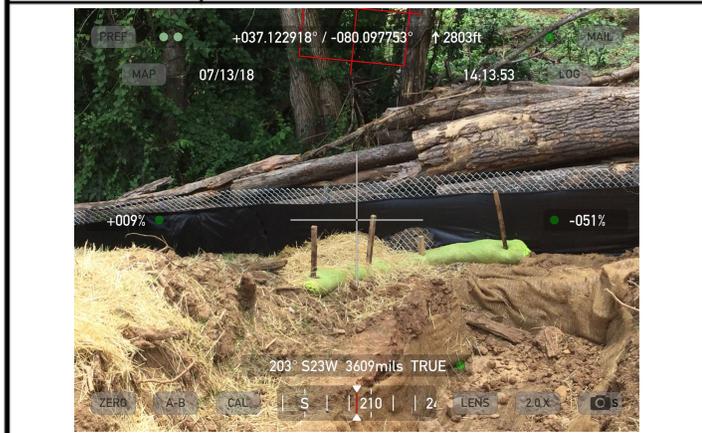
GPS Location 37.1503591211859, -80.1180593670161

Description Berms were stabilized behind the j hook

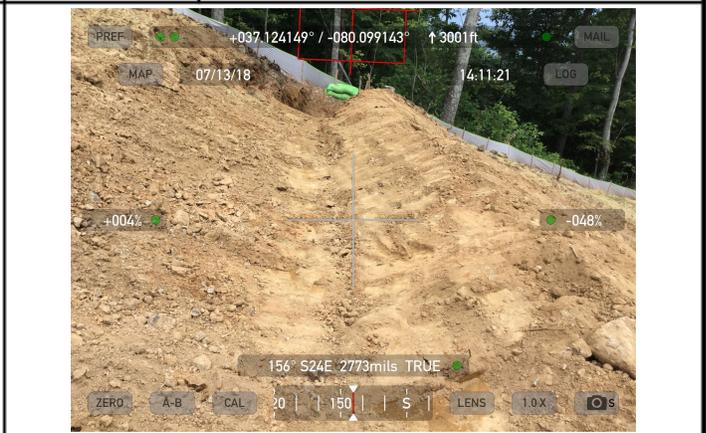
GPS Location 37.1503591211859, -80.1180593670161

Description The faces of the water bars were compacted and obstructions were removed
