# Visual Site Inspection Report

<b>Project Name</b>	H-600 Pipeline Spread H	<b>AFE</b>	124300138	<b>Spread</b>	H-600 Pipeline Spread H
<b>Contractor</b>	Precision			<b>Report #</b>	6446
<b>Inspector</b>	Joe Scott			<b>Date/Time</b>	8/16/2018 6:28 PM
<b>Permit #</b>	TBD	<b>Inspection Type</b>	VA SWPP	<b>Station Begin</b>	13024+50
<b>State</b>	VA	<b>Inspection Area</b>	Partial	<b>Station End</b>	13120+17
<b>County</b>	Franklin	<b>Ground</b>	Dry	<b>Temperature (°F)</b>	90.00
<b>Municipality</b>	N/A	<b>Weather</b>	Sunny	<b>Rain Gauge (in)</b>	0.00
<b>GPS Location</b>	37.2937227739369, -80.0227843691409			<b>Rain Accumulation Time (days)</b>	1.00

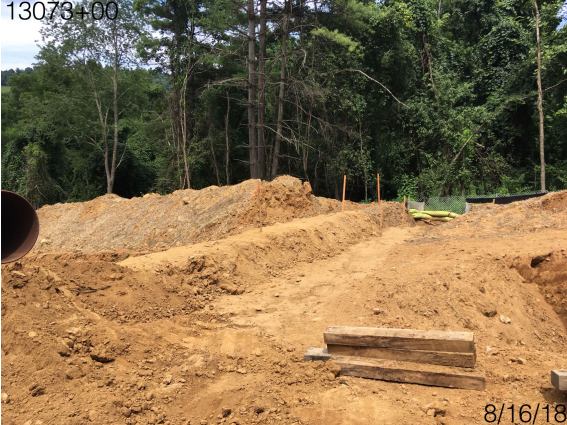
8/16/18			
<b>GPS Location</b>	37.2939510422068, -80.0227873463219	<b>GPS Location</b>	37.2936253343125, -80.0227624923736		
<b>Description</b>	Water bars and ECD's maintained throughout the area.	<b>Description</b>	Spoil piles have been seeded and mulched.		
13117+00

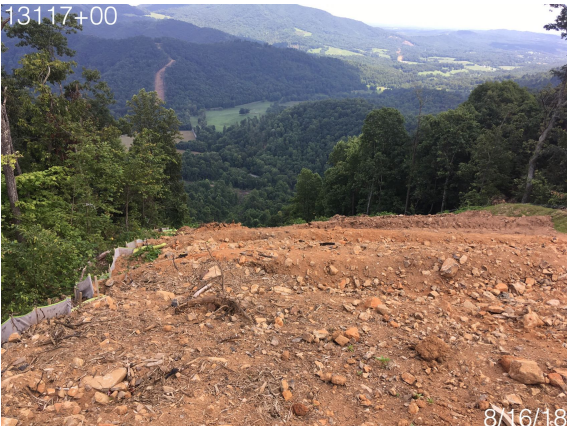
8/16/18		13025+50   8/16/18			
<b>GPS Location</b>	37.2938007675459, -80.0227982831001	<b>GPS Location</b>	37.2937535355215, -80.0228888914734		
<b>Description</b>	18" height requirement has been maintained on water bars.	<b>Description</b>	Stream crossing S-H25&24. Bridge cleaned off and water bars maintained.		
13062+00   8/16/18		13025+50

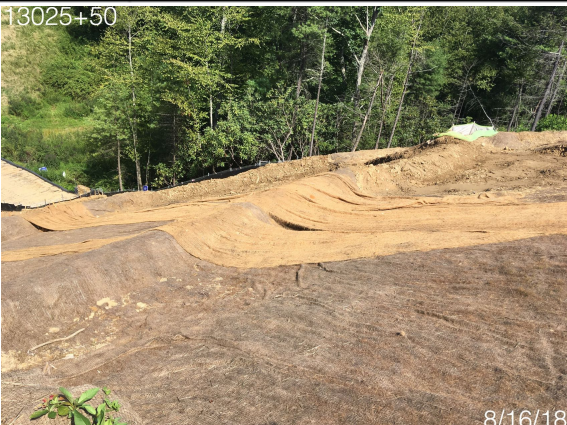
8/16/18			
<b>GPS Location</b>	37.2937496379365, -80.0228935853392	<b>GPS Location</b>	37.2936751647268, -80.0227629952878		
<b>Description</b>	Curlex is reapplied to water bars each time they are rebuilt after work activities are done.	<b>Description</b>	Curlex has not been reinstalled in the travel lane but the water bars and the lack of the curlex has not had any issues to date.
