Visual Site Inspection Report

Project Name	H-600 Pipeline Spread H	AFE	124300138	Spread	H-600 Pipeline Spread H
Contractor	Precision			Report #	7041
Inspector	Joe Scott			Date/Time	8/28/2018 9:27 AM
Permit #	TBD	Inspection Type	VA SWPP	Station Begin	13024+50
State	VA	Inspection Area	Partial	Station End	13120+17
County	Franklin	Ground	Damp	Temperature (°F)	88.00
Municipality	N/A	Weather	Sunny	Rain Gauge (in)	0.00
GPS Location	37.1253764815974, -80.1206969004871			Rain Accumulation Time (days)	1.00

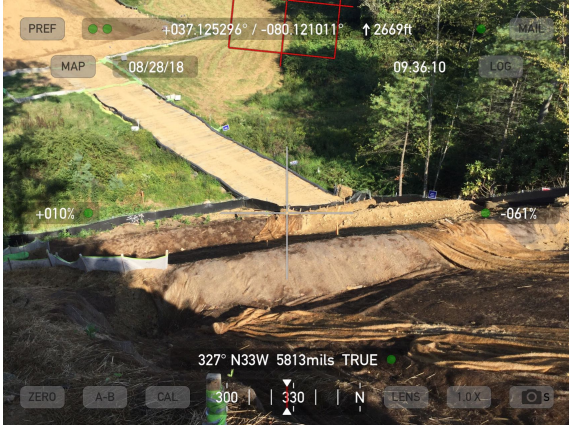
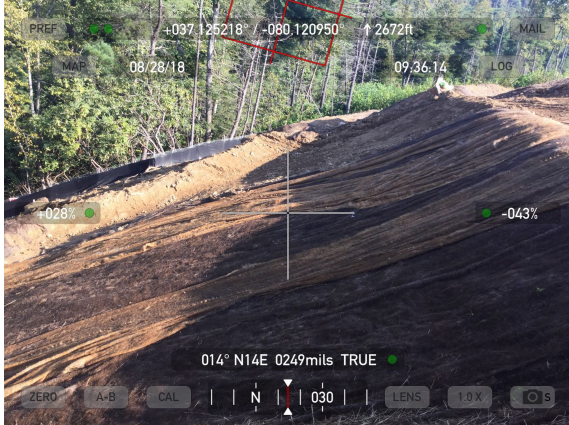
GPS Location	37.1252668043944, -80.1210645307602	GPS Location	37.1252676844943, -80.1210672967882		
Description	ECD's have been maintained, mat bridge is clean of soil. No impact to resource. 13024+50	Description	Slope is stabilized except travel lane. Water bars maintained and functional. 13025+50

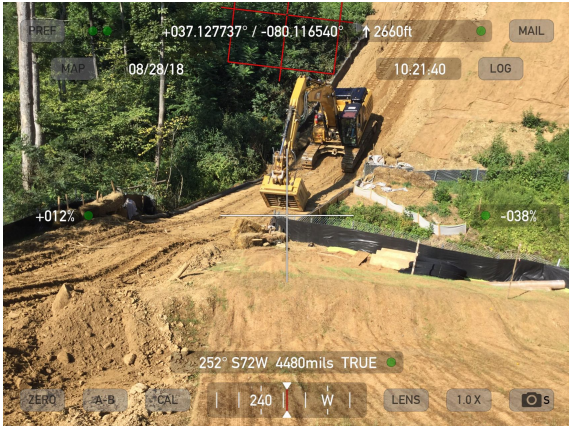
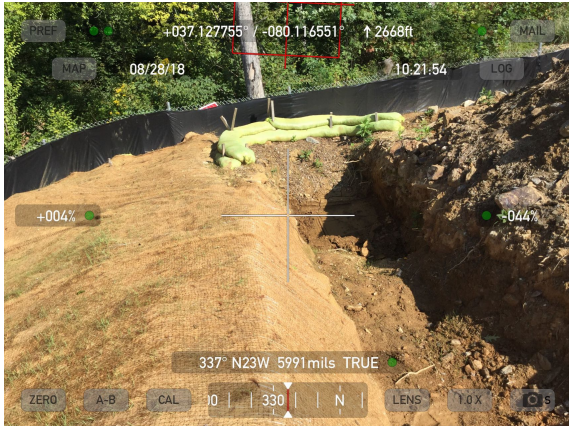
GPS Location	37.1277450817052, -80.116447024122	GPS Location	37.1276494860995, -80.1166271512211		
Description	Cleaning as he crossed. S-H1 13043+00	Description	Sumps recently cleaned out. 13043+50

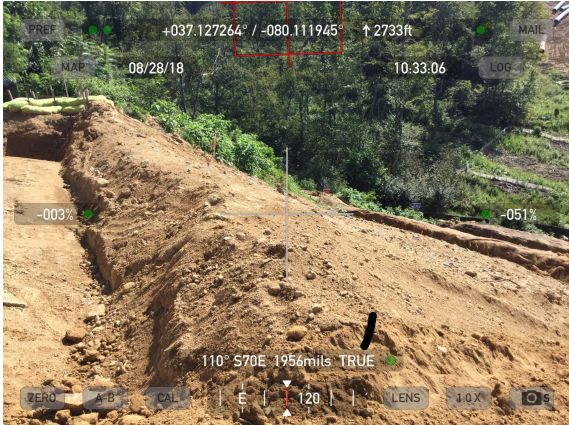
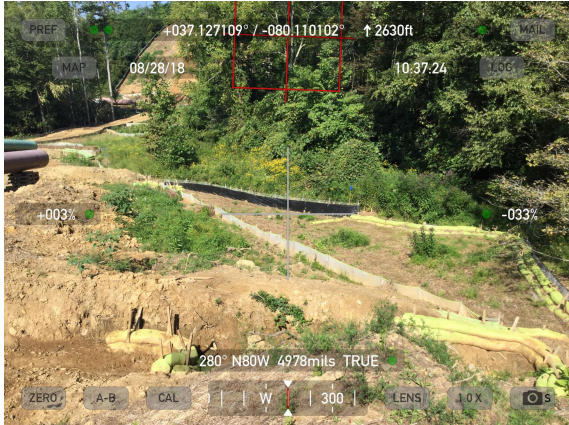
GPS Location	37.1272387309346, -80.1120300126077	GPS Location	37.1269573504451, -80.1101441682131		
Description	Water bars and sumps maintained up slope of S-G26. 13060+00	Description	Water bars are within specifications. Sumps have been recently cleaned out. Silt sock could use some maintenance.
