Visual Site Inspection Report

Project Name	H-600 Pipeline Spread H	AFE	124300138	Spread	H-600 Pipeline Spread H
Contractor	Precision			Report #	7825
Inspector	Joe Scott			Date/Time	9/13/2018 10:33 AM
Permit #	TBD	Inspection Type	VA SWPP	Station Begin	13024+00
State	VA	Inspection Area	Partial	Station End	13120+17
County	Franklin	Ground	Muddy	Temperature (°F)	77.00
Municipality	N/A	Weather	Light Rain	Rain Gauge (in)	0.10
GPS Location	37.1270205080855, -80.1113763079793			Rain Accumulation Time (days)	1.00

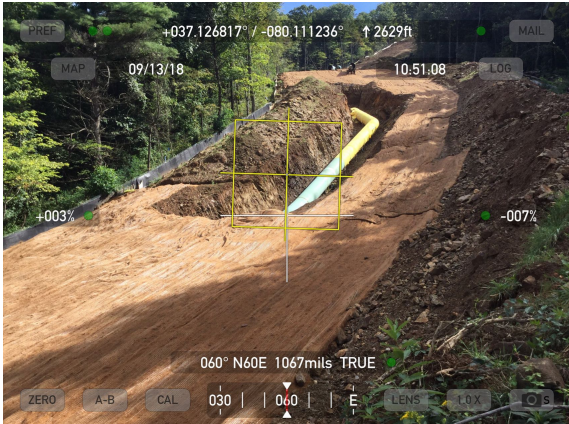
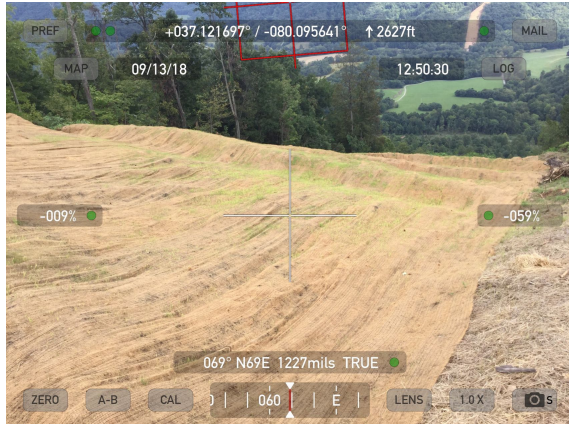
AFE	124300138	Date/Time	9/13/2018 10:33 AM	Report #	7825
Pictures					
 		 		GPS Location 37.127023148385, -80.1113677584381	
Description		Description		13062+00 S-G26 slope above the stream has been stabilized with curlex
