# Visual Site Inspection Report

<b>Project Name</b>	H-600 Pipeline Spread H	<b>AFE</b>	124300138	<b>Spread</b>	H-600 Pipeline Spread H
<b>Contractor</b>	Precision			<b>Report #</b>	8709
<b>Inspector</b>	Joe Scott			<b>Date/Time</b>	10/1/2018 9:24 AM
<b>Permit #</b>	TBD	<b>Inspection Type</b>	VA SWPP	<b>Station Begin</b>	13024+00
<b>State</b>	VA	<b>Inspection Area</b>	Partial	<b>Station End</b>	13120+17
<b>County</b>	Franklin	<b>Ground</b>	Damp	<b>Temperature (°F)</b>	77.00
<b>Municipality</b>	N/A	<b>Weather</b>	Sunny	<b>Rain Gauge (in)</b>	0.00
<b>GPS Location</b>	37.1218192018914, -80.0959733036161			<b>Rain Accumulation Time (days)</b>	1.00

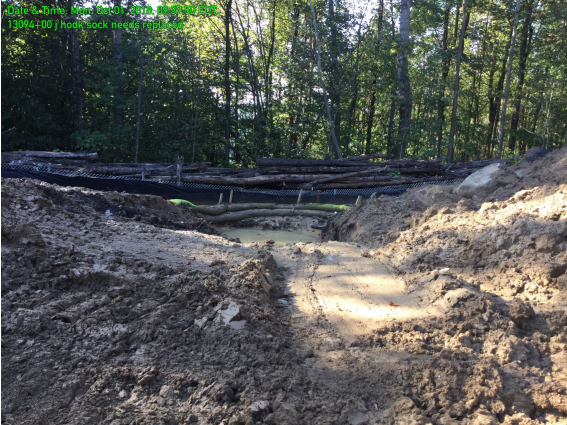
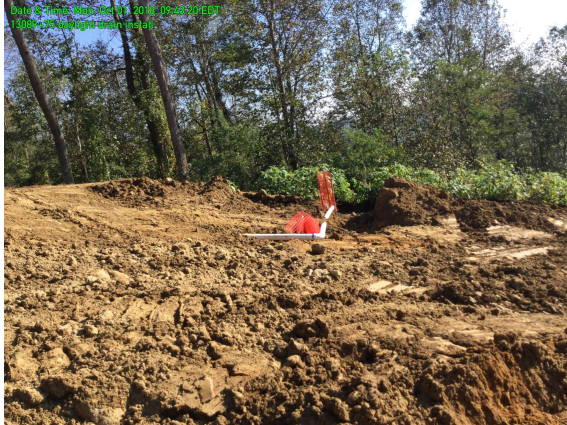
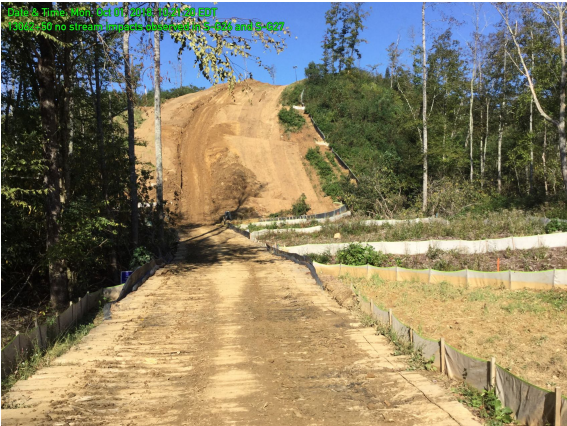
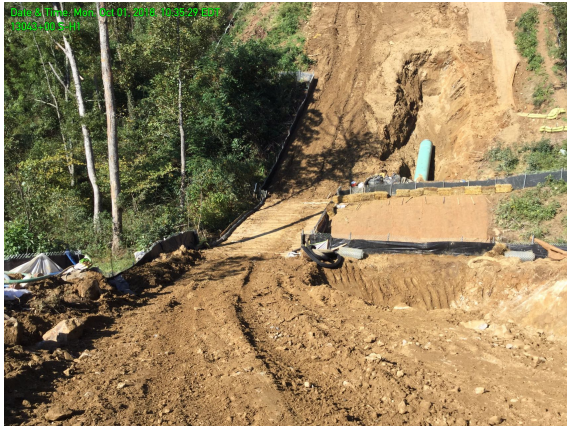
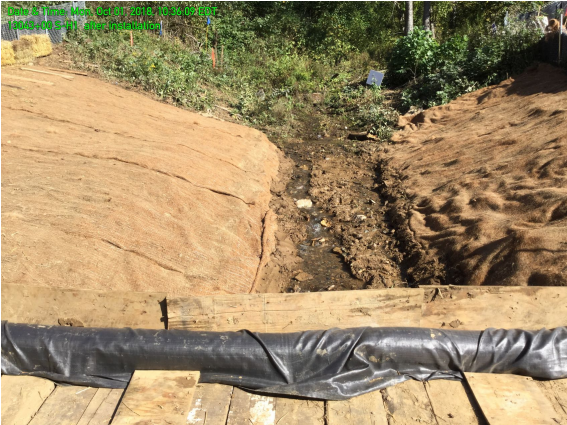
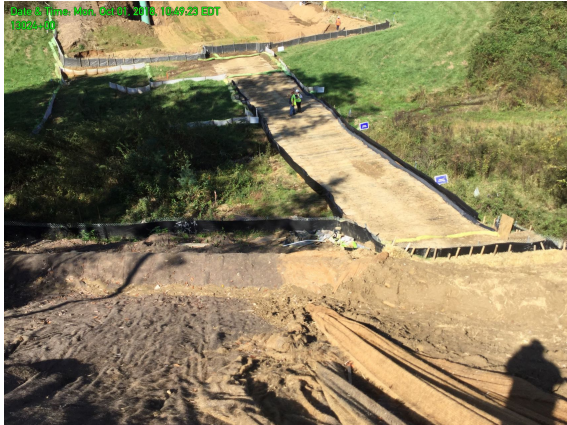
<b>GPS Location</b>	37.1219034819278, -80.0958685298265	<b>GPS Location</b>	37.1253218315887, -80.103259189129		
<b>Description</b>	ECD's in need of maintenance	<b>Description</b>	Daylight drain from trench breaker installed

<b>GPS Location</b>	37.1262123668912, -80.1185088884831	<b>GPS Location</b>	37.1261648834097, -80.1185017638655		
<b>Description</b>	No impacts to resources. Water bars cut out for the work day.	<b>Description</b>	Restored S-H1. ECD's reinstalled

<b>GPS Location</b>	37.2939006734815, -80.0229190045279	<b>GPS Location</b>	37.2937880485452, -80.0229266463443		
<b>Description</b>	Channel kept straight to minimize erosion. Original stream bed material put back into the stream.	<b>Description</b>	No impacts were observed to S-G24 and S-G25.
