Visual Site Inspection Report

Project Name	H-600 Pipeline Spread H	AFE	124300138	Spread	H-600 Pipeline Spread H
Contractor	Precision			Report #	4015
Inspector	John Brcic			Date/Time	7/3/2018 6:49 AM
Permit #	TBD	Inspection Type	VA SWPP	Station Begin	12005+00
State	VA	Inspection Area	Partial	Station End	120140+00
County	Montgomery	Ground	Dry	Temperature (°F)	90.00
Municipality	N/A	Weather	Sunny	Rain Gauge (in)	0.00
GPS Location	37.3087950007113, -80.0103475925423			Rain Accumulation Time (days)	1.00

A/E	124300138	Date/Time	7/3/2018 6:49 AM	Report #	4015
Pictures

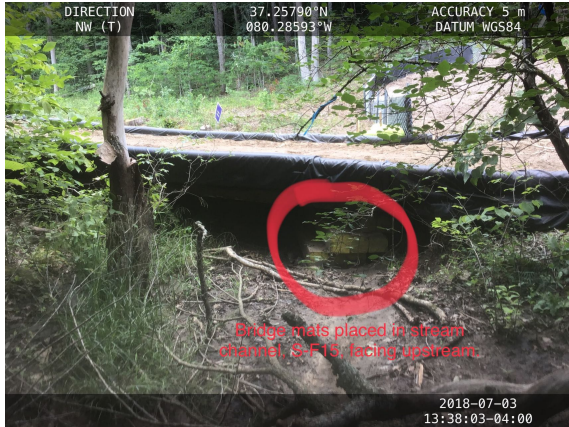
GPS Location	37.3086929620659, -80.0103560575147		GPS Location	37.3087311647813, -80.0104083114684	
Description	Bridge mats in stream channel, geotech lining incomplete with gaps above stream channel @ S-F15, station 12108+41, ~MP 229.33~.		Description	Clean debris out of water bars that was dumped there while cleaning out water bodies, station 12036+50, ~MP-227.96~.

E&S BMPs	Compliance Level	Corrective Action	Corrective Time Frame
Housekeeping	Communication	Remove trash @ 12037+00	24 Hours
Housekeeping	Communication	Remove trash @ 12031+00	24 Hours
Other	Noncompliance	Rebuild bridge @ S-F15, 12108+41	Immediate
Waterbar	Communication	Clean debris from channel, 12036+50	24 Hours

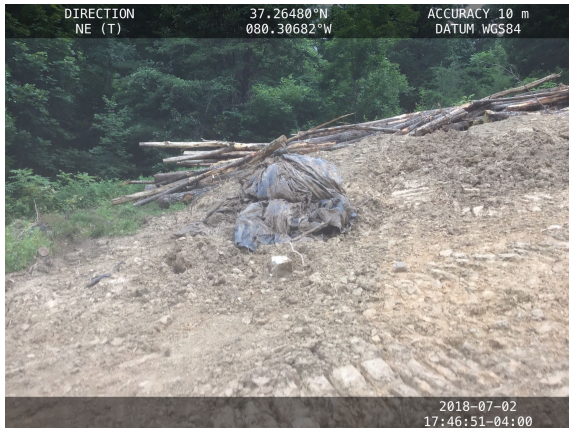
GPS Location	37.3086934253259, -80.0103545890181		GPS Location	37.308520437253, -80.0101857819408	
Description	Clean up trash at station 12037+00, ~MP 227.97~.		Description	Remove trash from station 12031+00, ~MP 227.86~.

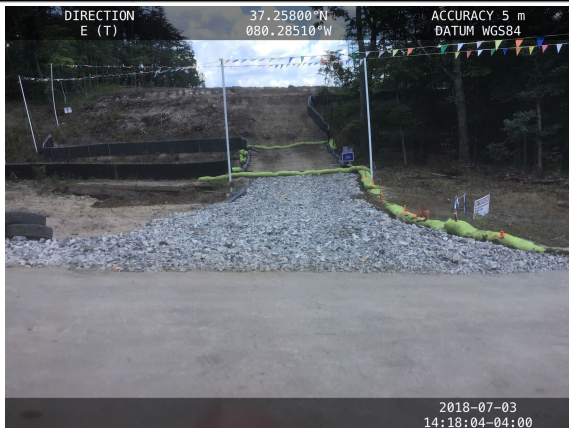
GPS Location	37.3086919495539, -80.0103567631768		GPS Location	37.3086158794378, -80.0105125349007	
Description	New RCE at access road MVP-MN-271.		Description	Cleanup completed where sediment left ROW at station 12067+50, ~MP 228.55~.
