# Visual Site Inspection Report

<b>Project Name</b> H-600 Pipeline Spread H		<b>AFE</b> 124300138	<b>Spread</b> H-600 Pipeline Spread H
<b>Contractor</b> Precision		<b>Report #</b> 5563	
<b>Inspector</b> John Brcic		<b>Date/Time</b> 7/31/2018 7:13 PM	
<b>Permit #</b> TBD	<b>Inspection Type</b> VA SWPP	<b>Station Begin</b>	12005+00
<b>State</b> VA	<b>Inspection Area</b> Partial	<b>Station End</b>	12102+69
<b>County</b> Montgomery	<b>Ground</b> Wet	<b>Temperature (°F)</b>	75.00
<b>Municipality</b> N/A	<b>Weather</b> Cloudy	<b>Rain Gauge (in)</b>	0.50
<b>GPS Location</b> 37.3086484923834, -80.0104781817074		<b>Rain Accumulation Time (days)</b>	1.00

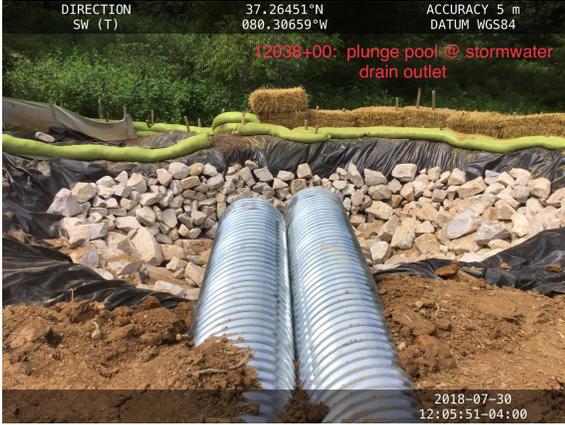
<p>DIRECTION SW (T) 37.26451°N 080.30659°W ACCURACY 5 m DATUM WGS84 12038+00: plunge pool @ stormwater drain outlet 2018-07-30 12:05:51-04:00</p>

Bridges were rebuilt with improved geotech liners at streams S-G40 and S-MM15. A drainage system engineered by Tetra Tech was installed at station 12038+00 to 12040+00 to alleviate stormwater being funneled down to stream S-G40 by the natural trough on the ROW. Punchlist items were addressed through this stretch of ROW such as upgrading j-hooks at sumps and adding ECDs near waterbodies. General maintenance was also performed such as cleaning out sumps and ECDs where needed.

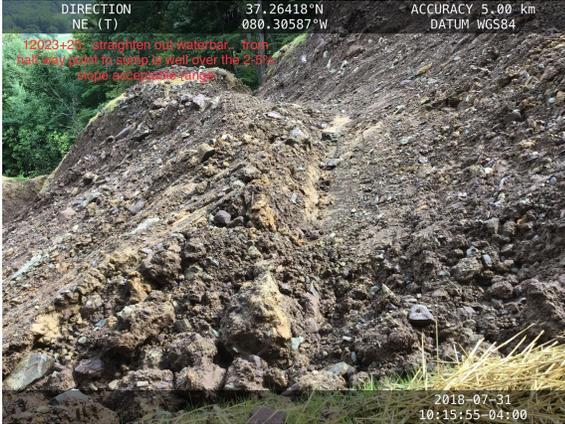
<p>DIRECTION NE (T) 37.26418°N 080.30587°W ACCURACY 5.00 Km DATUM WGS84 12023+25: straighten out waterbar, from last way point to sump to well over the 2-5% pipe access to ridge 2018-07-31 10:15:55-04:00</p>

E&S BMPs	Compliance Level	Corrective Action	Corrective Time Frame
Waterbar	Communication	12023+25: straighten waterbar	24 Hours
Waterbar	Communication	12049+00: restore travel lane properly	24 Hours
Waterbar Outlet Protection	Communication	12060+70: triple stack j-hook	24 Hours
Sensitive Resource Buffer	Problem Area	Stream S-MM15 impacted	Immediate

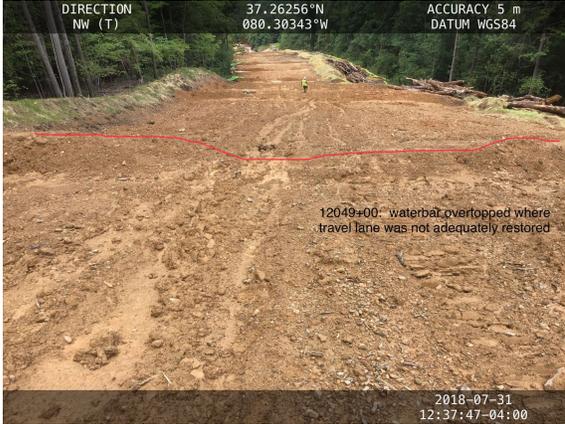
<p>DIRECTION NW (T) 37.26256°N 080.30343°W ACCURACY 5 m DATUM WGS84 12049+00: waterbar overtopped where travel lane was not adequately restored 2018-07-31 12:37:47-04:00</p>		<p><b>GPS Location</b> 37.308670399159, -80.0101705953396</p> <p><b>Description</b> Waterbar has large hump in the middle and needs to be straightened out @ station 12023+25, ~MP 227.5~.</p>		<p><b>GPS Location</b> 37.3086266359662, -80.0101019629091</p> <p><b>Description</b> Waterbar not properly restored in travel lane @ station 12049+00, ~MP 228.0~. See photo for location.</p>

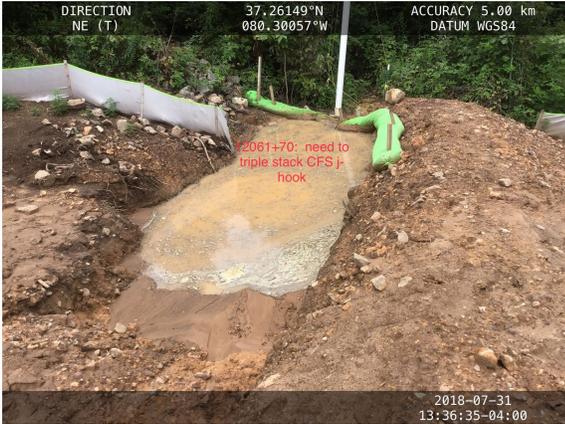
<p>DIRECTION NE (T) 37.26149°N 080.30057°W ACCURACY 5.00 km DATUM WGS84 12061+70: need to triple stack CFS j-hook 2018-07-31 13:36:35-04:00</p>

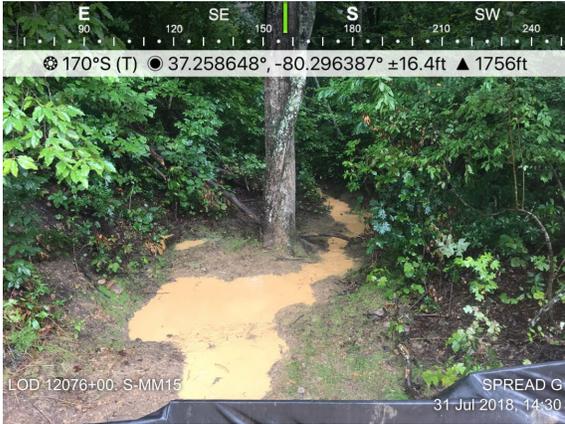
A stream impact was recorded at stream S-MM15, station 12076+95, today after a rain event in the afternoon by the WSSI inspectors.

<p>E 90 120 SE 150 S 180 SW 210 240 170°S (T) 37.258648°, -80.296387° ±16.4ft ▲ 1756ft LOD 12076+00: S-MM15 SPREAD G 31 Jul 2018, 14:30</p>		<p><b>GPS Location</b> 37.3087178078399, -80.0100690985339</p> <p><b>Description</b> CFS j-hook should be triple stacked at station 12061+70, ~MP 228.2~. See photo for location.</p>		<p><b>GPS Location</b> 37.3087415518587, -80.0100375060737</p> <p><b>Description</b> Stream S-MM15 was impacted by sediment during an afternoon rain event today, station 12076+95, ~MP 228.5~.</p>
