Visual Site Inspection Report

Project Name	H-600 Pipeline Spread H	AFE	124300138	Spread	H-600 Pipeline Spread H
Contractor	Precision			Report #	5932
Inspector	John Brcic			Date/Time	8/6/2018 9:53 AM
Permit #	TBD	Inspection Type	VA SWPP	Station Begin	12005+00
State	VA	Inspection Area	Partial	Station End	12102+69
County	Montgomery	Ground	Damp	Temperature (°F)	85.00
Municipality	N/A	Weather	Sunny	Rain Gauge (in)	0.00
GPS Location	37.3086054209736, -80.0103016781885			Rain Accumulation Time (days)	1.00

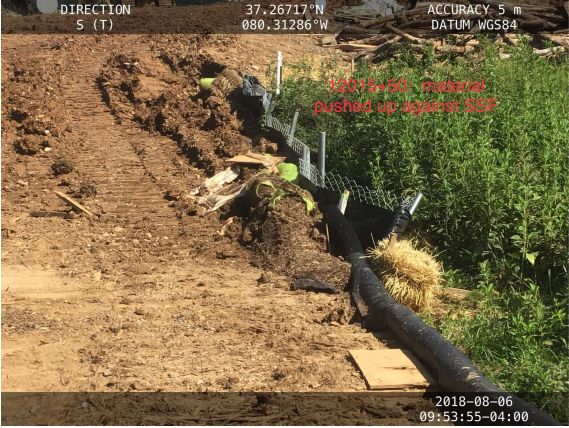
GPS Location	37.3085757413677, -80.0103702762016		GPS Location	37.3086459079087, -80.0101762220205	
Description	Dirt needs to be pulled back where it is pushed up against SSF @ station 12015+50, ~MP 227.3~. See photo for location.		Description	P1 silt fence needs to be cleaned out @ station 12037+00, ~MP 227.8~. See photo for location.

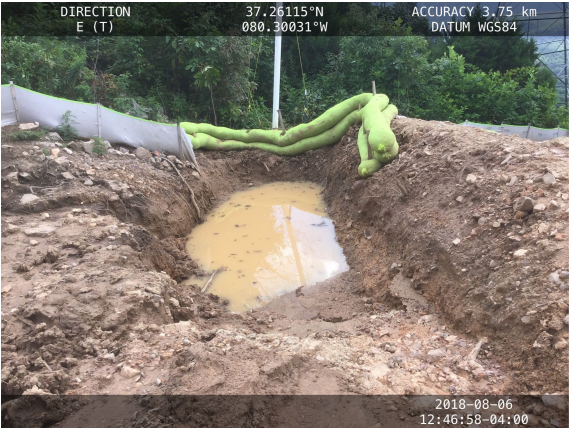
GPS Location	37.3086621863101, -80.0103286123186		GPS Location	37.3085247958426, -80.0101109315455	
Description	Triple stack CFS installed @ 12061+70 where runoff was overtopping single stack per PL item 959. See photo for location.		Description	Trash needs to be picked up @ station 12097+50, ~MP 228.9~. See photo for location.

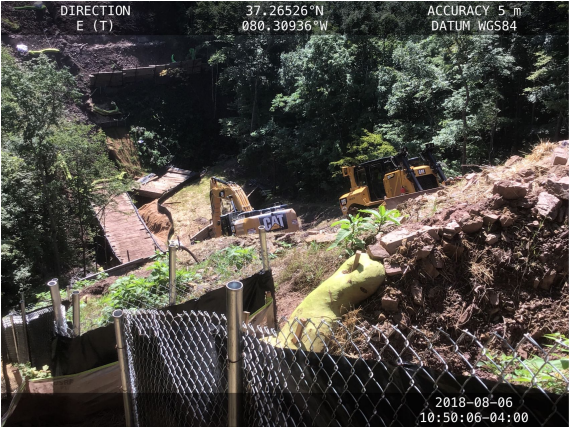
GPS Location	37.3085250472997, -80.0100895576924		GPS Location	37.3086092027687, -80.0102926360969	
Description	Operators performed maintenance on waterbars between stations 12027+00 and 12031+00, ~MP 227.7~. See photo for location		Description	Sumps were cleaned out near the top of the hill on the coming in side of AR 270, station 12057+00, ~MP 228.1~. See photo for location
