Visual Site Inspection Report

Project Name	H-600 Pipeline Spread H	AFE	124300138	Spread	H-600 Pipeline Spread H
Contractor	Precision			Report #	6449
Inspector	John Brsic			Date/Time	8/16/2018 12:05 PM
Permit #	TBD	Inspection Type	VA SWPP	Station Begin	12005+00
State	VA	Inspection Area	Partial	Station End	12102+69
County	Montgomery	Ground	Dry	Temperature (°F)	90.00
Municipality	N/A	Weather	Sunny	Rain Gauge (in)	0.00
GPS Location	37.288472011003, -80.288846329545			Rain Accumulation Time (days)	1.00

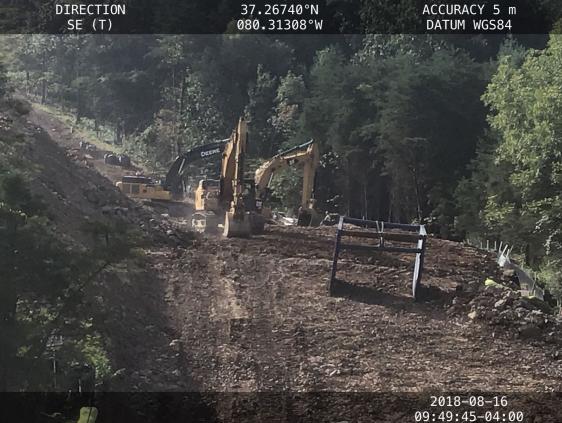
37.26848°N 080.31451°W ACCURACY 30 m DATUM WGS84	2018-08-16 08:08:02-04:00	GPS Location	37.2688546730553, -80.314562609494
Description	Operators finished backfilling pipe to station 12020+00, ~MP 227.4~.	GPS Location	37.3086617856119, -80.0104646401183	Description	ESI continued with fish removal activities at the S-G36 crossing today. See photo for location.
DIRECTION N (T)

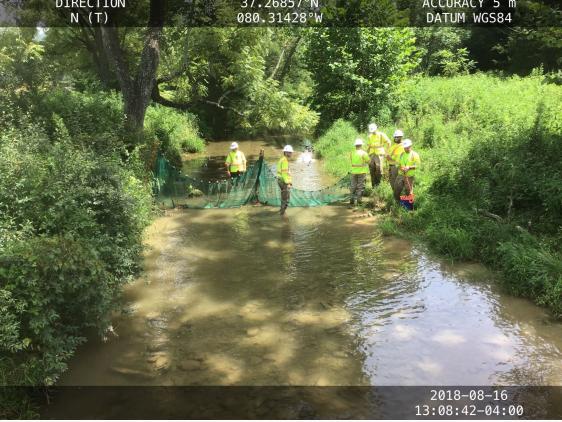
37.26865°N 080.31448°W ACCURACY 5 m DATUM WGS84	2018-08-16 08:39:45-04:00	GPS Location	37.3084333911886, -80.0101030525565
Description	ESI expanded the removal area @ S-G36 to accommodate a pump around for reshaping the stream bed. See photo for location.	GPS Location	37.3086997679668, -80.0104636963705	Description	A turbidity curtain was installed downstream from the crossing @ S-G36 in preparation for in-stream activity. See photo for location.

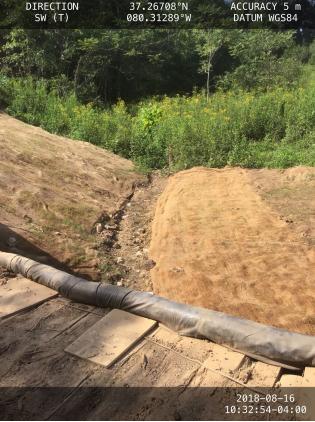
37.26865°N 080.31445°W ACCURACY 10 m DATUM WGS84	2018-08-15 14:37:27-04:00	GPS Location	37.3086711857815, -80.0103208144009
Description	WSSI specialists determined that stream S-G38 had been adequately restored and did not require regrading. See photo for location.	GPS Location	37.3085417272871, -80.0101394300163	Description	Approximately 0.9 feet will be removed from the stream bed grade of the S-G36 crossing tomorrow.
