Visual Site Inspection Report

Project Name	H-600 Pipeline Spread H	AFE	124300138	Spread	H-600 Pipeline Spread H
Contractor	Precision			Report #	1930
Inspector	Pat Davis			Date/Time	5/18/2018 7:19 AM
Permit #	TBD	Inspection Type	VA SWPP	Station Begin	12005+00
State	VA	Inspection Area	Partial	Station End	12026+00
County	Montgomery	Ground	Muddy	Temperature (°F)	70.00
Municipality	N/A	Weather	Light Rain	Rain Gauge (in)	1.90
GPS Location	37.2789841142201, -80.0284684834355			Rain Accumulation Time (days)	1.00

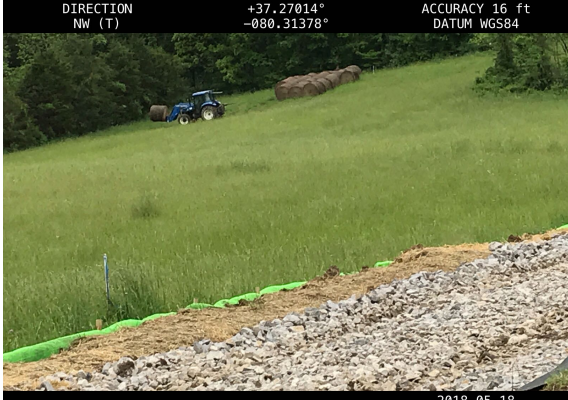
<div>2018-05-18 13:57:33-04:00</div>		
GPS Location	37.278985418414, -80.0287371129543		GPS Location	37.278985418414, -80.0287371129543	
Description	MVP-ATWS-473_052818 more mulch has moved from berm by rain. Looking W. See photo for gps data.		Description	MVP-MN-268_051818 landowner brought tractor Down access road, got hay bales and left, tracking mud onto Catawba Road.
