# Visual Site Inspection Report

<b>Project Name</b>	H-600 Pipeline Spread H	<b>AFE</b>	124300138	<b>Spread</b>	H-600 Pipeline Spread H
<b>Contractor</b>	Precision			<b>Report #</b>	2719
<b>Inspector</b>	Pat Davis			<b>Date/Time</b>	6/5/2018 6:36 AM
<b>Permit #</b>	TBD	<b>Inspection Type</b>	VA SWPP	<b>Station Begin</b>	12371+00
<b>State</b>	VA	<b>Inspection Area</b>	Partial	<b>Station End</b>	13415+00
<b>County</b>	Franklin	<b>Ground</b>	Dry	<b>Temperature (°F)</b>	82.00
<b>Municipality</b>	N/A	<b>Weather</b>	Sunny	<b>Rain Gauge (in)</b>	0.00
<b>GPS Location</b>	37.1258313674825, -80.1196525153519			<b>Rain Accumulation Time (days)</b>	0.00

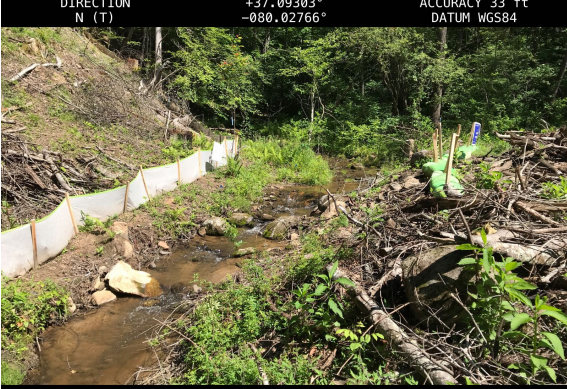
2018-06-05 11:41:51-04:00			
<b>GPS Location</b>	37.1257832553583, -80.1196724642814	<b>GPS Location</b>	37.1258547949019, -80.120059792027		
<b>Description</b>	13413+05_060518 S-IJ1 temp. ECD's in place. Looking N. See photo for gps data.	<b>Description</b>	13200+00_060518 Clearing stacking trees. Looking E. See photo for gps data.		
DIRECTION NW (T)      +37.12528°      ACCURACY 16 ft -080.12086°      DATUM WGS84

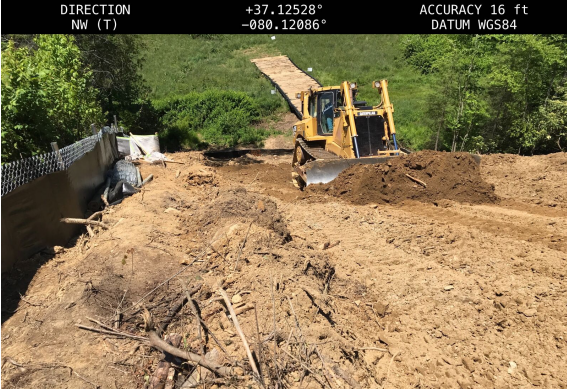
<b>Description</b>	13027+00_060518 Grade crew making ROW cuts. Looking NW. See photo for gps data.	<b>Description</b>	13084+77_060518 Grade crew making ROW cut. Looking E. See photo for gps data.		
DIRECTION NE (T)      +37.12318°      ACCURACY 16 ft -080.11625°      DATUM WGS84

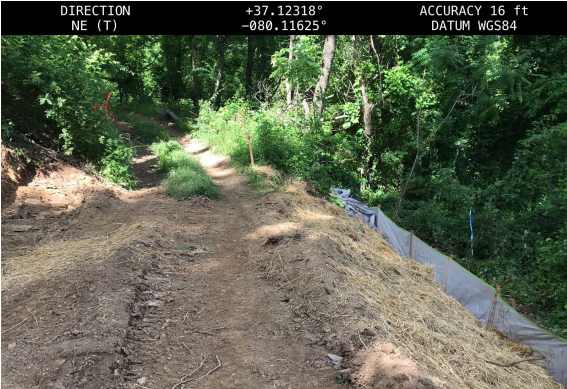
2018-06-05 18:18:47-04:00			
<b>GPS Location</b>	37.1256063552919, -80.1199160423876	<b>GPS Location</b>	37.1256063552919, -80.1199160423876		
<b>Description</b>	MVP-FR-290_060518 contractor has bladed access road up to the bird buffer. Looking NE. See photo for gps data.	<b>Description</b>	13027+00_060518 breaker installed after Grade crew made ROW cut. Looking N. See photo for gps data.
