Visual Site Inspection Report

Project Name	H-600 Pipeline Spread H		AFE	124300138	Spread	H-600 Pipeline Spread H	
Contractor	Precision				Report #	2919	
Inspector	Pat Davis				Date/Time	6/11/2018 8:04 AM	
Permit #	TBD	Inspection Type	VA SWPP		Station Begin	13061+89	
State	VA	Inspection Area	Partial		Station End	13413+01	
County	Franklin	Ground	Muddy		Temperature (°F)	70.00	
Municipality	N/A	Weather	Light Rain		Rain Gauge (in)	1.30	
GPS Location	37.2788327963123, -80.0288837640432				Rain Accumulation Time (days)	4.00

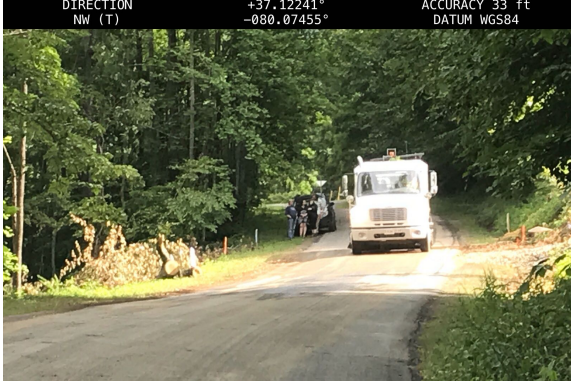
<div>2018-06-11 10:01:48-04:00</div> </div>		
GPS Location	37.2788598067137, -80.028942794588			GPS Location	37.2787651868454, -80.0289025432773
Description	13197+64_061118 Water/ sweeper truck cleaning Dillion's Mill Road. Looking NW. See photo for gps data.			Description	13197+64_061118 crew added P 1 silt fence to protect Dillion's Mill Road. Looking SE. See photo for gps data.
<div data-bbox="162 785 730 1205">

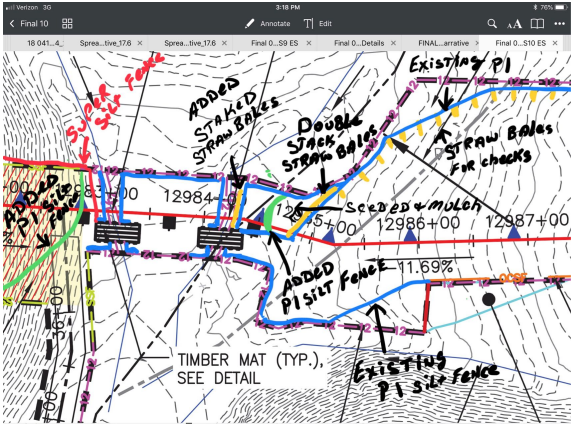
GPS Location	37.2787535079629, -80.0288981162751			GPS Location	37.2788487427254, -80.0287353608035
Description	Drawing of corrective actions S-G26 and S-G27			Description	13062+96_061118 crew cleaning mat bridge over S-G27. Looking M. See photo for gps data.
<div data-bbox="162 1365 730 1785"> <div>DIRECTION SW (T)</div> <div>+37.12331° -080.12075°</div> <div>ACCURACY 16 ft DATUM WGS84</div>

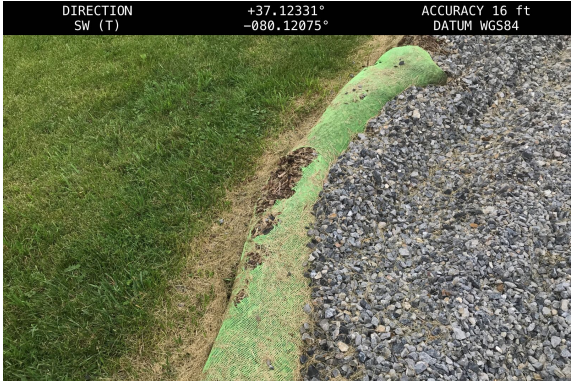
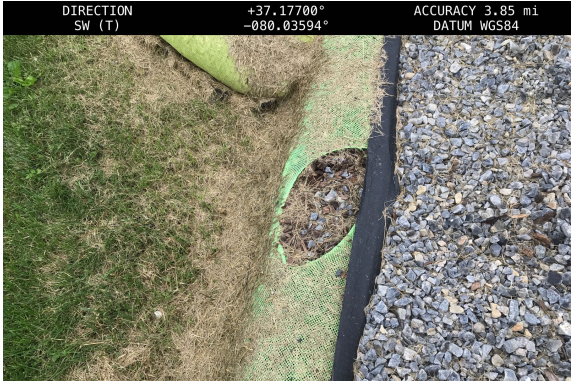
<div>2018-06-11 16:29:39-04:00</div> </div>		
GPS Location	37.2788560096227, -80.0287255700714			GPS Location	37.2788577972328, -80.0289818683641
Description	MVP-FR-290_061118 damaged compost filter sock. Looking SW. See photo for gps data.			Description	MVP-FR-290_061118 damaged compost filter sock. Looking SW. See photo for gps data.

4. E&S BMPs (List BMPs and note if installed and maintained as per the plan. If corrective action is needed, a picture is required.)							
E&S BMPs		Compliance Level		Corrective Action		Corrective Time Frame	
Compost Filter Sock		Problem Area		Repair or replace along access road 2		24 Hours	
Housekeeping		Communication		Remove trash		24 Hours	
Waterbar		Communication		Re-work and reshape		Immediate	
Silt Fence (Filter Fabric Fence)		Communication		Repair and re-enforce		Immediate
