Visual Site Inspection Report

Project Name	H-600 Pipeline Spread H	AFE	124300138	Spread	H-600 Pipeline Spread H
Contractor	Precision			Report #	3142
Inspector	Pat Davis			Date/Time	6/15/2018 6:45 AM
Permit #	TBD	Inspection Type	VA SWPP	Station Begin	13062+96
State	VA	Inspection Area	Partial	Station End	1311+00
County	Franklin	Ground	Damp	Temperature (°F)	87.00
Municipality	N/A	Weather	Sunny	Rain Gauge (in)	0.00
GPS Location	37.1668567891038, -80.1156789268			Rain Accumulation Time (days)	0.00

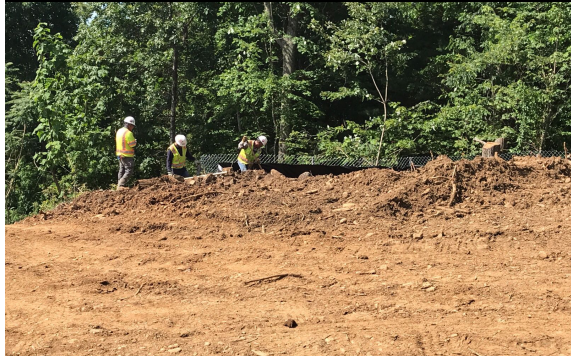
<div>2018-06-15 10:37:36-04:00</div>		
GPS Location	37.1669460099712, -80.1153876518779		GPS Location	37.1668586042124, -80.1152887289227	
Description	13115+97_061518 Environmental crew installing super silt fence. Looking S. See photo gps data.		Description	13094+45_061518 Grade crew making cuts and moving rock. Looking N. See photo for gps data.	
<div>DIRECTION NE (T)</div> <div>+37.12562° -080.11285°</div> <div>ACCURACY 16 ft DATUM WGS84</div>

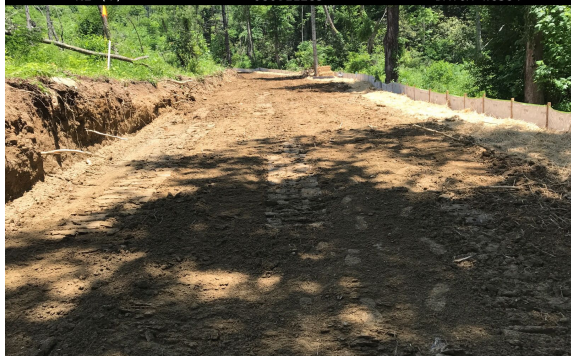
GPS Location	37.1668365178976, -80.1152309776098		GPS Location	37.1668591909457, -80.1151868049801	
Description	MVP-FR-290_061518 access road with ECD's on low side. Looking NE. See photo for gps data.		Description	13076+00_061518 Blasting crew packing charges. Looking E. See photo for gps data.	
<div>DIRECTION SW (T)</div> <div>+37.12388° -080.11566°</div> <div>ACCURACY 33 ft DATUM WGS84</div>

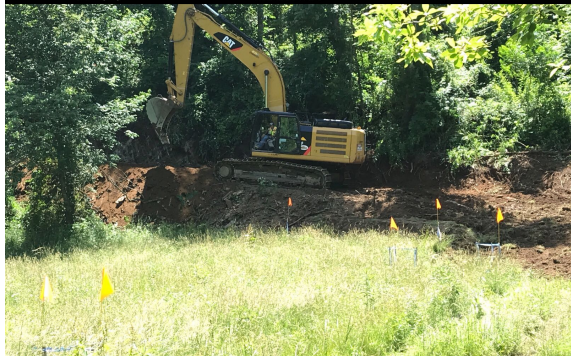
<div>2018-06-15 16:53:05-04:00</div>		
GPS Location	37.1668591490361, -80.1151882299037		GPS Location	37.1668583108458, -80.1151889004559	
Description	MVP-FR-290_061518 crew working on access road. Looking SW. See photo for gps data.		Description	13082_0615189 waterbar extended to edge of ROW with filter. Looking E. See photo for gps data.
