Visual Site Inspection Report

Project Name	H-600 Pipeline Spread H	AFE	124300138	Spread	H-600 Pipeline Spread H
Contractor	Precision			Report #	3646
Inspector	Pat Davis			Date/Time	6/25/2018 11:06 AM
Permit #	TBD	Inspection Type	Weekly	Station Begin	13244+07
State	VA	Inspection Area	Partial	Station End	13262+66
County	Franklin	Ground	Muddy	Temperature (°F)	76.00
Municipality	N/A	Weather	Light Rain	Rain Gauge (in)	0.00
GPS Location	37.0891004381296, -80.0432873834512			Rain Accumulation Time (days)	0.00

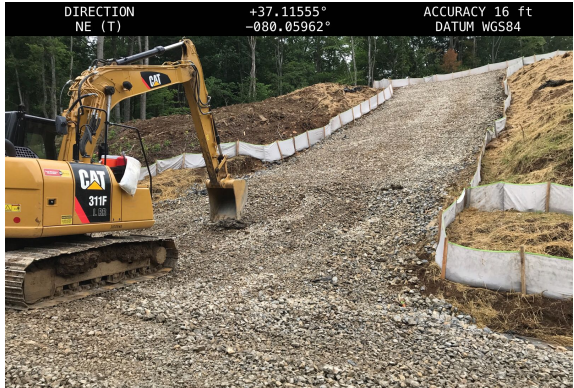
<p>DIRECTION NE (T) +37.11555° -080.05962° ACCURACY 16 ft DATUM WGS84</p> <p>2018-06-25 11:22:05-04:00</p>

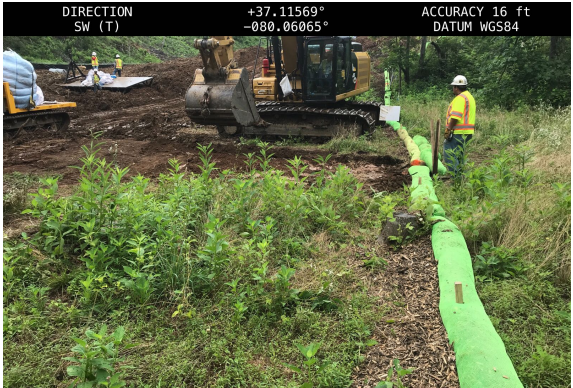
<p>DIRECTION SW (T) +37.11569° -080.06065° ACCURACY 16 ft DATUM WGS84</p> <p>2018-06-25 13:12:48-04:00</p>		
GPS Location	37.2788227869146, -80.0288010061434		GPS Location	37.2788153205892, -80.0287571614162	
Description	13262+66_062518 crew finishing rock approach. Looking NE. See photo for gps data.		Description	13260+00_062518 crew installing waterbar and sump. Looking SW. See photo for gps data.

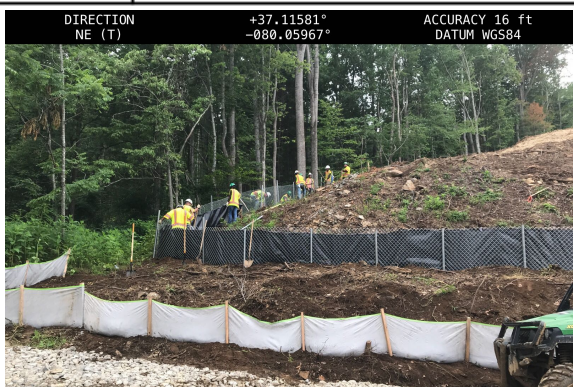
<p>DIRECTION NE (T) +37.11581° -080.05967° ACCURACY 16 ft DATUM WGS84</p> <p>2018-06-25 15:09:27-04:00</p>

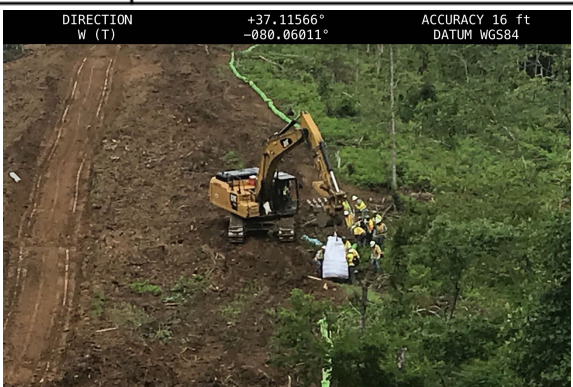
<p>DIRECTION W (T) +37.11566° -080.06011° ACCURACY 16 ft DATUM WGS84</p> <p>2018-06-25 12:36:33-04:00</p>		
GPS Location	37.2789854603235, -80.0285727438331		GPS Location	37.2789854603235, -80.0285727438331

Description	13262+84_062518 crew upgrading single 18 inch sock with super silt fence. Looking NE. See photo for gps data.		Description	13256+52_062518 crew chinking compost filter sock. Looking W. See photo for gps data.

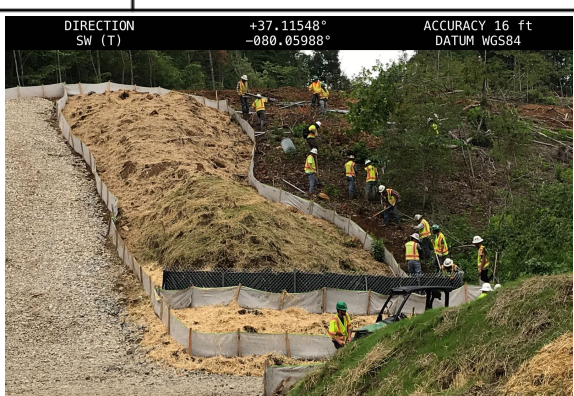
<p>DIRECTION SW (T) +37.11548° -080.05988° ACCURACY 16 ft DATUM WGS84</p> <p>2018-06-25 16:42:28-04:00</p>

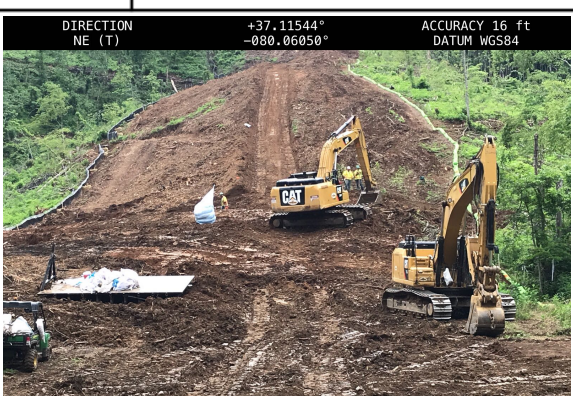
<p>DIRECTION NE (T) +37.11544° -080.06050° ACCURACY 16 ft DATUM WGS84</p> <p>2018-06-25 16:43:36-04:00</p>		
GPS Location	37.2789854603235, -80.0285727438331		GPS Location	37.2789854603235, -80.0285727438331	
Description	13262+84_062518 crew installing super silt fence. Looking SW. See photo for gps data.		Description	13259+00_062518 crew installing waterbars. Looking NE. See photo for gps data.
