# Visual Site Inspection Report

<b>Project Name</b>	H-600 Pipeline Spread H	<b>AFE</b>	124300138	<b>Spread</b>	H-600 Pipeline Spread H
<b>Contractor</b>	Precision			<b>Report #</b>	3742
<b>Inspector</b>	Pat Davis			<b>Date/Time</b>	6/27/2018 8:07 PM
<b>Permit #</b>	TBD	<b>Inspection Type</b>	VA SWPP	<b>Station Begin</b>	13197+55
<b>State</b>	VA	<b>Inspection Area</b>	Partial	<b>Station End</b>	13357+18
<b>County</b>	Franklin	<b>Ground</b>	Muddy	<b>Temperature (°F)</b>	83.00
<b>Municipality</b>	N/A	<b>Weather</b>	Cloudy	<b>Rain Gauge (in)</b>	0.20
<b>GPS Location</b>	37.2786939021075, -80.028898723583			<b>Rain Accumulation Time (days)</b>	0.00

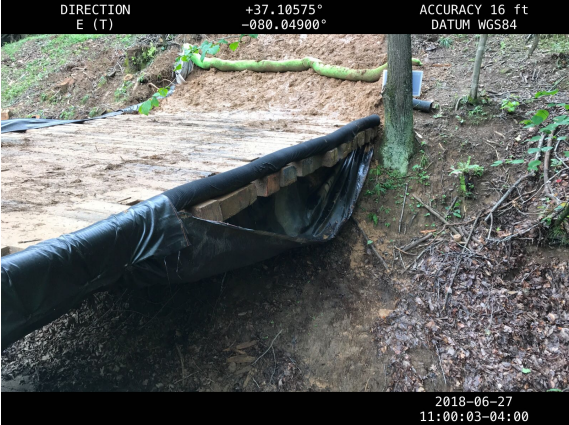
<b>GPS Location</b>	37.2787482292019, -80.0291891864767		<b>GPS Location</b>	37.2789401219056, -80.0288821239142	
<b>Description</b>	13325+30_062718 S-GH14 geotech pulled loose on bridge. Looking E. See photo for gps data.		<b>Description</b>	13325+30_062718 S-GH14 sediment on streambank. Looking SE. See photo for gps data.

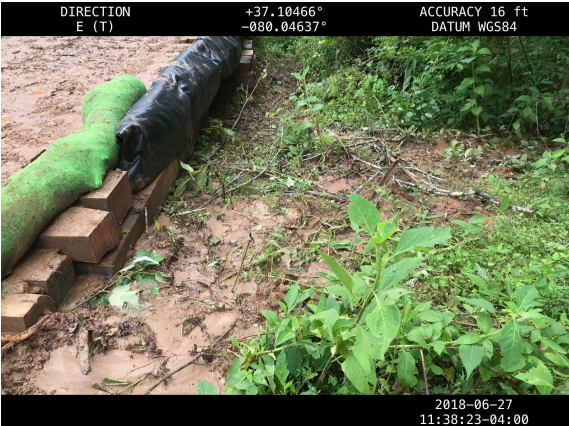
Spread 10..... Summary of activities: The contractor has installed E&S controls along both edges of the ROW to station 13120+15 (MP 248.3) Due to stay off tract the (John Davis) Environmental crew has moved to Dillion's Mill Road station 13197+55 (MP 249.8) installing environmental controls to station 13262+84 (MP 251.0). The (Hail) environmental crew has started at Wades Gap Road station 13315+70 (MP 252.0) installing environmental controls to station 13272+02 (MP 251.2). The crews have upgraded 213 feet of P1 silt fence for the designed single 12 inch compost filter sock, upgraded and installed 3434 feet of single 18 inch compost filter sock for the designed single 12 inch compost filter sock, and upgraded and installed 344 feet for the designed single 18 inch compost filter sock. The Mechanized Clearing crew has been processing timber and stacking timber at station 13315+70 (MP 252.0) to station 13357+18 (MP 252.8). Northern Clearing has installed two bridges at feature S-RR08 station 13348+46 (MP 252.7) and feature S-RR09 station 13352+23 (MP 252.8). Issues of no sumps on temporary waterbars were observed on waterbars between station 13315+70 (MP 252.2) to station 13357+18 (MP 252.7). EI observed at feature S-GH14 geotech came loose from the bottom of the bridge mats and sediment dropped on the waterbody bank. At feature S-GH11 sediment impacted the waterbody and discolored a pond about 200 feet south of the ROW.

<b>GPS Location</b>	37.2788549960007, -80.0287848898024		<b>GPS Location</b>	37.278876872768, -80.0286832173169	
<b>Description</b>	13334+17_062718 S-GH11 sediment off bridge. Looking E. See photo for gps data.		<b>Description</b>	13334+17_062718 pond discolored. Looking S. See photo for gps data.

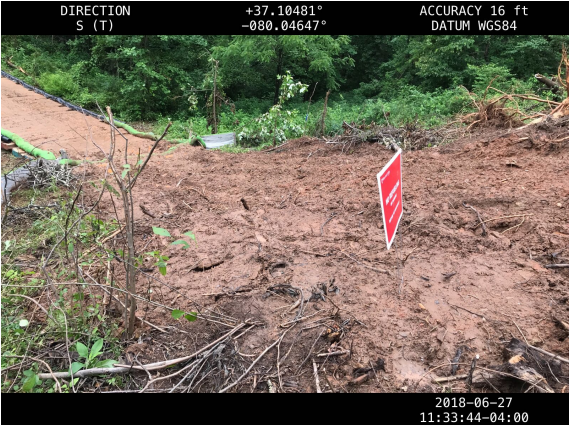
<b>GPS Location</b>	37.278876872768, -80.0286832173169		<b>GPS Location</b>	37.278876872768, -80.0286832173169	
<b>Description</b>	13333+00_062718 area give S-GH11. Looking S. See photo for gps data.		<b>Description</b>	13321+47_062718 area above S-GH15. Looking S. See photo for gps data.
