Visual Site Inspection Report

Project Name	H-600 Pipeline Spread H		AFE	124300138	Spread	H-600 Pipeline Spread H	
Contractor	Precision				Report #	4022	
Inspector	Pat Davis				Date/Time	7/3/2018 7:11 PM	
Permit #	TBD	Inspection Type	VA SWPP		Station Begin	13197+35	
State	VA	Inspection Area	Partial		Station End	13365+27	
County	Franklin	Ground	Dry		Temperature (°F)	93.00	
Municipality	N/A	Weather	Sunny		Rain Gauge (in)	0.00	
GPS Location	37.2786346922421, -80.0286455651601				Rain Accumulation Time (days)	0.00

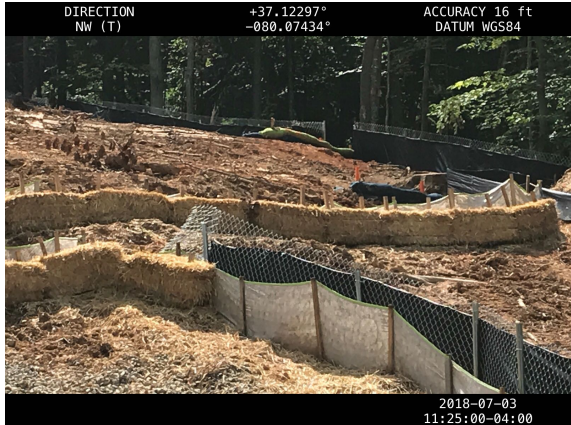
<div>2018-07-03 11:17:28-04:00</div>		
GPS Location	37.2791404256297, -80.0285004457667		GPS Location	37.2788502206088, -80.0289253687806	
Description	13197+35_070318 Dillion's Mill Road protected by ECD's. Looking NE. See photo for gps data.		Description	13260+60_070318 S-114 feature and slope with ECD's installed. Looking W. See photo for gps data.	
<div>DIRECTION W (T) +37.10656° -080.05415° ACCURACY 16 ft DATUM WGS84</div>

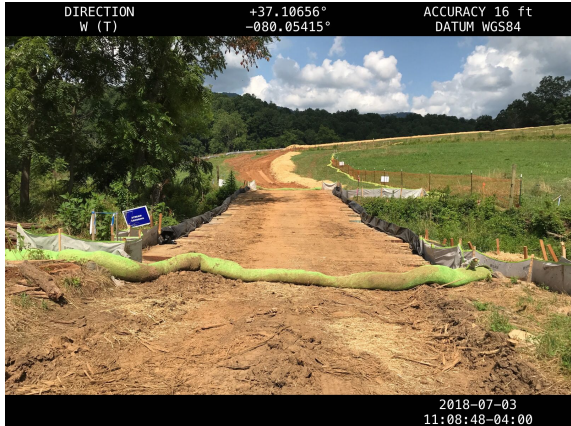
Description	13309+09_070318 S-GH7 Erosion controlled devices installed. Looking W. See photo for gps data.		Description	13261+28_070318 spoil pile stabilized. Looking SW. See photo for gps data.	
<div>DIRECTION E (T) +37.10658° -080.05188° ACCURACY 16 ft DATUM WGS84</div>

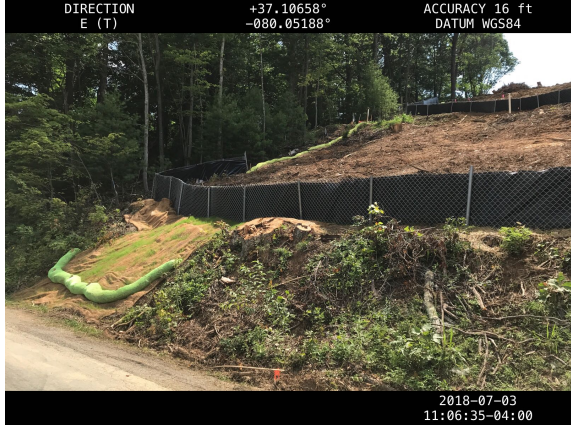
<div>2018-07-03 11:05:58-04:00</div>		
GPS Location	37.2788543673579, -80.028924113214		GPS Location	37.2788543673579, -80.028924113214	
Description	13262+62_070318 slope stabilized and ECD's installed. Looking E. See photo for gps data.		Description	13317+02_070318 ECD's installed to protect private drive. Looking E. See photo for gps data.
