Visual Site Inspection Report

Project Name	H-600 Pipeline Spread H	AFE	124300138	Spread	H-600 Pipeline Spread H
Contractor	Precision			Report #	4339
Inspector	Pat Davis			Date/Time	7/9/2018 2:52 PM
Permit #	TBD	Inspection Type	VA SWPP	Station Begin	13197+55
State	VA	Inspection Area	Partial	Station End	13360+00
County	Franklin	Ground	Dry	Temperature (°F)	85.00
Municipality	N/A	Weather	Sunny	Rain Gauge (in)	0.00
GPS Location	37.2044927927862, -79.950553100954			Rain Accumulation Time (days)	0.00

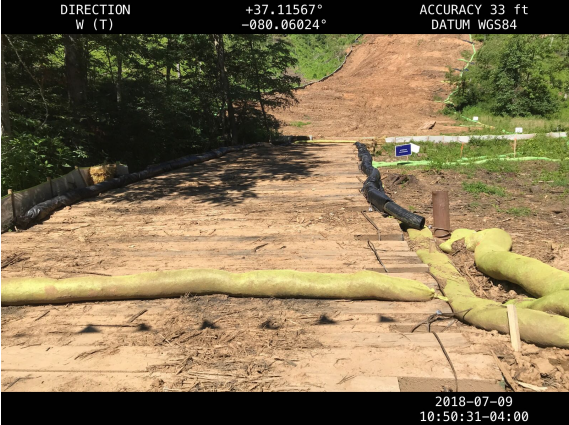
GPS Location	37.2039044901498, -79.9503384831299	GPS Location	37.2050791187558, -79.9500287790596		
Description	13260+66_070918 S-GH114 anchor and cable installed. Looking W. See photo for GPS data.	Description	13264+25_070918 crew installed triple stack j hook. Looking N. See photo for gps data.

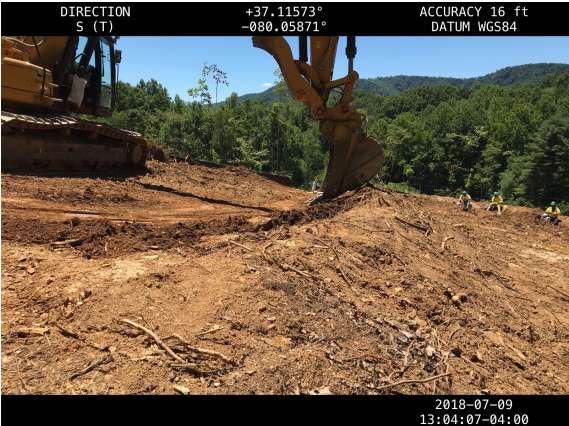
GPS Location	37.205030797084, -79.9499454629421	GPS Location	37.2052697651435, -79.950169930309		
Description	13265+50_070918 crew repairing berm height. Looking S. See photo for gps data.	Description	13264+90_070918 crew cleaning obstructed channel. Looking SE. See photo for gps data.

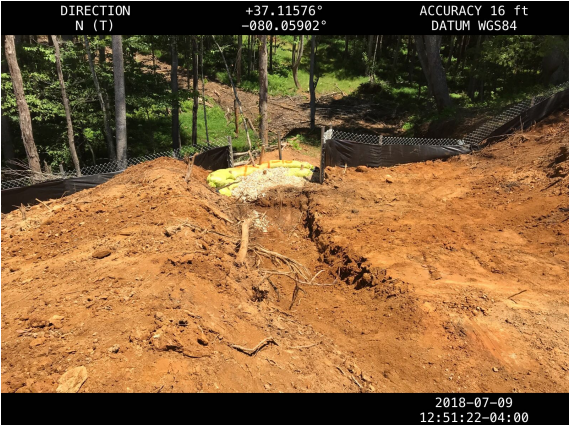
GPS Location	37.2049988201235, -79.9500302878022	GPS Location	37.2050098004166, -79.950006064102		
Description	13264+90_070918 crew installed triple stack j hook. Looking N. See photo for gps data.	Description	13265+50_070918 crew checking berm height. Looking E. See photo for gps data.
