# Visual Site Inspection Report

<b>Project Name</b>	H-600 Pipeline Spread H	<b>AFE</b>	124300138	<b>Spread</b>	H-600 Pipeline Spread H
<b>Contractor</b>	Precision			<b>Report #</b>	4552
<b>Inspector</b>	Pat Davis			<b>Date/Time</b>	7/13/2018 4:18 PM
<b>Permit #</b>	TBD	<b>Inspection Type</b>	VA SWPP	<b>Station Begin</b>	13197+55
<b>State</b>	VA	<b>Inspection Area</b>	Partial	<b>Station End</b>	13360+00
<b>County</b>	Franklin	<b>Ground</b>	Dry	<b>Temperature (°F)</b>	85.00
<b>Municipality</b>	N/A	<b>Weather</b>	Sunny	<b>Rain Gauge (in)</b>	0.00
<b>GPS Location</b>	37.205055817065, -79.9499005359411			<b>Rain Accumulation Time (days)</b>	0.00

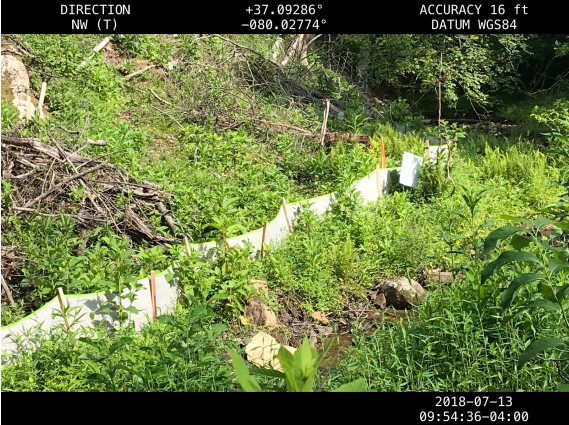
<b>GPS Location</b>	37.2052944917578, -79.9501243327557	<b>GPS Location</b>	37.2050773166467, -79.94986340411		
<b>Description</b>	13413+01_071318 S-IJ1 ECD's in place. Looking NW. see photo for gps data.	<b>Description</b>	13348+46_071318 S-RR08 ECD' in place bridge clean. Looking E. See photo for gps data.

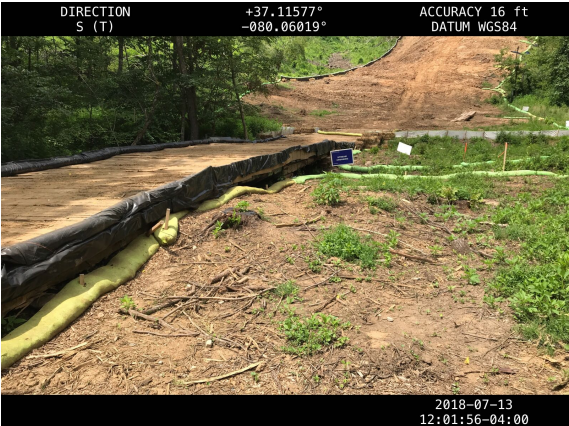
<b>GPS Location</b>	37.2050900571395, -79.9497888051718	<b>GPS Location</b>	37.2050900571395, -79.9497888051718		
<b>Description</b>	13260+66_071318 S-114 ECD's installed and bridge clean. Looking S. See photo for gps data.	<b>Description</b>	13309+09_071318 S-GH7 ECD's installed and bridge clean. Looking SW. See photo for gps data.

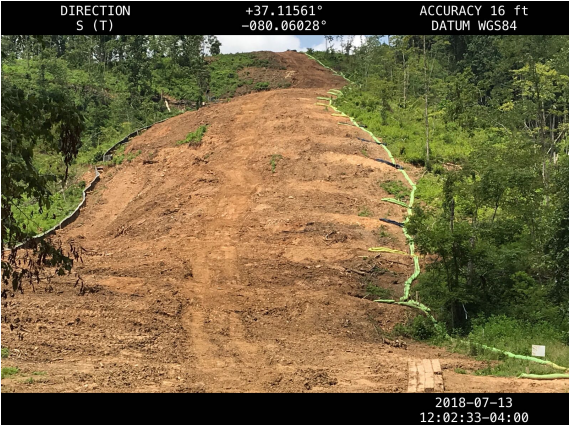
<b>GPS Location</b>	37.2053466307403, -79.9500757033135	<b>GPS Location</b>	37.2053466307403, -79.9500757033135		
<b>Description</b>	13254+82_071318 slope with interim waterbars. Looking S. See photo for gps data.	<b>Description</b>	13197+98_071318 spoil pile stabilized. Looking SW. See photo for gps data.
