# Visual Site Inspection Report

<b>Project Name</b>	H-600 Pipeline Spread H	<b>A/E</b>	124300138	<b>Spread</b>	H-600 Pipeline Spread H	
<b>Contractor</b>	Precision			<b>Report #</b>	4853	
<b>Inspector</b>	Pat Davis			<b>Date/Time</b>	7/19/2018 4:29 PM	
<b>Permit #</b>	TBD	<b>Inspection Type</b>	VA SWPP	<b>Station Begin</b>	+0	
<b>State</b>	VA	<b>Inspection Area</b>	Partial	<b>Station End</b>	+0	
<b>County</b>	Roanoke	<b>Ground</b>	Damp	<b>Temperature (°F)</b>	84.00	
<b>Municipality</b>	N/A	<b>Weather</b>	Cloudy	<b>Rain Gauge (in)</b>	0.00	
<b>GPS Location</b>	37.2702391120021, -80.1214454882593			<b>Rain Accumulation Time (days)</b>	0.00

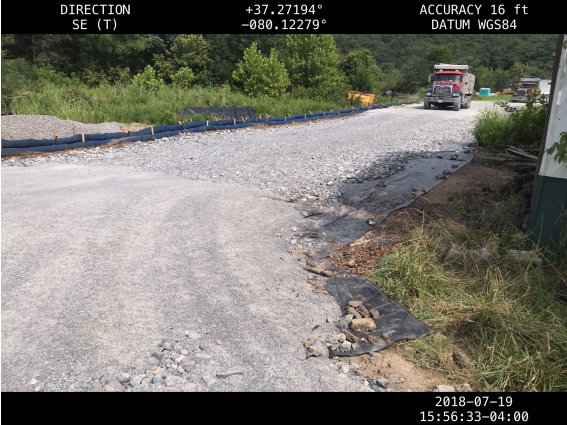
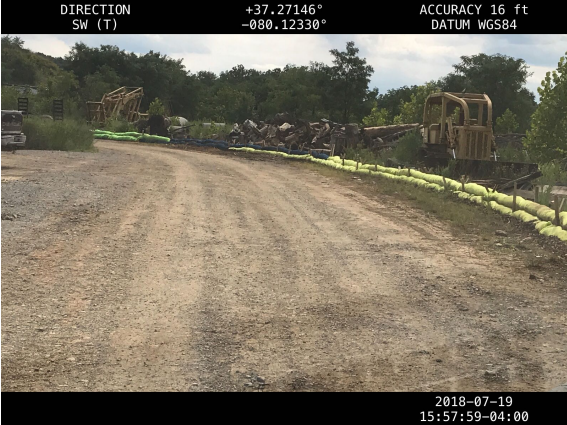
<b>GPS Location</b>	37.2700984217573, -80.1214438118786	<b>GPS Location</b>	37.2702622879644, -80.1216409542413		
<b>Description</b>	MVP-LY-049_071918 rock approach installed. Looking SE. See photo for gps data.	<b>Description</b>	MVP-LY-049_071918 triple stack compost filter sock installed along boundary of LOD. Looking SW. See photo for gps data.

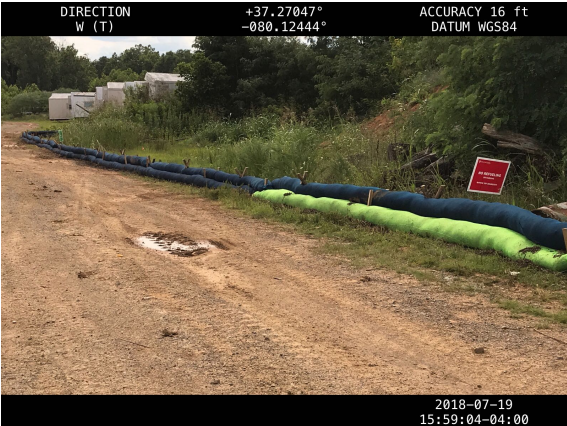
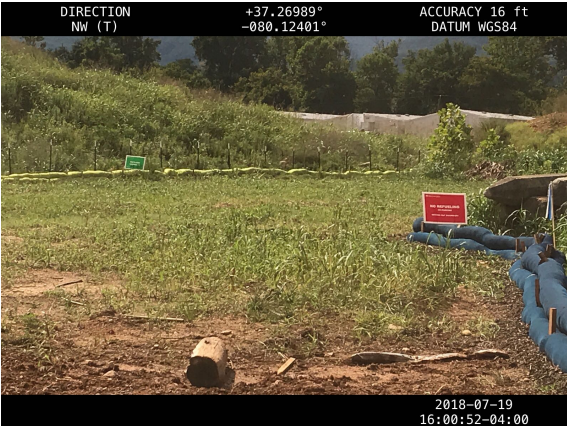
<b>GPS Location</b>	37.2702642996211, -80.1216396131368	<b>GPS Location</b>	37.2702642996211, -80.1216396131368		
<b>Description</b>	MVP-LY-049_071918 triple stack filter sock and signage at wetland W-CV21A. Looking W. See photo for gps data.	<b>Description</b>	MVP-LY-049_071918 triple stack filter sock and signage at wetland W-CV21B. Looking NW. See photo for gps data.

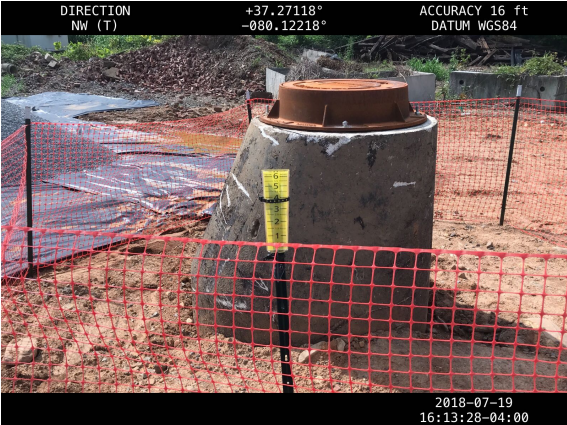
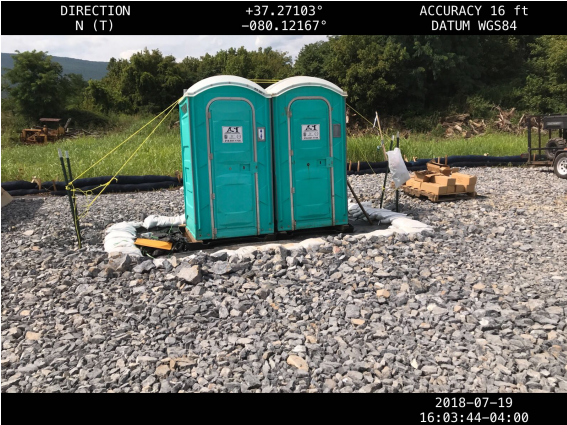
<b>Description</b>	MVP-LY-049_071918 rain gauge installed at yard. Looking NW. See photo for gps data.	<b>Description</b>	MVP-LY-049_071918 porta toilets set in containment per E&S Plan. Looking N. See photo for gps data.
