Visual Site Inspection Report

Project Name	H-600 Pipeline Spread H		AFE	124300138	Spread	H-600 Pipeline Spread H	
Contractor	Precision				Report #	4859	
Inspector	Pat Davis				Date/Time	7/19/2018 6:14 PM	
Permit #	TBD	Inspection Type	VA SWPP		Station Begin	+0	
State	VA	Inspection Area	Partial		Station End	+0	
County	Montgomery	Ground	Damp		Temperature (°F)	83.00	
Municipality	N/A	Weather	Cloudy		Rain Gauge (in)	0.20	
GPS Location	37.2788208418179, -80.0291302758245				Rain Accumulation Time (days)	4.00

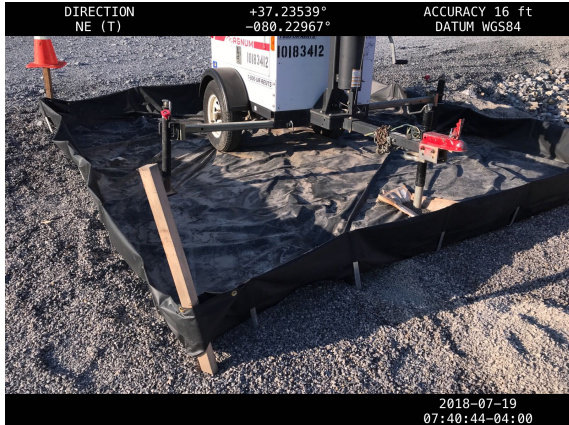
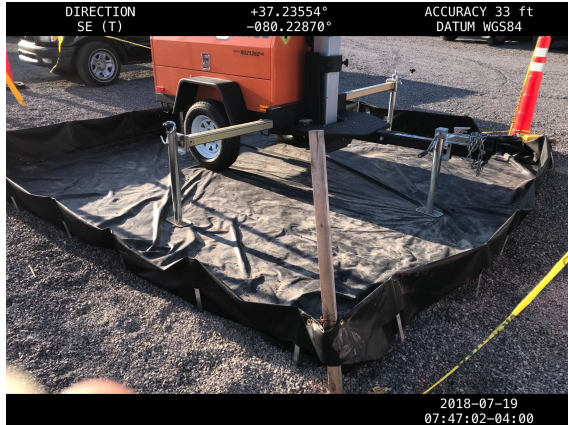
GPS Location	37.27885893872, -80.0290009401166		GPS Location	37.2788563020201, -80.0289647922174	
Description	MVP-PY-006_071918 containment under light plant. Looking NE. See photo for gps data.		Description	MVP-PY-006_071917 containment under generator. Looking SE. See photo for gps data.

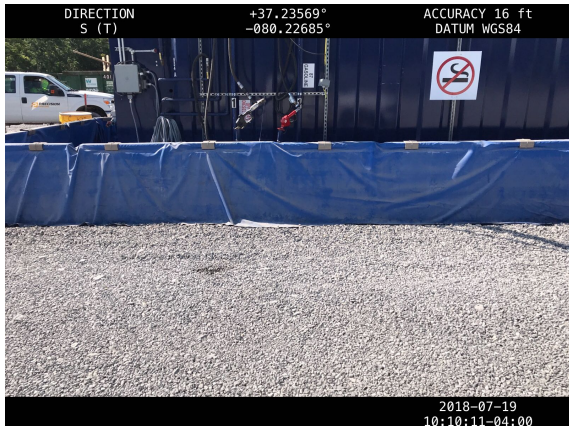
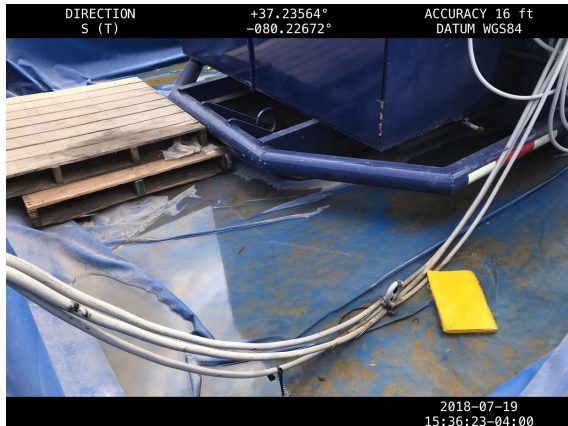
GPS Location	37.2788850300068, -80.0289598020737		GPS Location	37.2788849833138, -80.0288502410263	
Description	MVP-PY-006_071918 nozzles and hoses inside containment. Looking S. See photo for gps data.		Description	MVP-PY-006_071918 containment under bulk fuel tanks. Looking S. See photo for gps data.

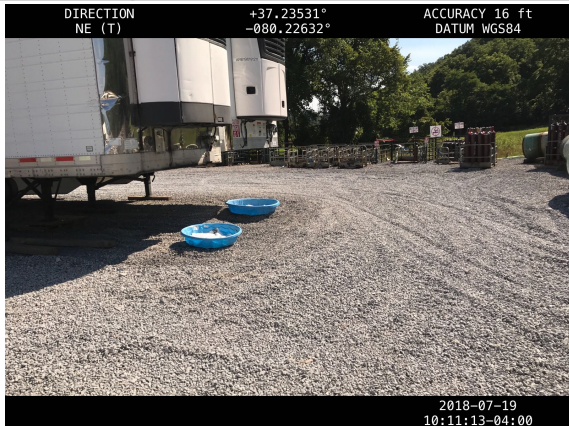
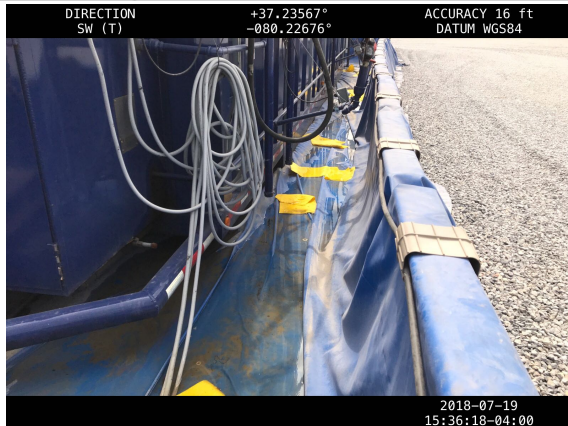
GPS Location	37.2788854677418, -80.0288493323688		GPS Location	37.2788855287167, -80.0288492179962	
Description	MVP-PY-006_071918 containment and absorbent pads under units. Looking NE. See photo for gps data.		Description	MVP-PY-006_071918 containment around bulk fuel storage. Looking SW. See photo for gps data.
