Visual Site Inspection Report

Project Name	H-600 Pipeline Spread H	AFE	124300138	Spread	H-600 Pipeline Spread H
Contractor	Precision			Report #	5166
Inspector	Pat Davis			Date/Time	7/25/2018 5:25 PM
Permit #	TBD	Inspection Type	VA SWPP	Station Begin	+0
State	VA	Inspection Area	Partial	Station End	+0
County	Roanoke	Ground	Muddy	Temperature (°F)	84.00
Municipality	N/A	Weather	Light Rain	Rain Gauge (in)	0.00
GPS Location	37.27638351, -80.1102746			Rain Accumulation Time (days)	0.00

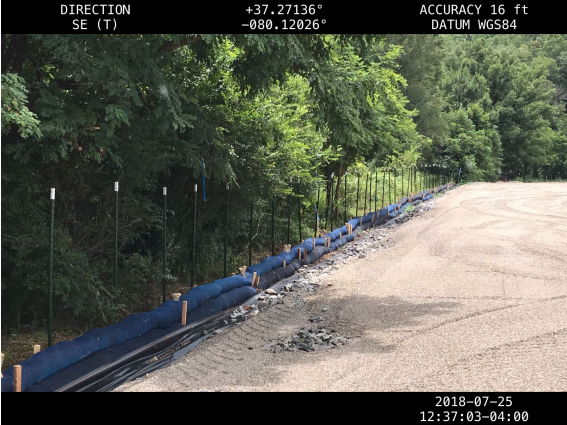
2018-07-25 12:41:57-04:00			
GPS Location	37.2711489675914, -80.1212109626086	GPS Location	37.2711489675914, -80.1212109626086		
Description	MVP-LY-049_072518 triple stack compost filter sock along east LOD boundary. Looking SE. see photo for gps data.	Description	MVP-LY-049_072518 triple stack compost filter sock along the north edge of drive. Looking S. See photo for gps data.		
DIRECTION +37.27036° ACCURACY 16 ft SE (T) -080.12479° DATUM WGS84

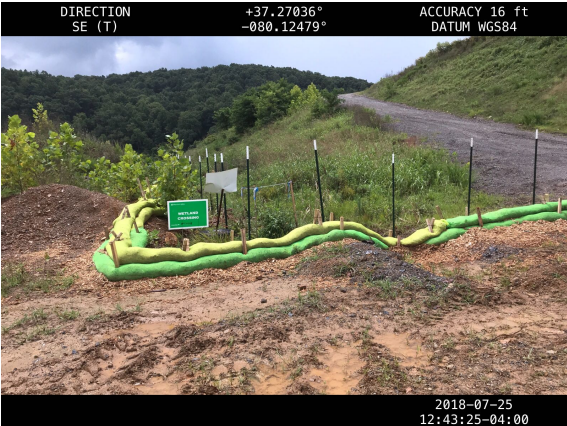
Description	MVP-LY-049_072518 triple stack compost filter sock along the boundary of W-CV21B. Looking SE. See photo for gps data.	Description	MVP-LY-049_072518 fluids on pallets under Norther Clearing's trailers. Looking N. See photo for gps data.		
DIRECTION +37.27101° ACCURACY 16 ft NW (T) -080.12164° DATUM WGS84

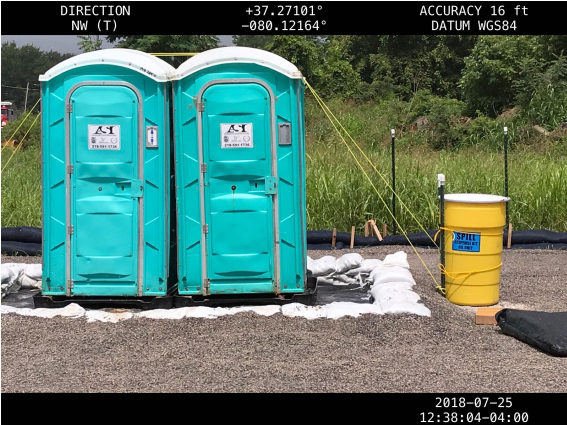
2018-07-25 16:07:12-04:00			
GPS Location	37.2711485484962, -80.1211533789338	GPS Location	37.2701581009079, -80.1225902047754		
Description	MVP-LY-049_072518 porta toilets in containment. Looking NW. See photo for gps data.	Description	MVP-LY-049_072518 fluids placed in containments under Northern Clearings trailer. Looking N. See photo for gps data.
